## UPDATE HANDBOOK AODE, 4R70W, 4R70E, 4R75E

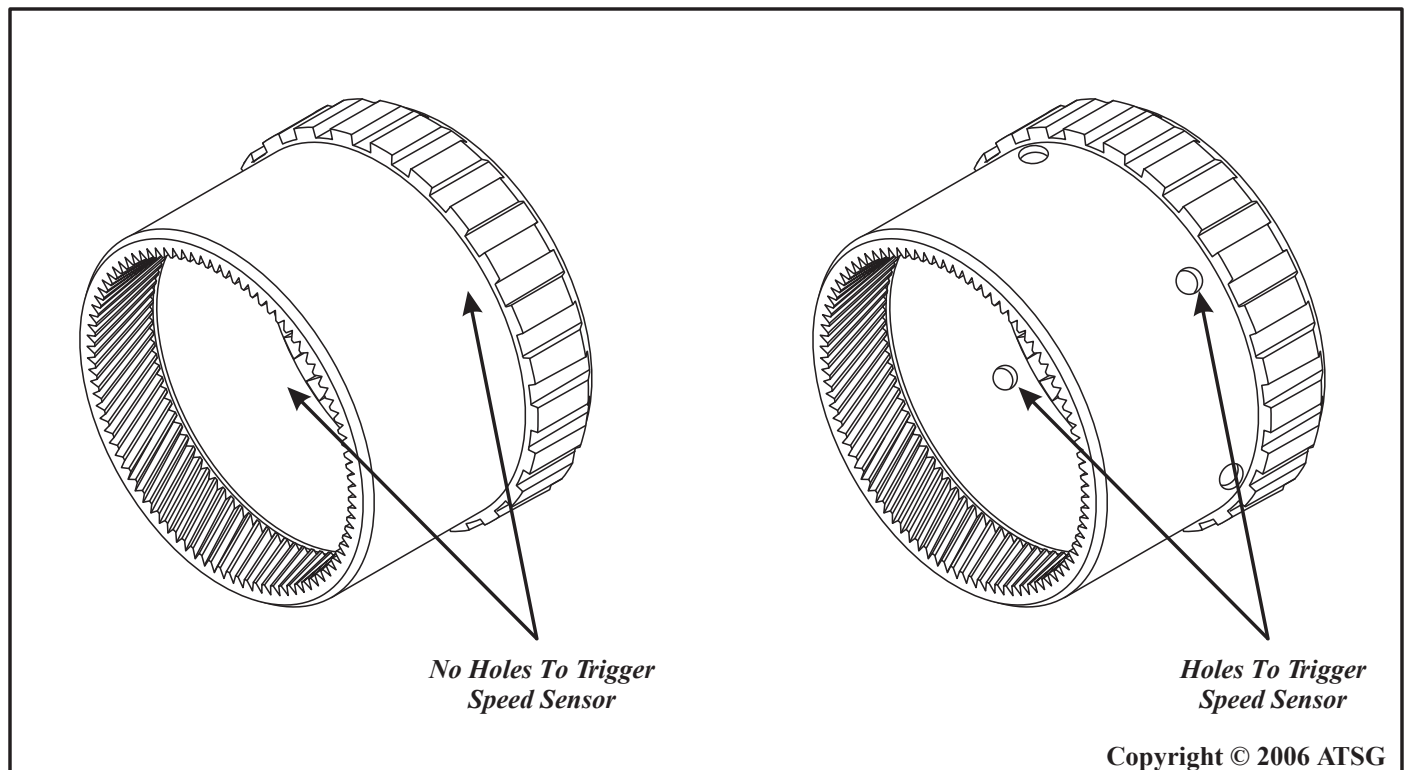
Figure 8

**CAUSE:** The cause may be, AOD internal ring gear that has no holes to trigger the output speed sensor has been installed by mistake.

**CORRECTION:** Install the AODE internal ring gear with the holes to trigger the output speed sensor, as shown in Figure 8.

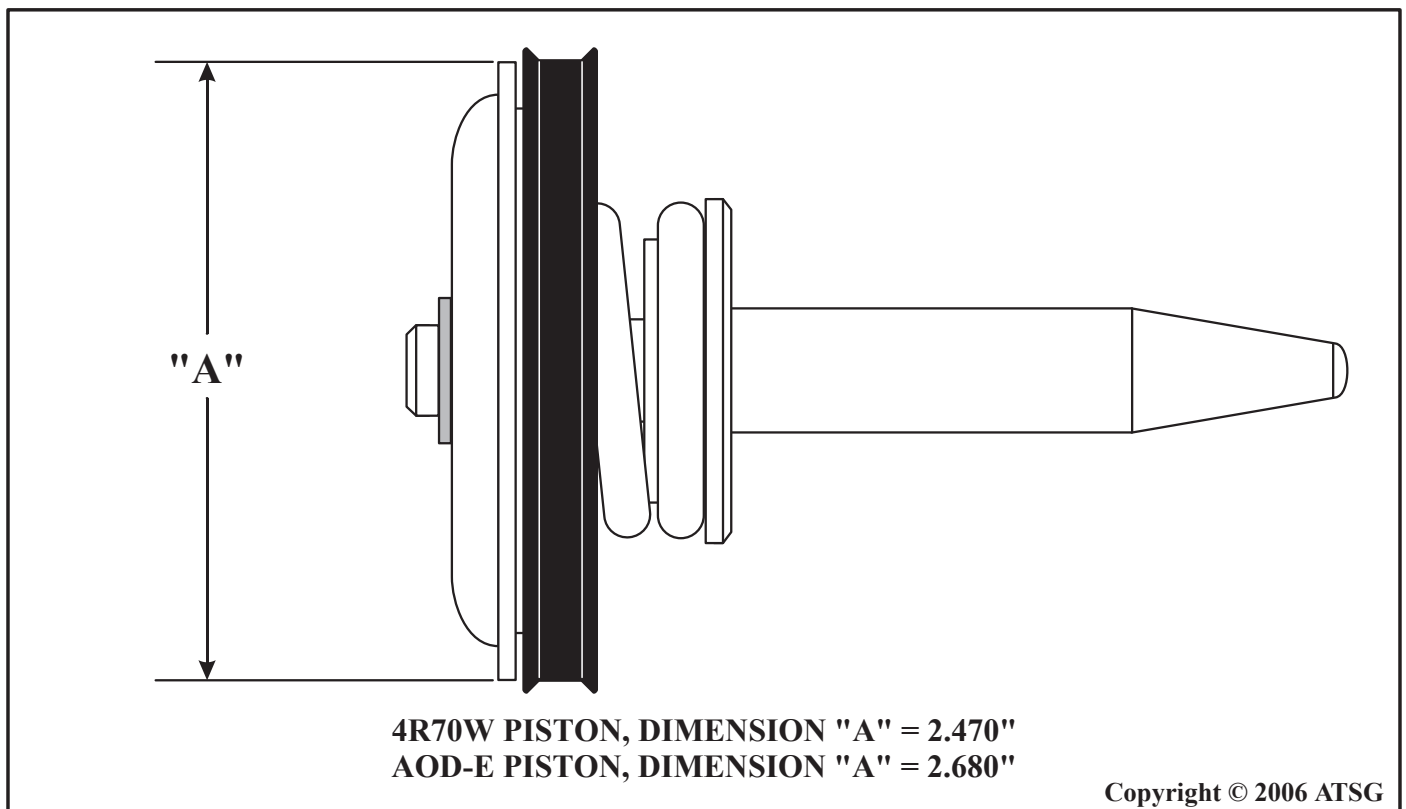
Figure 18

**CAUSE:** The cause may be, a mis-assembled Overdrive Servo Assembly, with the "Rubber Coated Sleeve" omitted. The 4R70W transmission is calibrated with a smaller diameter overdrive servo piston than is the AOD-E transmission. To retain a common case between the two transmissions, an additional "Rubber Coated Sleeve" is required on the 4R70W Overdrive Servo Assembly, as shown in Figure 19.

**CORRECTION:** Install the "Rubber Coated Sleeve" in the Overdrive Servo Assembly case bore, as shown in Figure 19. If your rubber coated sleeve is missing or lost, you **must** purchase the complete Overdrive Servo Assembly, available under part number F3LY-7H188-A. It is not available individually.  
Overdrive servo piston dimensions are shown in Figure 18, to identify the two different overdrive servo pistons.

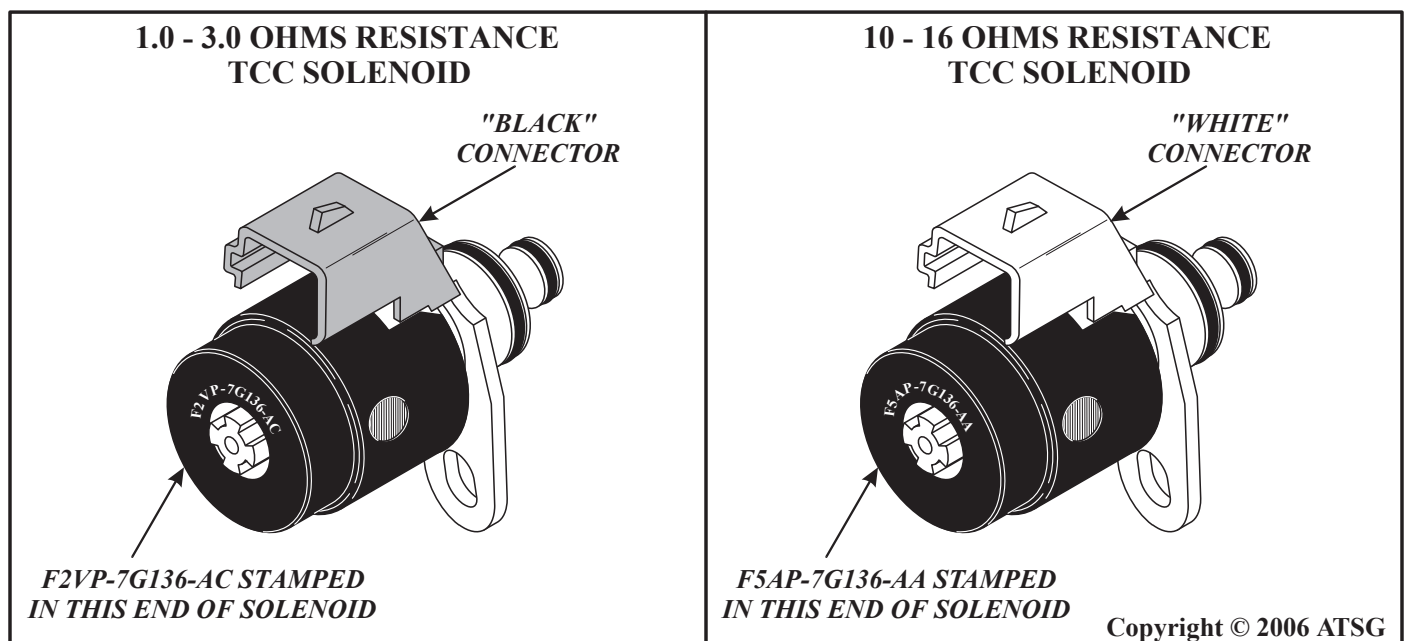
Figure 20

**CAUSE:** The cause may be, an incorrect Torque Converter Clutch (TCC) Solenoid, with low resistance (1.0 - 3.0 ohms), mistakenly installed in *some* 4R70W transmissions, as shown in Figure 20. The resistance should be 10-16 ohms on *some* models.

*Step 3:* If the valve body I.D. code is G2T, G3T, or G2U, **and** resistance on the TCC solenoid measures 1.0-3.0 ohms, **replace** the TCC Solenoid with OEM part number F5AZ-7G136-A. The resistance on these models should be 10-16 ohms.

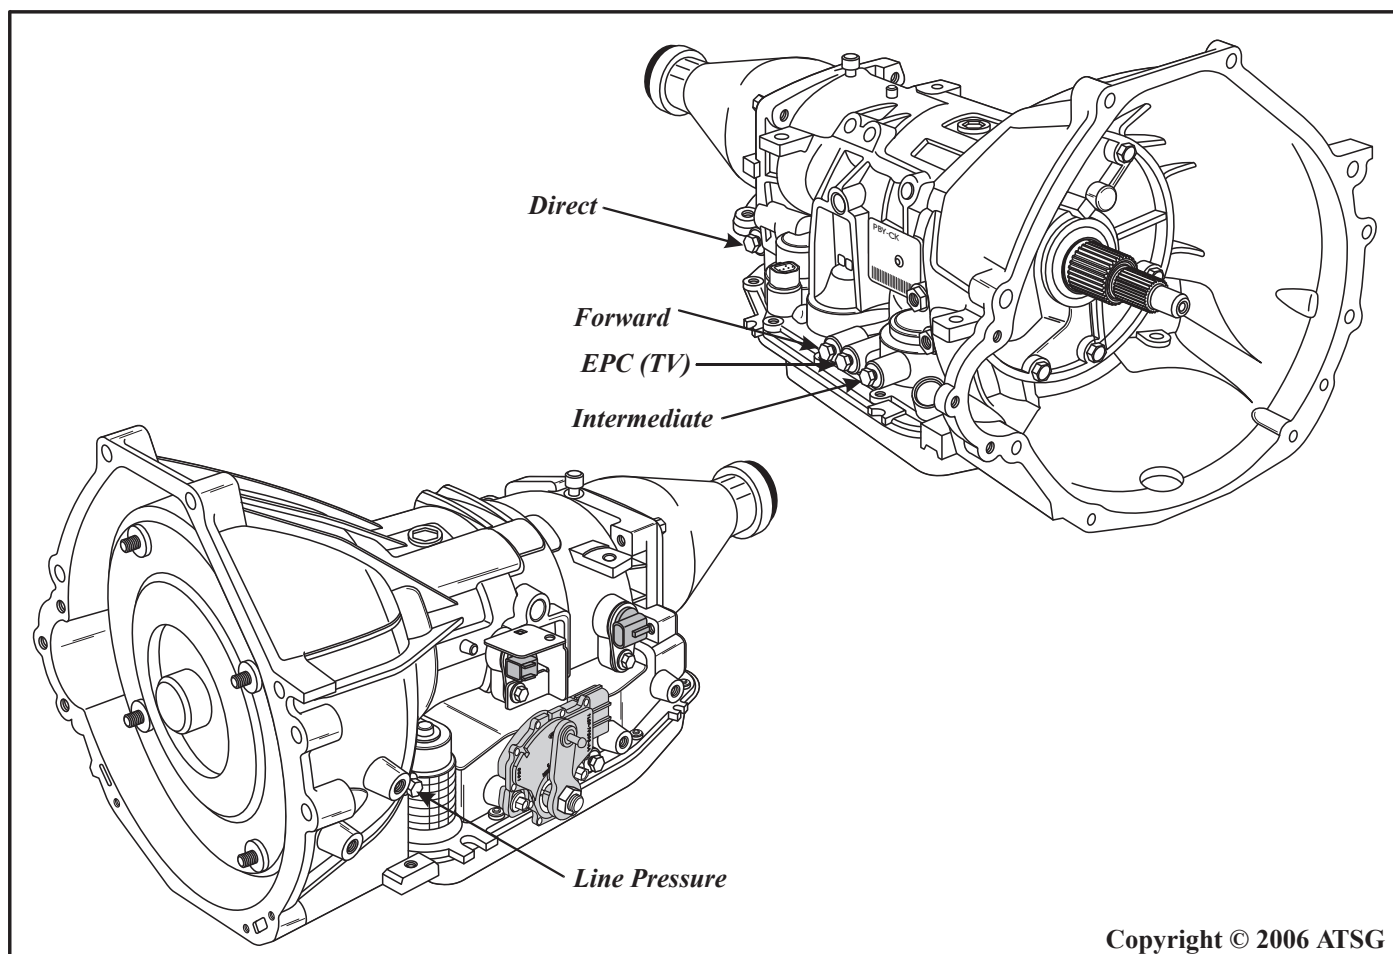
Figure 22

**CAUSE:** The cause may be, a partially clogged Shift Solenoid No. 2, which will stroke the 3-4 shift valve far enough to exhaust *some* of the forward clutch oil.

**CORRECTION:** Install two pressure gages to check line pressure and forward clutch pressure, as shown in Figure 22. With the transmission in Drive, both gages should read the same and should be approximately 55-75 PSI. If the forward clutch gage reads lower than the line pressure gage, ***and all internal parts are known to be good***, replace the Shift Solenoid Assembly with OEM part number F5AZ-7G484-A (See Figure 23).

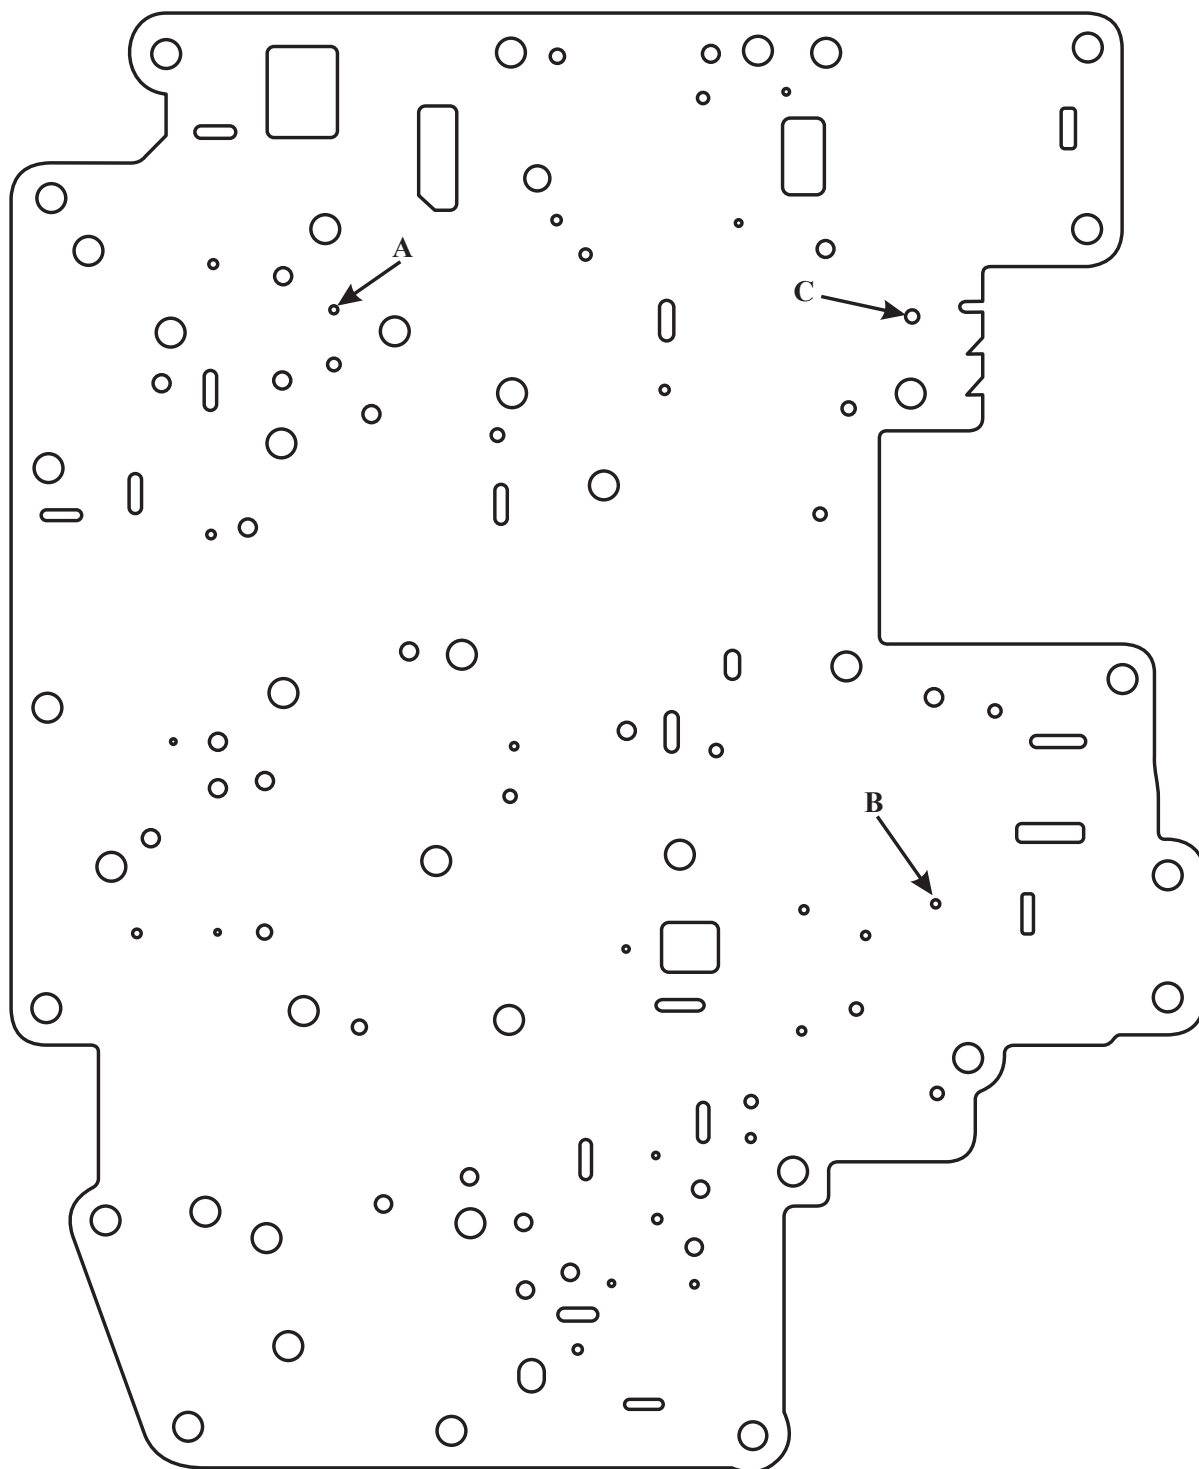
**COMPLAINT:** Before and/or after rebuild, the vehicle exhibits a converter clutch shudder condition, even with the proper Mercon® transmission fluid installed.

**CAUSE:** The cause may be, not enough oil to the converter clutch apply circuit.

***Restrict*** the hole marked "C" in Figure 24, to approximately .030" using a cotter key, which ensures that apply oil can overcome this balance circuit.

1. DRILL HOLE MARKED "A" OUT TO .062".
2. DRILL HOLE MARKED "B" OUT TO .062".
3. INSTALL COTTER PIN IN HOLE MARKED "C" TO REDUCE SIZE TO APPROXIMATELY .030".

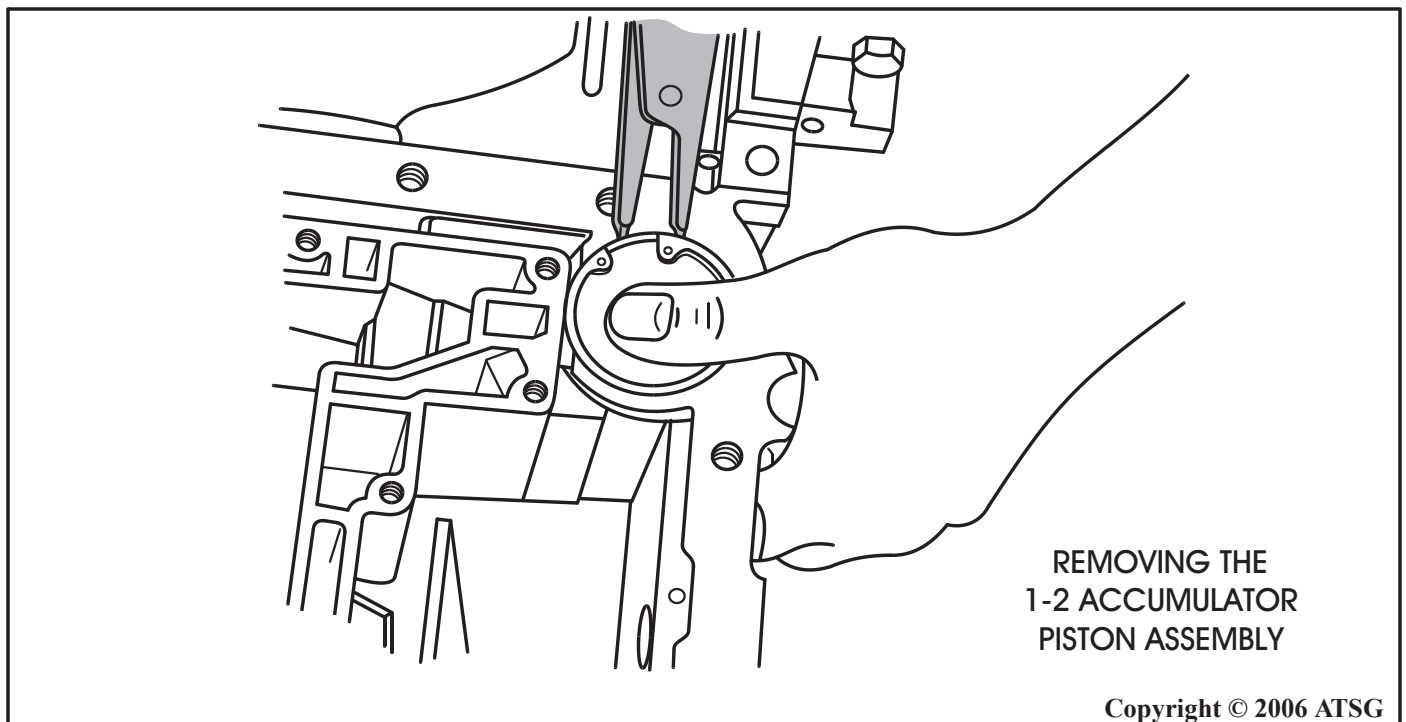
**CAUSE:** The cause may be, premature 1-2 accumulator seal wear, which also creates the case accumulator bore to become scuffed, which leads to the slipping condition and possible loss of intermediate clutches..

**CORRECTION:** Replace the cast aluminum 1-2 accumulator piston with a new design one piece stamped steel piston with molded rubber lip seals, and replace the top accumulator spring with the revised parts available from Ford Motor Co. Case replacement should not be necessary with the use of the revised stamped steel accumulator piston. Refer to Figure 27 to remove the piston assembly. Refer to Figure 28 for illustration of both design stack-ups, and to Figure 29 for a chart to install the proper revised springs into the proper model.

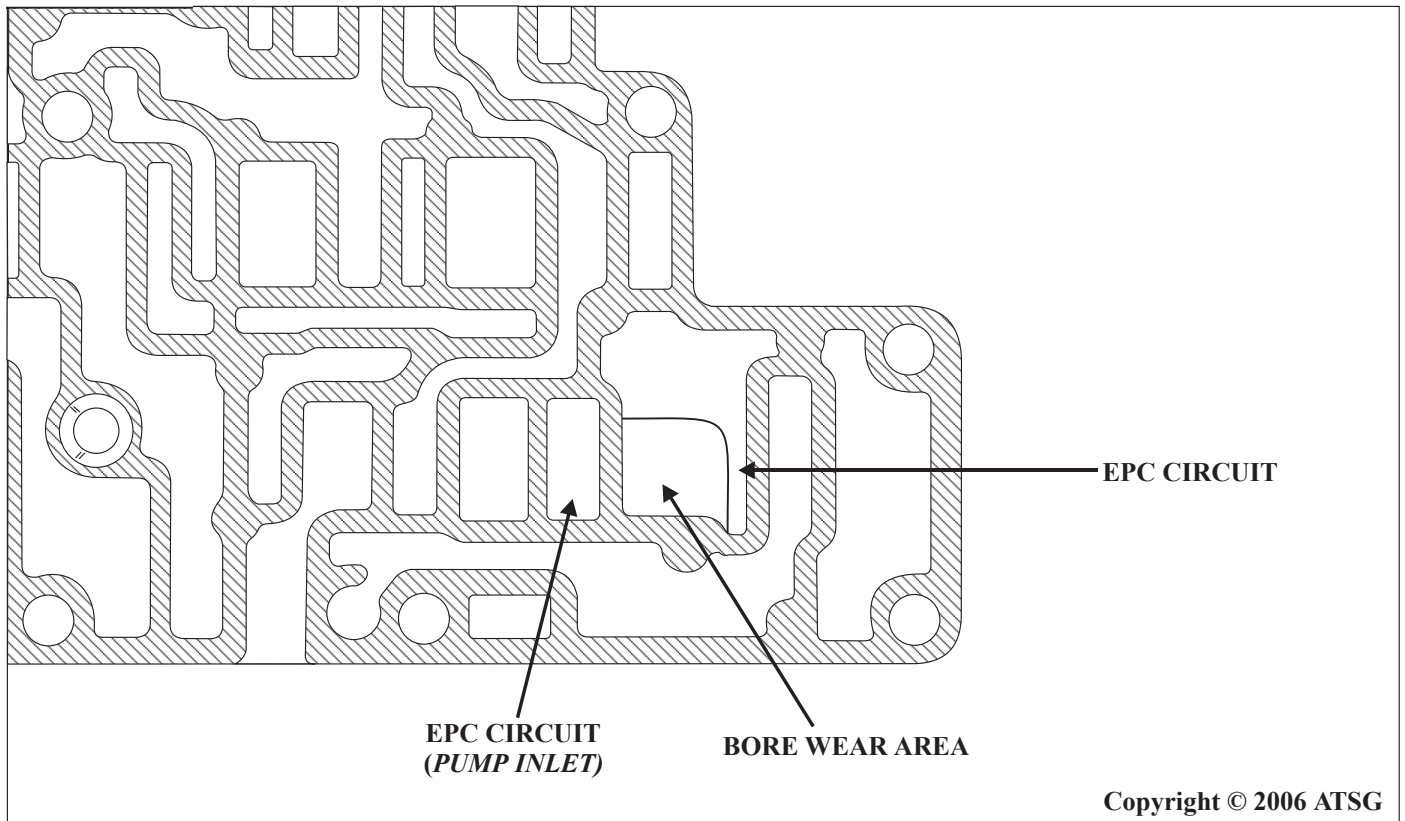
**CAUSE:** EPC pressure is routed to the Pressure Regulator Valve along side of a circuit that Ford identifies as the Boost Circuit. These oil passages can be identified in both the valve body and the case as seen in Figure 75 and 76. This is illustrated by the hydraulic schematic shown in Figure 77. This circuit is routed back to the inlet side of the pump. When the Pressure Regulator Valve or its bore is worn, (See Figure 78), EPC pressure is allowed to be sucked away by pump suction, (See Figure 79 and 80), preventing any line pressure rise from occurring when the throttle is opened.

**CORRECTION:** Always check the Pressure Regulator Valve and its bore for wear during the repair process. If it is worn use one of the repair kits that are available from Sonnax® to repair this condition, or, you must replace the valve body.

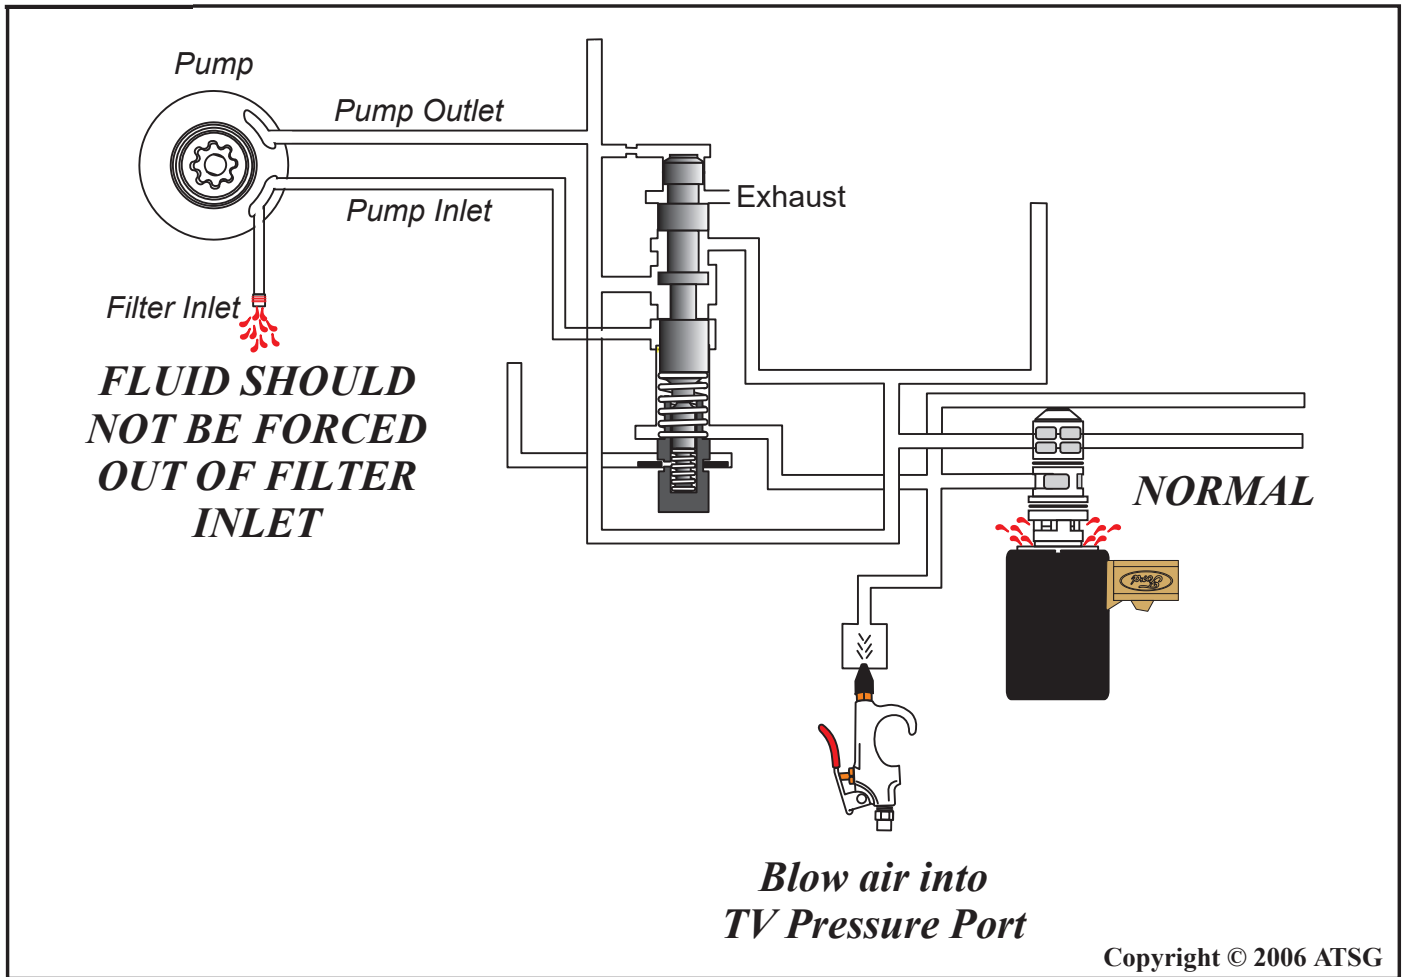
Figure 81

A quick test can be performed to verify if this condition exists. Remove the pan and filter. Blow compressed air into the TV pressure port in the case. It is normal to see some leakage around the EPC solenoid, but if you see *any* oil forced out of the filter neck bore by the air pressure, (Refer to Figure 81), ***PR valve and/or bore wear is the reason.***

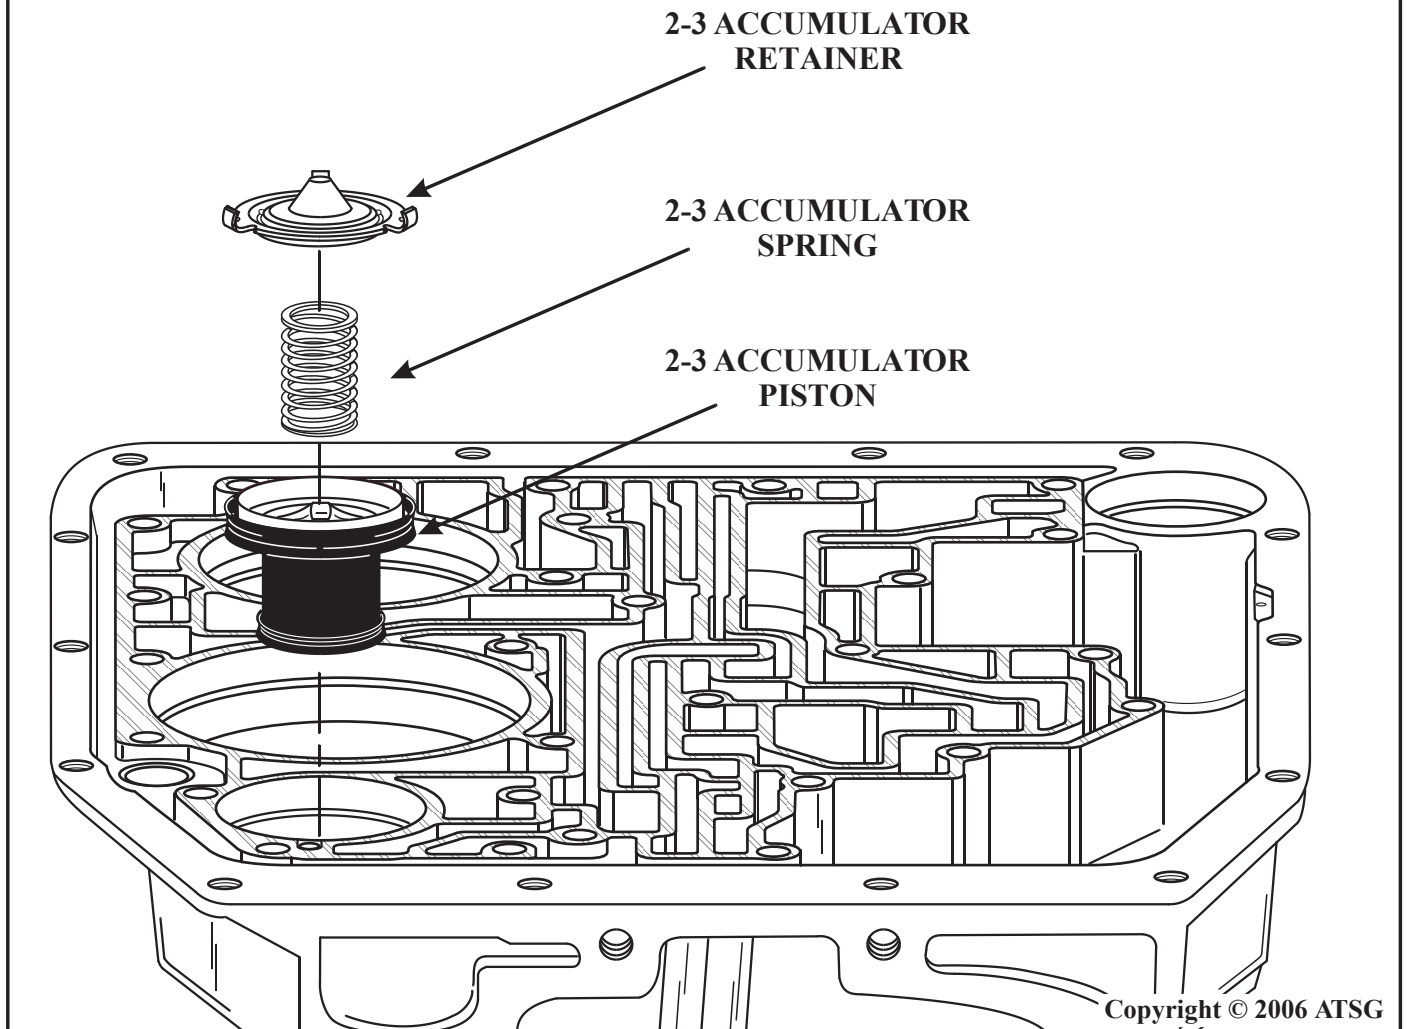
**CAUSE:** The cause may be, that a previous design 2-3 accumulator retainer was used, or the retainer was assembled upside down, when installing it into the case. **NOTE:** 2001 and up Valve Body assemblies, as shown in Figure 83, eliminated the small plate on the spacer plate side over the 2-3 accumulator retainer, which made a taller 2-3 accumulator retainer necessary for 2001 models, shown in Figure 82. When the early 2-3 accumulator retainer (shorter) is used, or if the retainer is installed upside down, the 2-3 accumulator piston may come out of its bore dumping Direct Clutch pressure to an exhaust. Refer to Figure 84 for a cutaway of the correct and incorrect assembly.

**CORRECTION:** Refer to Figure 85 for the location and proper installation of the 2-3 accumulator retainer, piston and spring.

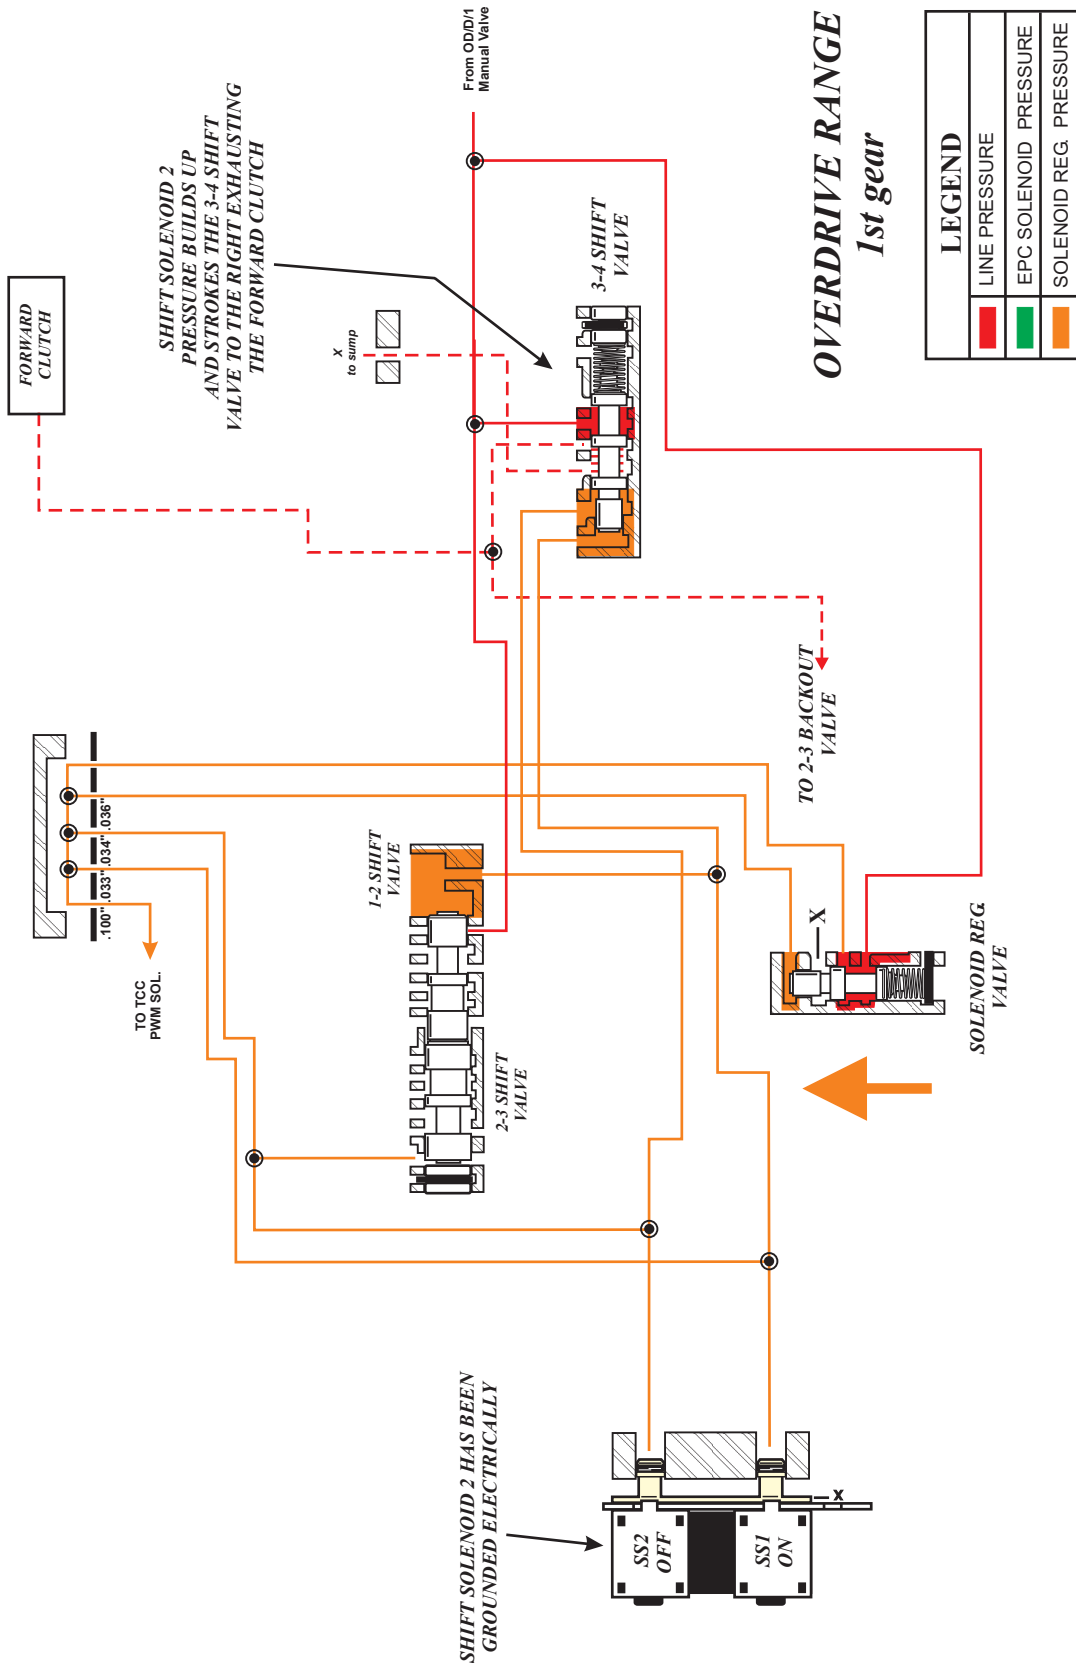
**CAUSE NO 1:** One cause for this condition may be that the PPL/ORG or VIO/ORG wire, which is model dependant, and controls Shift Solenoid 2, may have rubbed on the rear of the engine, causing the circuit to become grounded. When this occurs with the transmission in first gear, Shift Solenoid 2 closes and fluid pressure acts to stroke the 3-4 Shift Valve to the right, causing the Forward Clutch oil to exhaust through the 3-4 Shift Valve, creating the neutral condition. Refer to Figure 86 for hydraulic schematic. Diagnostic Trouble Code (DTC) P0755 may also be stored in memory.

**Summary:** SS1 is ON and SS2 has become energized, which in-turn strokes the 3-4 Shift Valve turning the Forward Clutch OFF.

- (1) Repair or replace the damaged Shift Solenoid 2 wire. Refer to Figure 92, for an index to locate the proper year and model vehicle that you are working on, and refer to schematic for that vehicle. Wire schematics have been provided in Figures 93, 94, 95 and 96.
- (2) Locate the Solenoid Regulator Valve in the Valve Body, as shown in Figure 88. To repair a sticking Solenoid Regulator Valve, it may become necessary to replace the valve assembly. There are replacement Solenoid Regulator Valve Kits available from aftermarket suppliers.
- (3) Replace the complete Shift Solenoid Assembly.

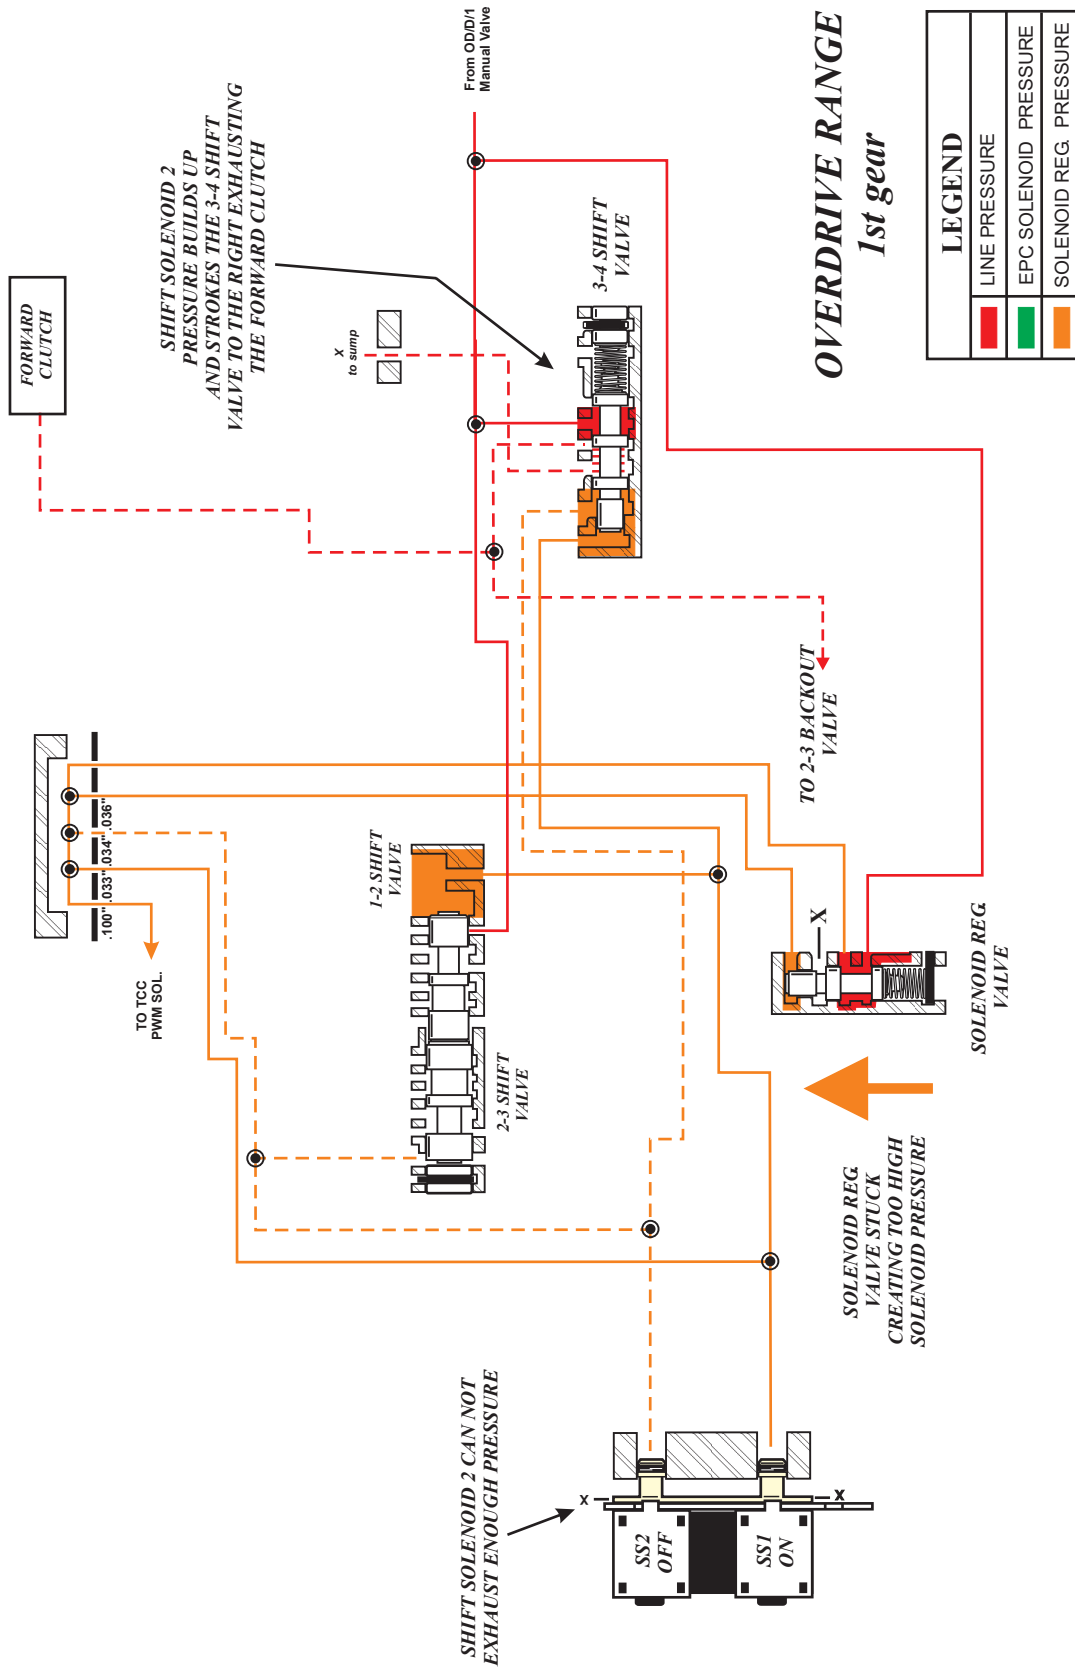
**CAUSE NO 3:** Cause 3 is almost identical to Cause 2 with the exception being that Shift Solenoid 2 is sticking closed, or has debris built up at the solenoid exhaust hole, which will allow Shift Solenoid 2 pressure to build up which causes the 3-4 Shift Valve to move to the right exhausting the Forward Clutch oil, and once again creating the neutral condition. Refer to Figure 87 for hydraulic schematic. No Diagnostic Trouble Codes will be stored.

**Summary:** SS1 is ON and SS2 can not exhaust the High Solenoid Reg. pressure, which in-turn strokes the 3-4 Shift Valve turning the Forward Clutch OFF.
