## UPDATE HANDBOOK AODE, 4R70W, 4R70E, 4R75E

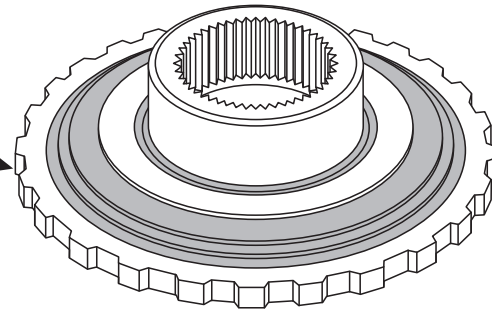
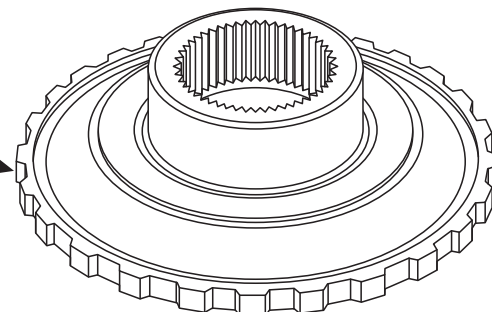
Figure 9

- (1) OUTPUT SHAFT RING GEAR SUPPORT - There is a different profile on the supports and each support requires a different style rear case bearing, as shown in Figure 9.  
The AOD-E transmission requires a two piece open (needles exposed) rear case bearing that is approximately .113" thick (See Figure 9).  
The 4R70W transmission requires a three piece closed (needles not exposed) rear case bearing that is approximately .144" thick (See Figure 9).

**DIFFERENT PROFILE ON SUPPORT  
AND WILL NOT INTERCHANGE**

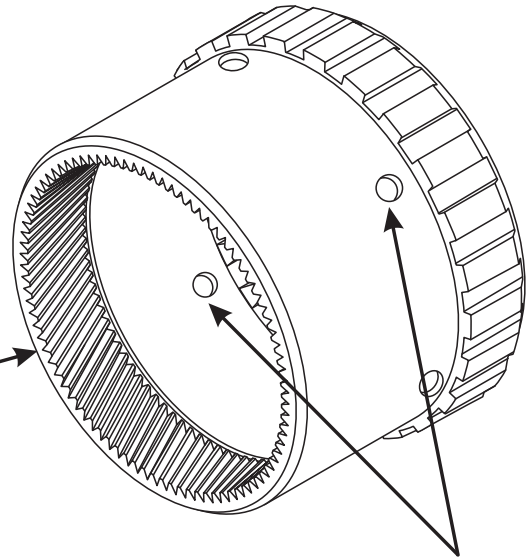
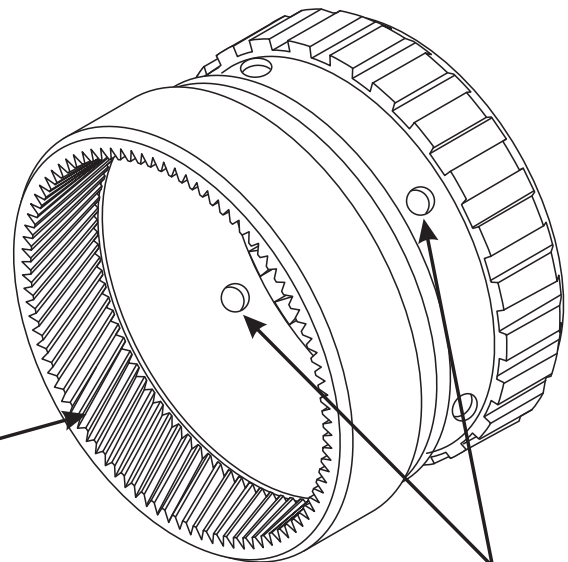
Figure 10

- (2) OUTPUT SHAFT RING GEAR - The AOD-E has 72 teeth on the Output Shaft Ring Gear, and the direct drum ***will not*** pass through the front side of the ring gear, as shown in Figure 10.  
The 4R70W has 88 teeth on the Output Shaft Ring Gear, and the direct drum ***will*** pass through the front side of the ring gear, as shown in Figure 10.

**72 TEETH, AND THE RING GEAR  
IS SMALLER IN DIAMETER THAN  
THE 4R70W RING GEAR**

**DIRECT CLUTCH HOUSING CANNOT  
BE REMOVED THROUGH THE FRONT**

**88 TEETH, AND THE RING GEAR  
IS LARGER IN DIAMETER THAN  
THE AOD-E RING GEAR**

**DIRECT CLUTCH HOUSING CAN  
BE REMOVED THROUGH THE FRONT**

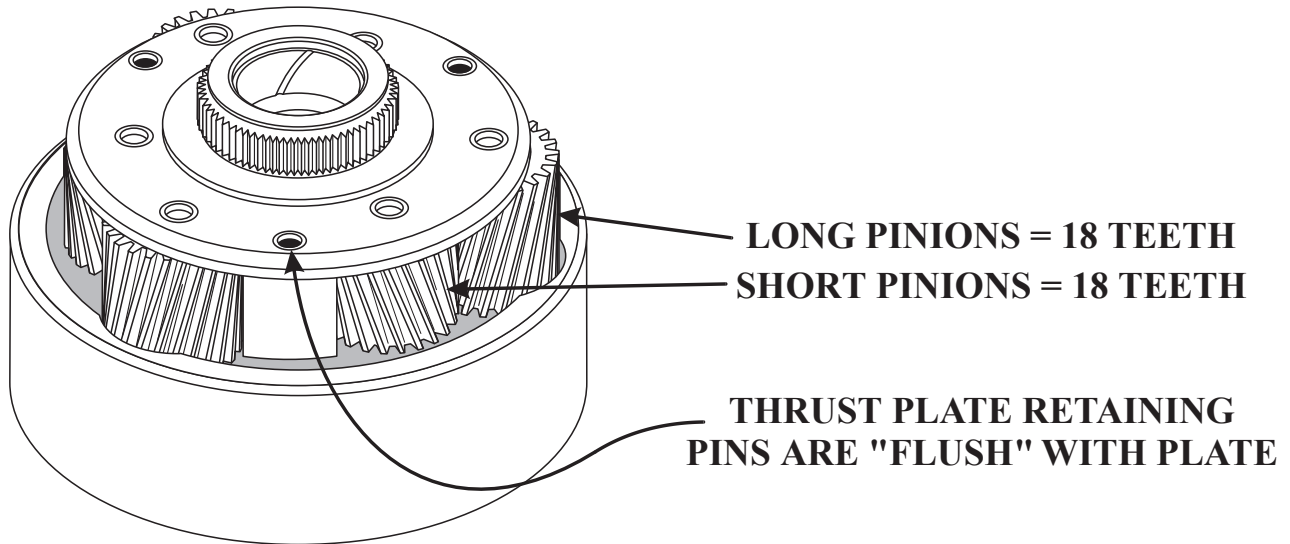
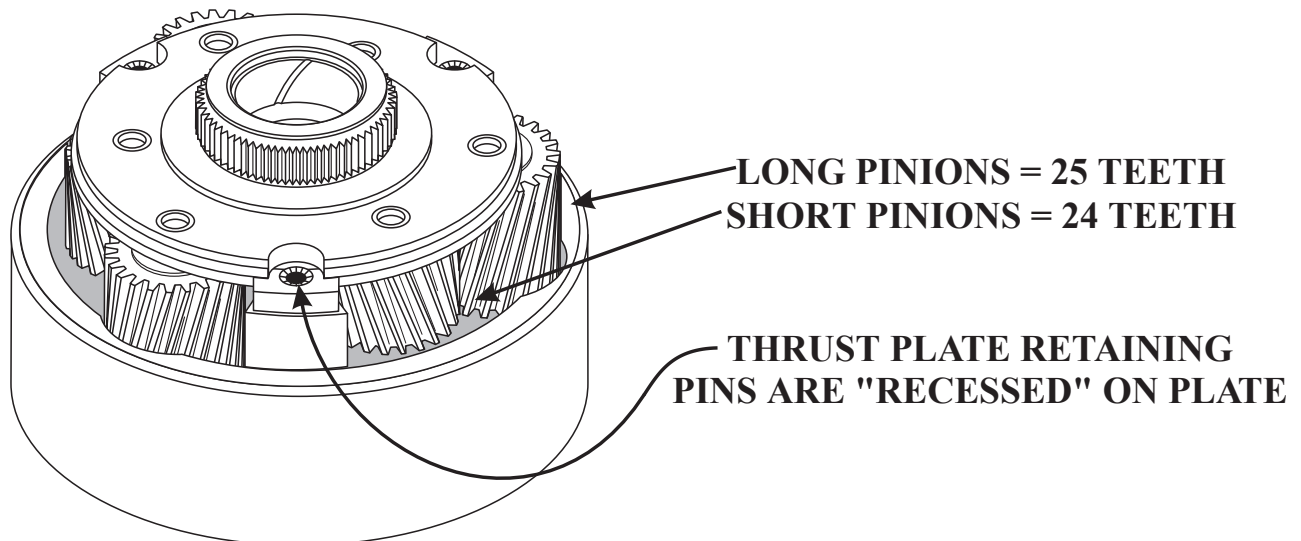
Figure 11

- (3) PLANETARY CARRIER ASSEMBLY - The AOD-E has 18 teeth on both the long, and the short pinions, and the thrust plate retaining pins are ***flush*** with the retaining plate, as shown in Figure 11.  
The 4R70W has 25 teeth on the long pinions, 24 teeth on the short pinions, and the thrust plate retaining pins are ***recessed***, as shown in Figure 11.

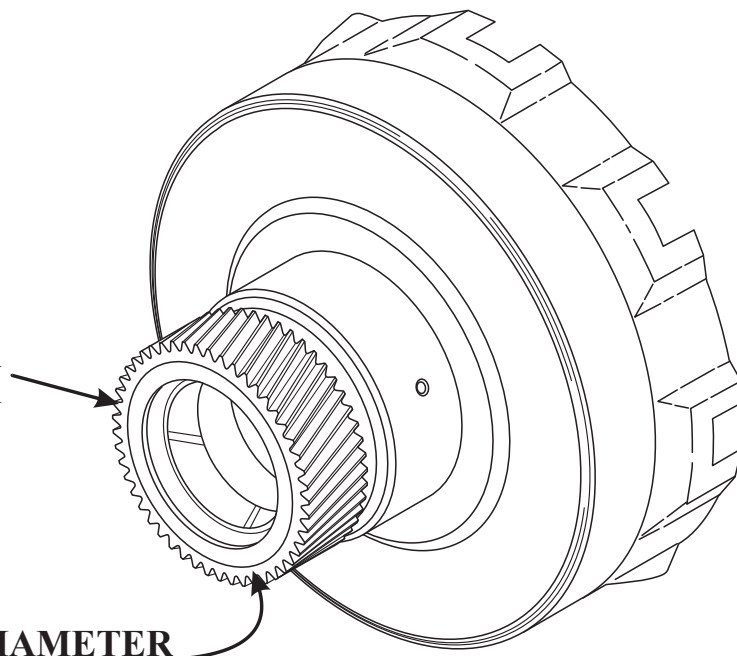
Figure 12

- (4) REVERSE SUN GEAR AND SHELL - The AOD-E has 36 teeth on the Reverse Sun Gear Shell and the outside diameter of the gear is approximately 2.600", as shown in Figure 12.  
The 4R70W has 38 teeth on the Reverse Sun Gear Shell and the outside diameter of the gear is approximately 2.438", as shown in Figure 12.

**AOD-E = 2.600" OUTSIDE GEAR DIAMETER**  
**4R70W = 2.438" OUTSIDE GEAR DIAMETER**

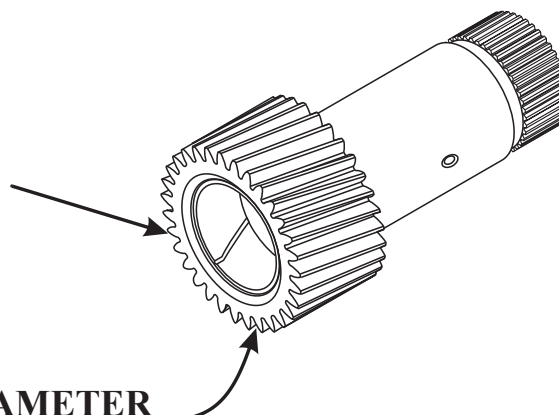
Figure 13

- (5) FORWARD SUN GEAR - The AOD-E has 30 teeth on the sun gear and the outside diameter of the gear is approximately 2.225", as shown in Figure 13.  
The 4R70W has 31 teeth on the sun gear and the outside diameter of the gear is approximately 2.062", as shown in Figure 13.

**AOD-E = 2.225" OUTSIDE GEAR DIAMETER**  
**4R70W = 2.062" OUTSIDE GEAR DIAMETER**

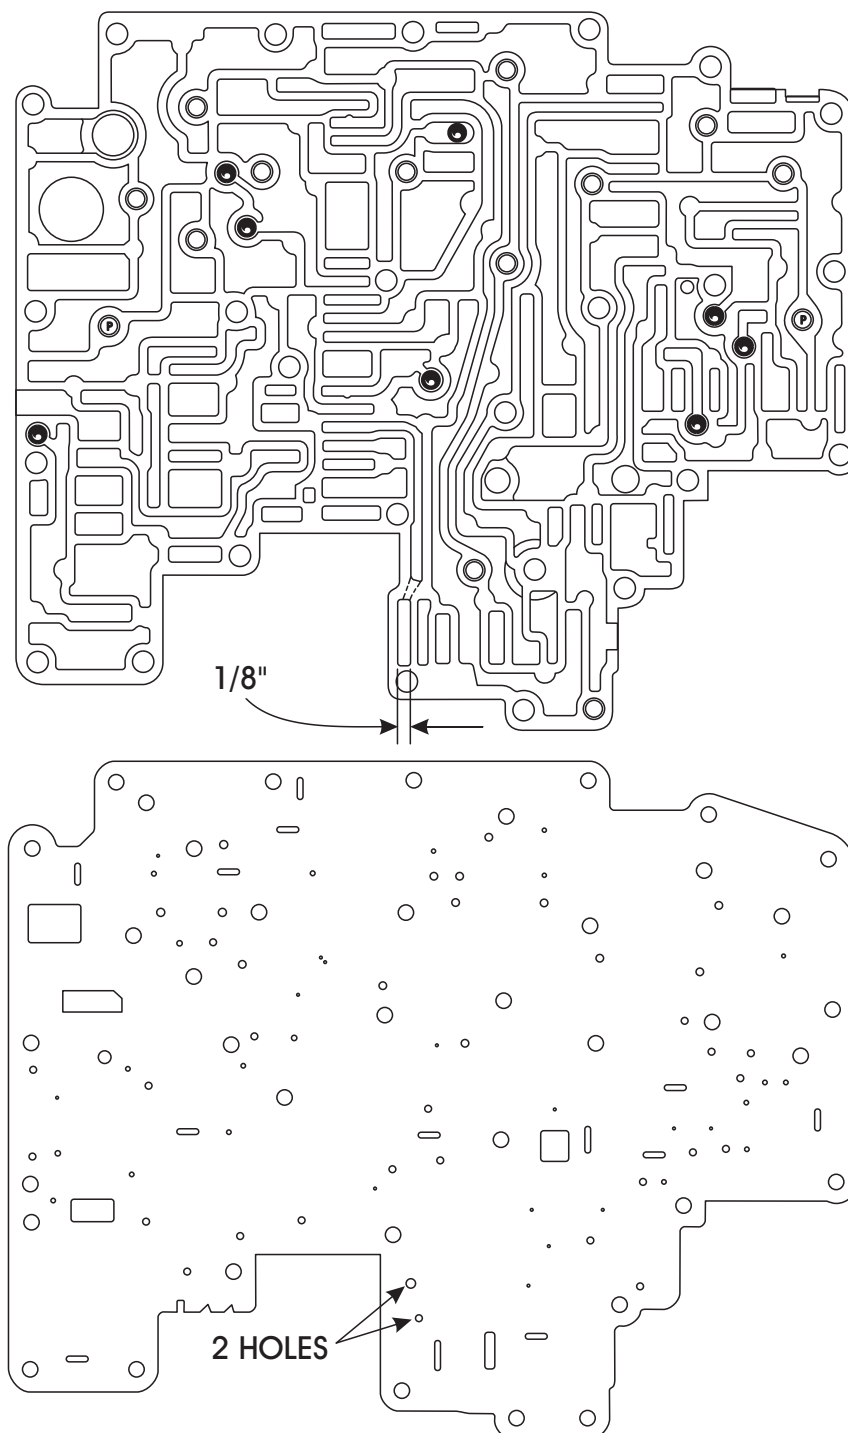
Figure 16

*Manual Selector Indicator with OD-D-1, has a 1/8" wide passage in the valve body by the manual valve, and the spacer plate has two (2) additional holes above the manual valve location, as shown below.*

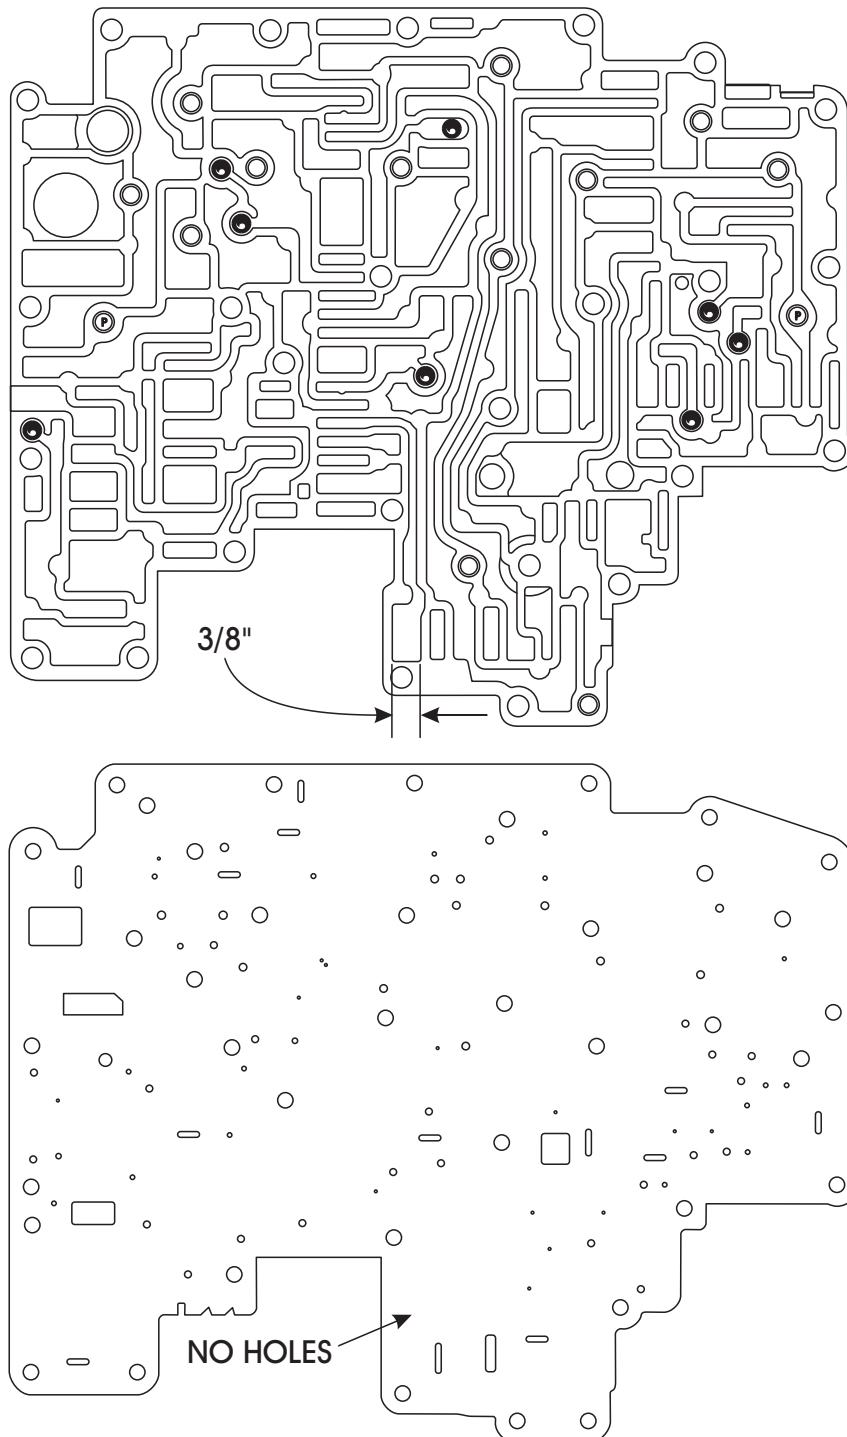
Figure 17

*Manual Selector Indicator with OD-2-1, and the Overdrive Cancel Switch, has a 3/8" wide passage in the valve body by the manual valve, and the spacer plate DOES NOT have the two holes above the manual valve location.*

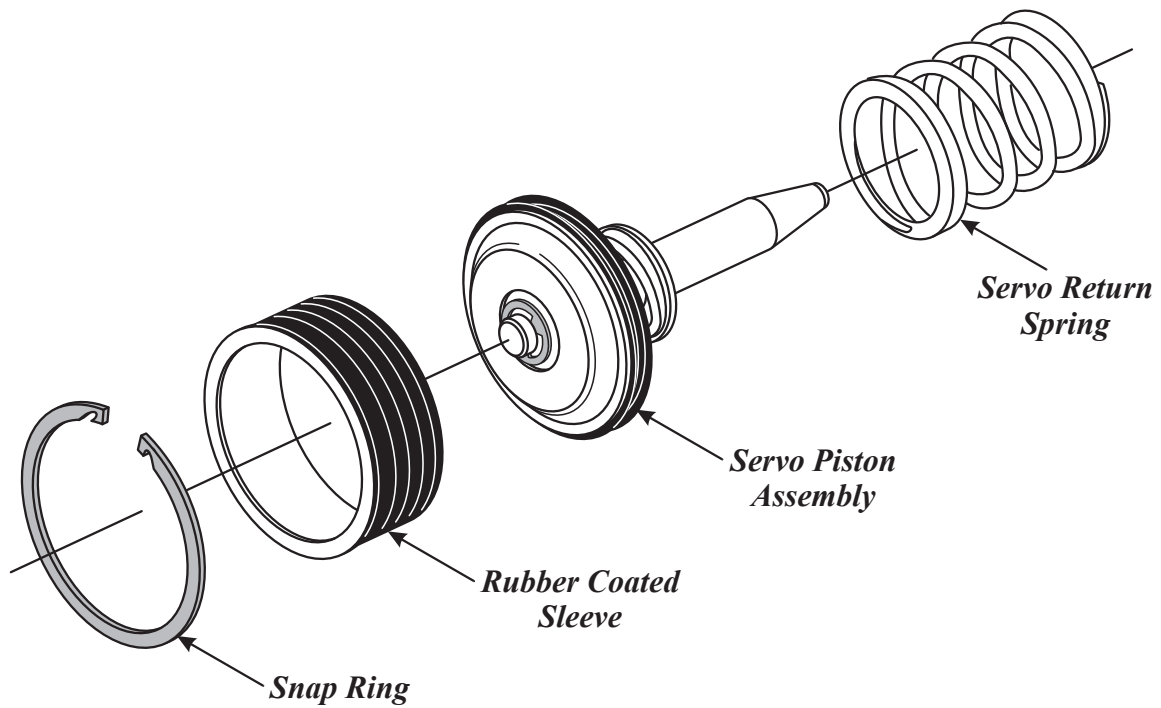
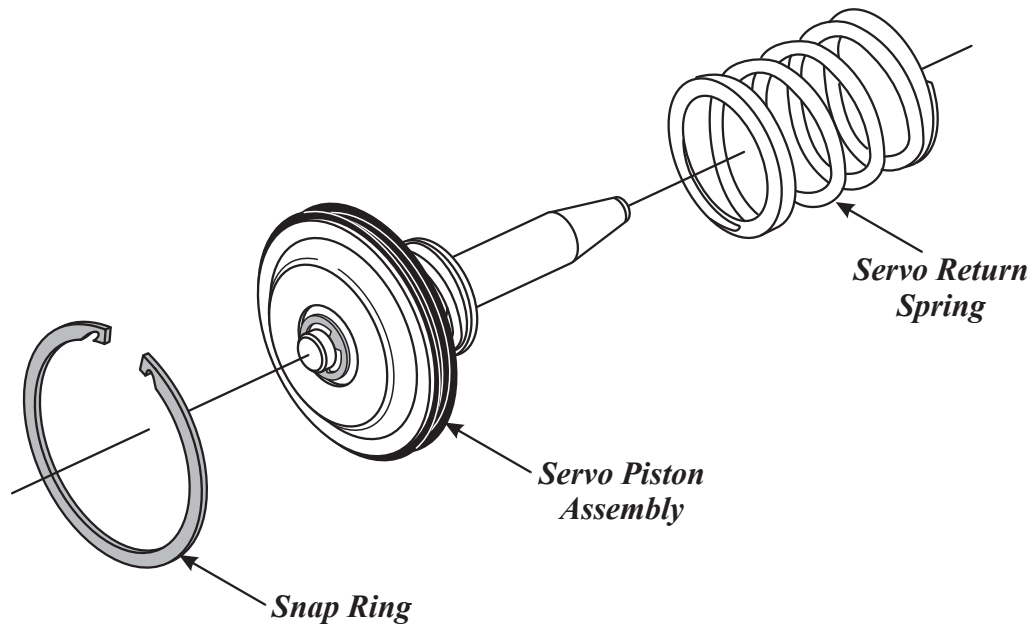
Figure 19

**COMPLAINT:** After overhaul, the 4R70W transmission displays a 3-neutral upshift and when the unit is disassembled, you find the forward clutches burnt.

**CAUSE:** The cause may be, a mis-assembled Overdrive Servo Assembly, with the "Rubber Coated Sleeve" omitted. The 4R70W transmission is calibrated with a smaller diameter overdrive servo piston than is the AOD-E transmission. To retain a common case between the two transmissions, an additional "Rubber Coated Sleeve" is required on the 4R70W Overdrive Servo Assembly, as shown in Figure 19.

**CORRECTION:** Install the "Rubber Coated Sleeve" in the Overdrive Servo Assembly case bore, as shown in Figure 19. If your rubber coated sleeve is missing or lost, you **must** purchase the complete Overdrive Servo Assembly, available under part number F3LY-7H188-A. It is not available individually.  
Overdrive servo piston dimensions are shown in Figure 18, to identify the two different overdrive servo pistons.

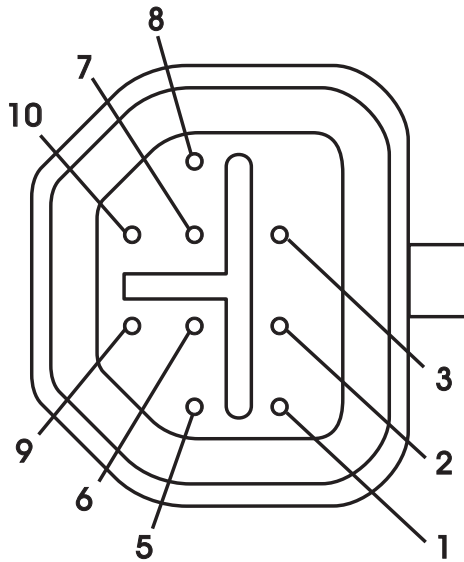
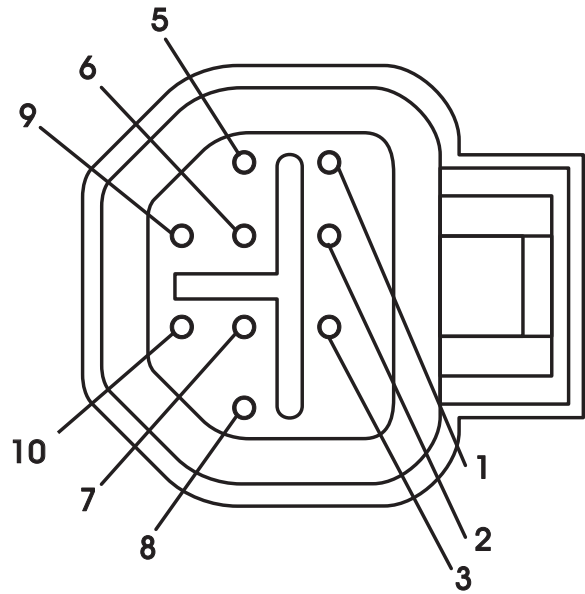
Figure 20

**CAUSE:** The cause may be, an incorrect Torque Converter Clutch (TCC) Solenoid, with low resistance (1.0 - 3.0 ohms), mistakenly installed in *some* 4R70W transmissions, as shown in Figure 20. The resistance should be 10-16 ohms on *some* models.

*Step 3:* If the valve body I.D. code is G2T, G3T, or G2U, **and** resistance on the TCC solenoid measures 1.0-3.0 ohms, **replace** the TCC Solenoid with OEM part number F5AZ-7G136-A. The resistance on these models should be 10-16 ohms.

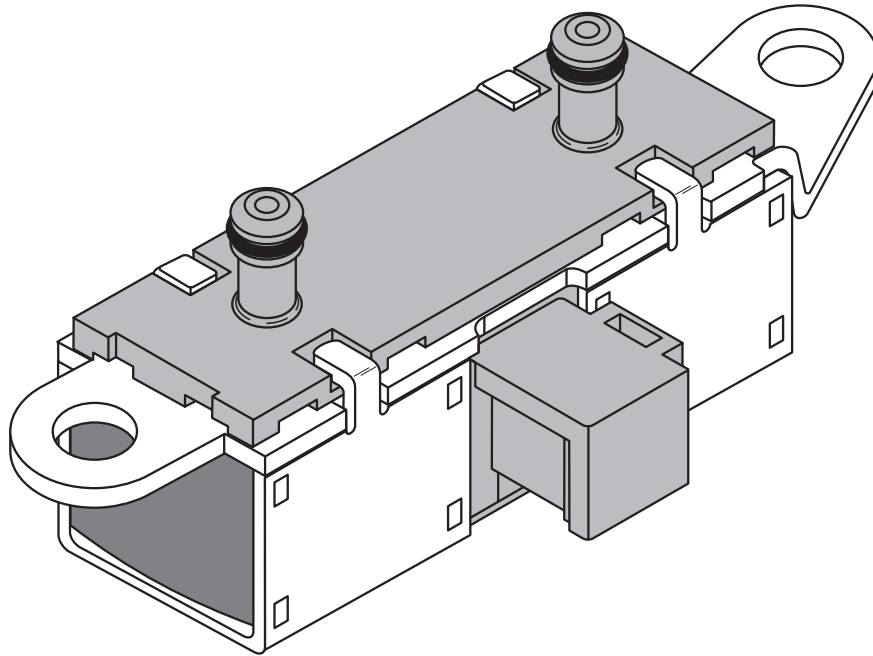
Figure 23

**CAUSE:** The cause may be, a partially clogged Shift Solenoid No. 2, which will stroke the 3-4 shift valve far enough to exhaust *some* of the forward clutch oil.

**CORRECTION:** Install two pressure gages to check line pressure and forward clutch pressure, as shown in Figure 22. With the transmission in Drive, both gages should read the same and should be approximately 55-75 PSI. If the forward clutch gage reads lower than the line pressure gage, ***and all internal parts are known to be good***, replace the Shift Solenoid Assembly with OEM part number F5AZ-7G484-A (See Figure 23).

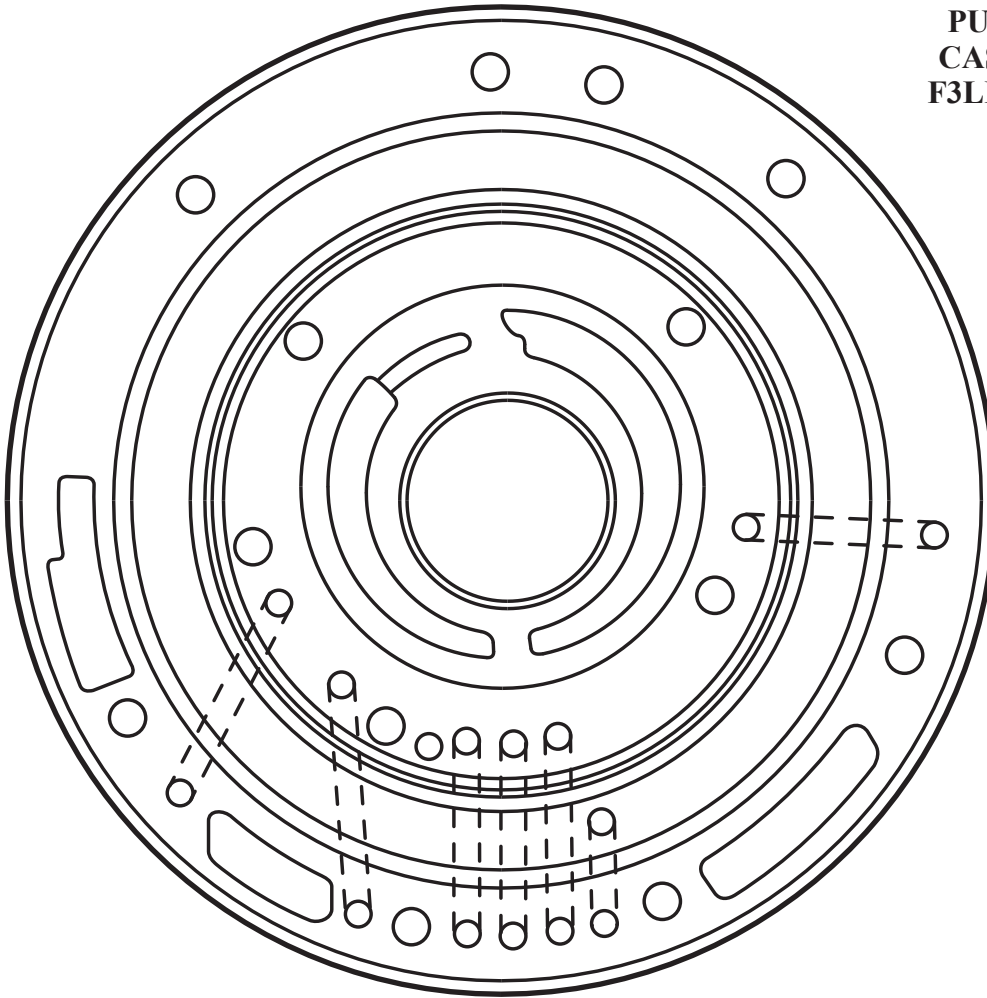
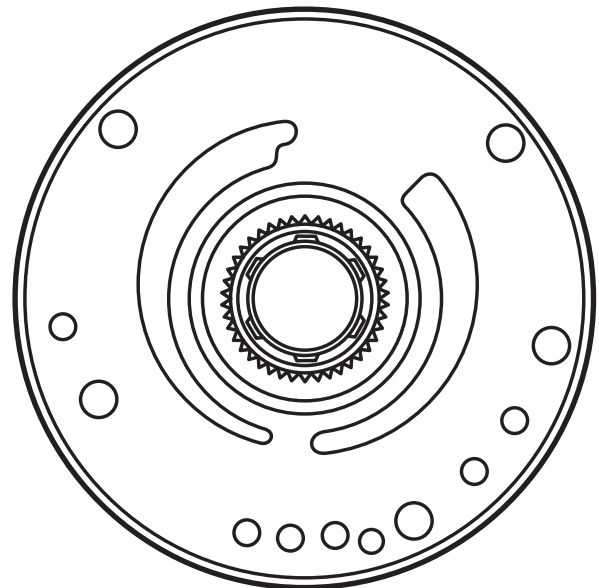
Figure 32

**CHANGE:** Beginning at the start of production for 1995 model vehicles equipped with the AODE/4R70W transmission, a new design oil pump was implemented with re-routed and enlarged pressure cavities (See Figures 32 and 33).

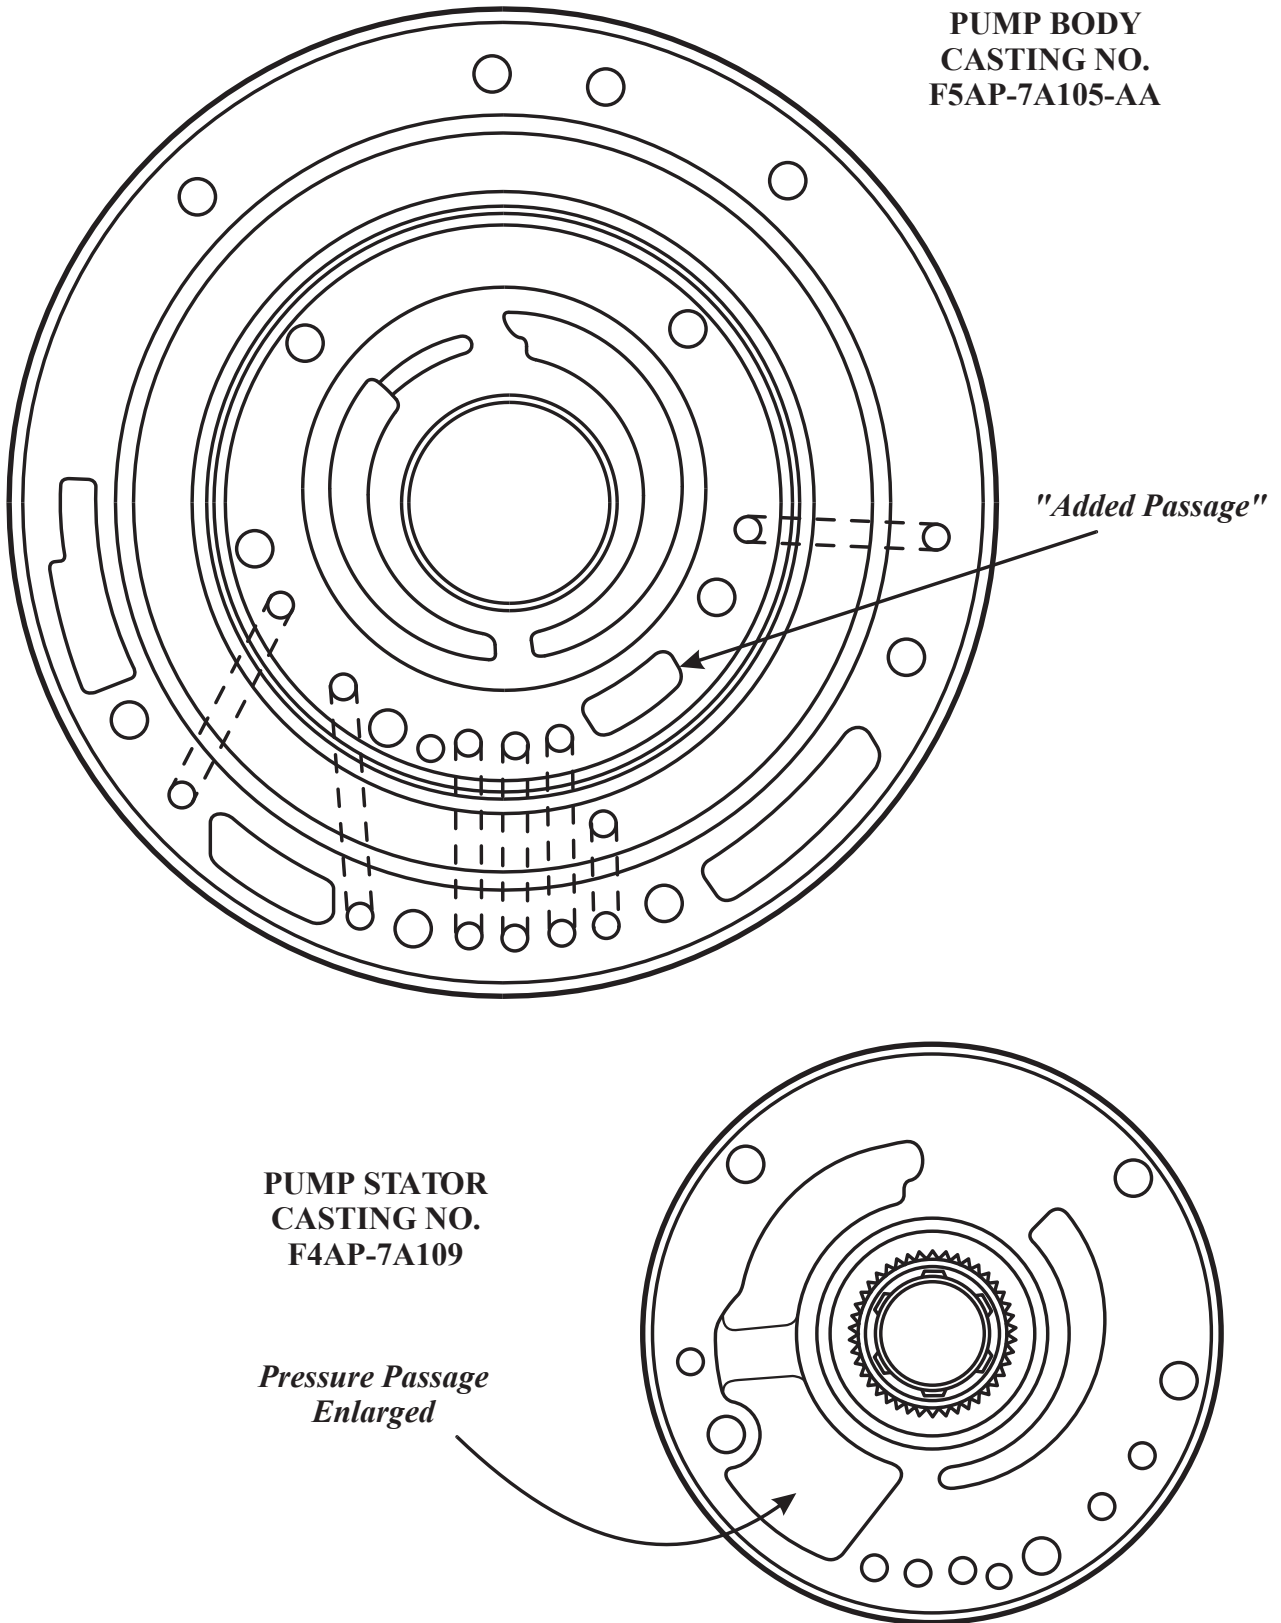
Figure 33

- (1) OIL PUMP BODY - Has an added pressure passage in pump body, shown in Figure 33, and is easily identified by casting number F5AP-7A105-AA located on the front side of pump body.
- (2) OIL PUMP STATOR - Has a much enlarged pressure passage in pump stator as illustrated in Figure 33, and is easily identified by casting number F4AP-7A109 located on back side of the pump stator.

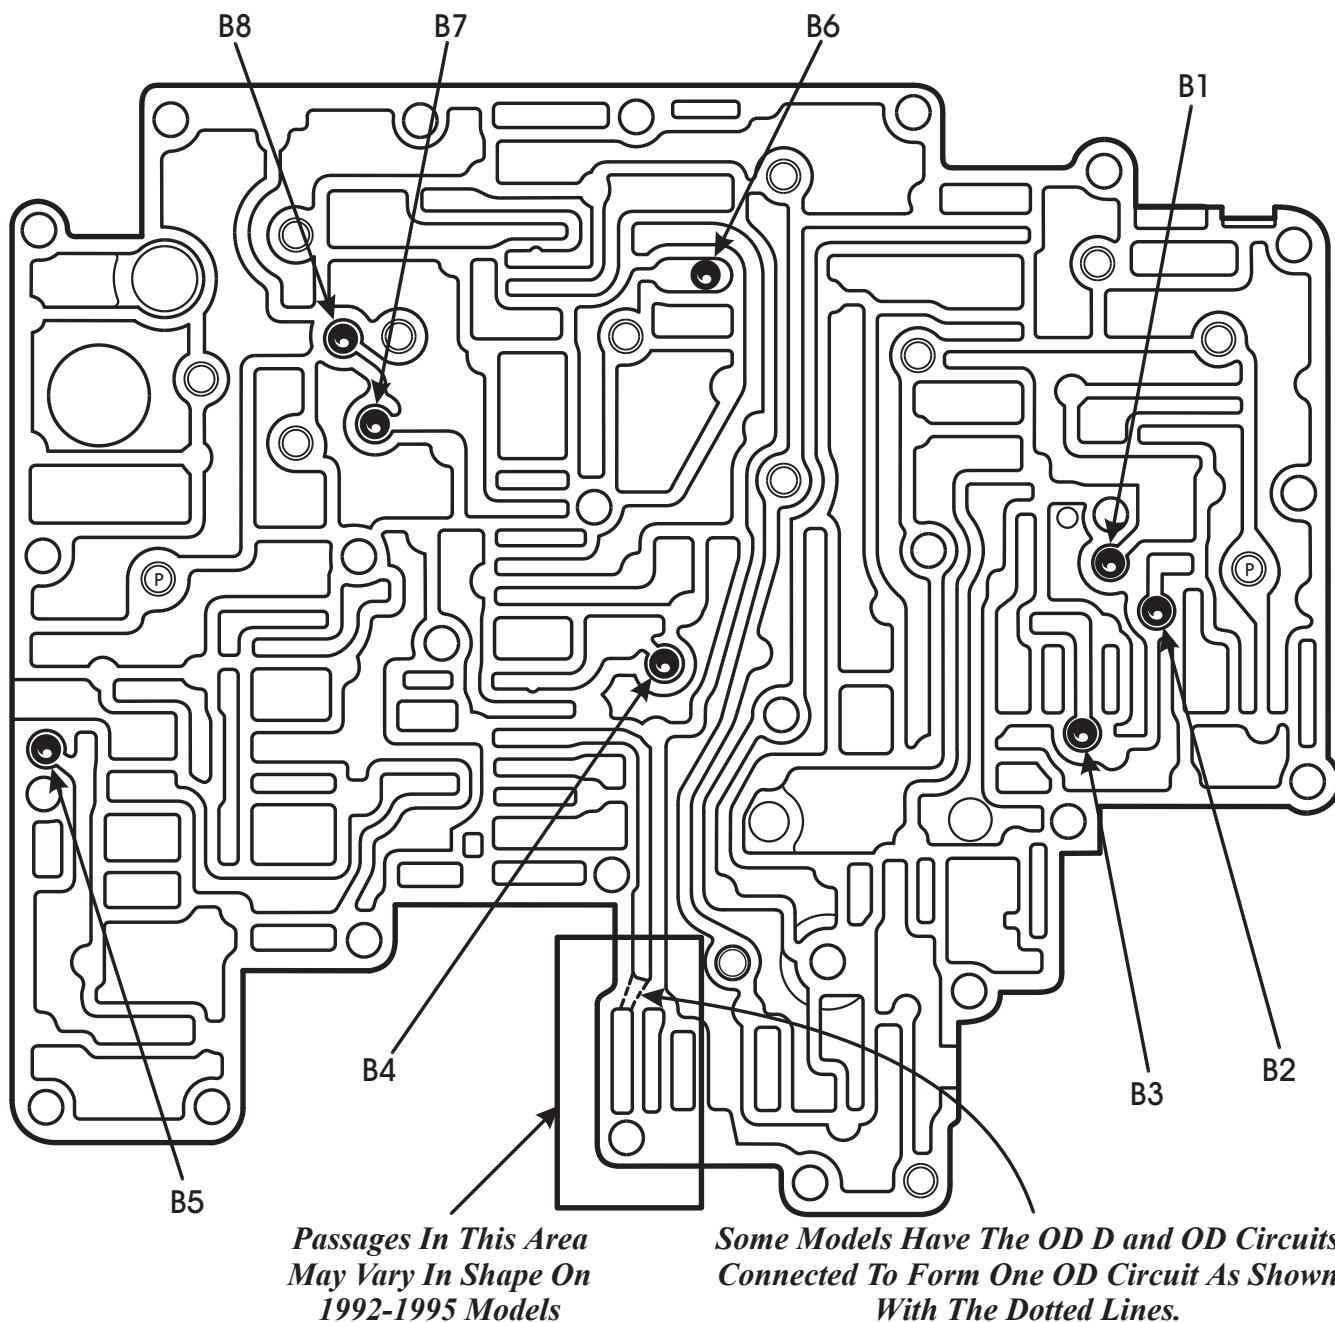
Figure 34

- (1) **VALVE BODY CASTING** - The number 1 checkball in the 1992-1995 models was eliminated, the location was moved, and the ball was re-numbered as the number 9 checkball. The worm track configuration also had to change to accommodate the new checkball locations, as shown in Figures 34, 35 and 36, and it received a thinner cover plate.

- B1 - Between the Forward Clutch circuit and the 23BP circuit (92-95 Only).
- B2 - In the Forward Clutch circuit near the 3-4 shift valve.
- B3 - In the Direct Clutch circuit near the 2-3 backout valve.
- B4 - In the Overdrive and Forward Clutch circuits near the 1-2 shift valve.
- B5 - In the Reverse circuit near orifice number one.
- B6 - Shuttle ball between the Low and Reverse circuits.
- B7 - Between the L234 and Torque Converter Clutch circuits.
- B8 - Between the L234 and Intermediate Clutch circuits.

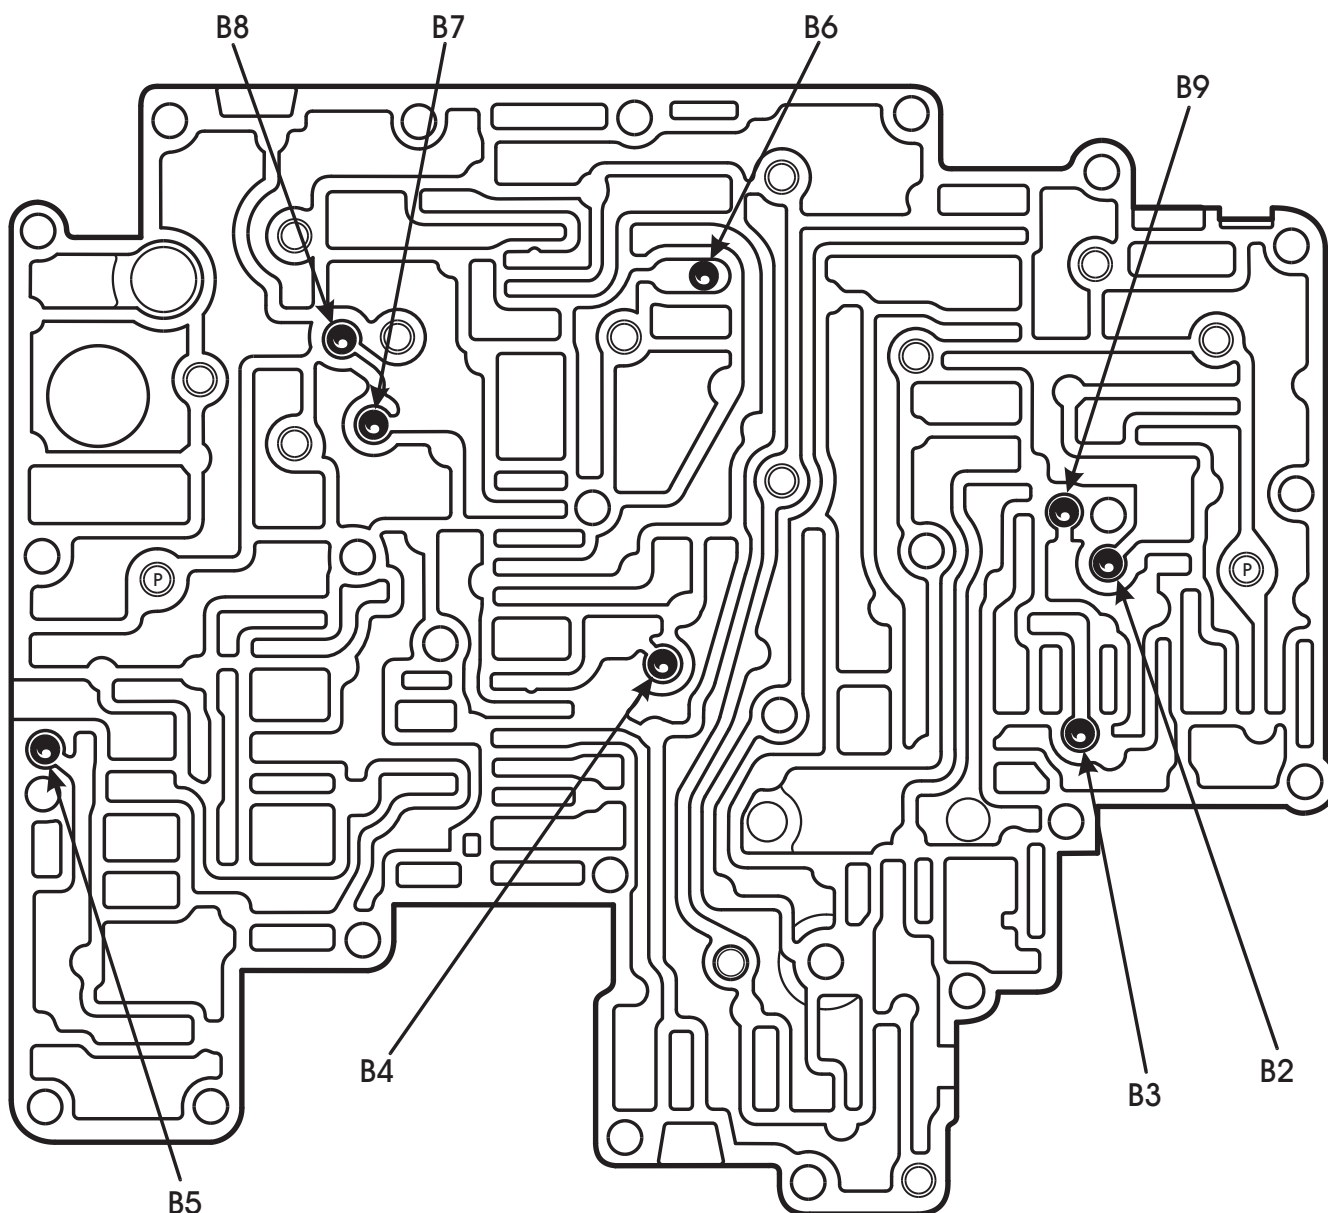
Figure 35

- B2 - In the Forward Clutch circuit near the 3-4 shift valve.
- B3 - In the Direct Clutch circuit near the 2-3 backout valve.
- B4 - In the Overdrive and Forward Clutch circuits near the 1-2 shift valve.
- B5 - In the Reverse circuit near orifice number one.
- B6 - Shuttle ball between the Low and Reverse circuits.
- B7 - Between the L234 and Torque Converter Clutch circuits.
- B8 - Between the L234 and Intermediate Clutch circuits.
- B9 - Between the FC34 and 23BP circuits (1996-Up Only).

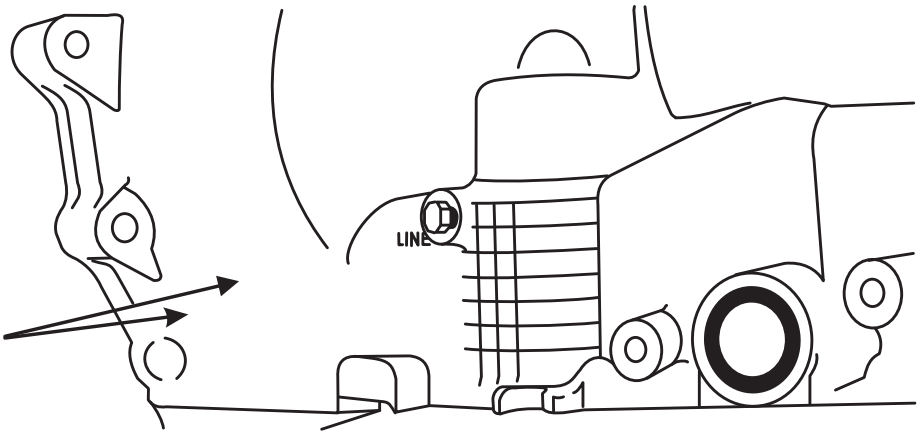
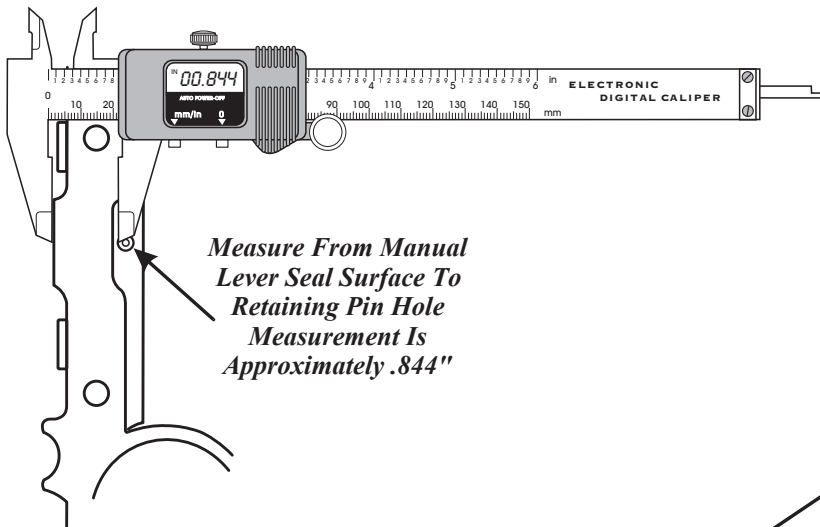
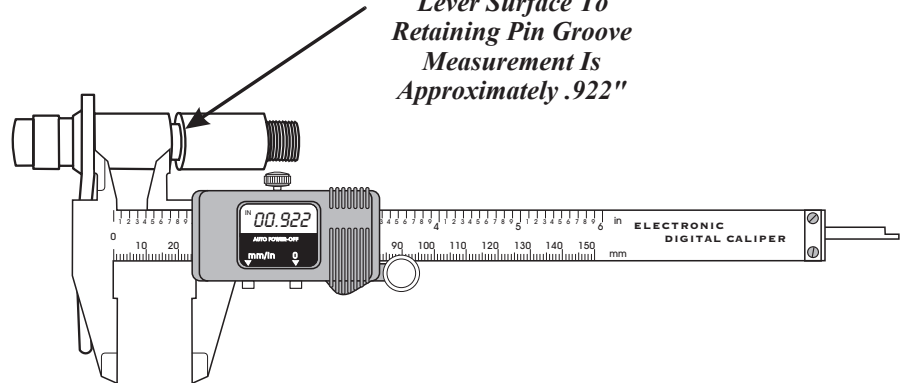
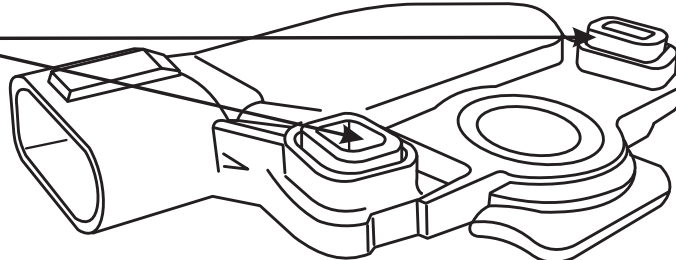
**CAUSE:** The AODE cases are different in thickness when measuring from the manual lever seal surface to the countersink in the manual lever retaining pin hole See Figure 44 and 45.

**Early Case** - The early case has None or One threaded boss on the lower left side of the case, as shown in Figure 44, and the measurement from the manual lever seal surface to the countersink in the manual lever retaining pin hole is approximately .844", which is also shown in Figure 44.

**Early Manual Shift Lever** - Measure from the back flange of shift lever to the first edge of the groove for the retaining pin, as shown in Figure 44. Early lever will measure approximately .922".

**Early MLPS** - Has the *short* torque limiters, as shown in Figure 44.

*Measure From Manual  
Lever Seal Surface To  
Retaining Pin Hole  
Measurement Is  
Approximately .844"*

*Measure From Manual  
Lever Surface To  
Retaining Pin Groove  
Measurement Is  
Approximately .922"*

**MLPS HAS SHORT  
TORQUE LIMITERS**

**CORRECTION:** It is *mandatory* that the proper parts be installed into the proper case, *as the parts listed above are not interchangeable.* Refer to Figure 44 for the early parts and to Figure 45 for the late parts.

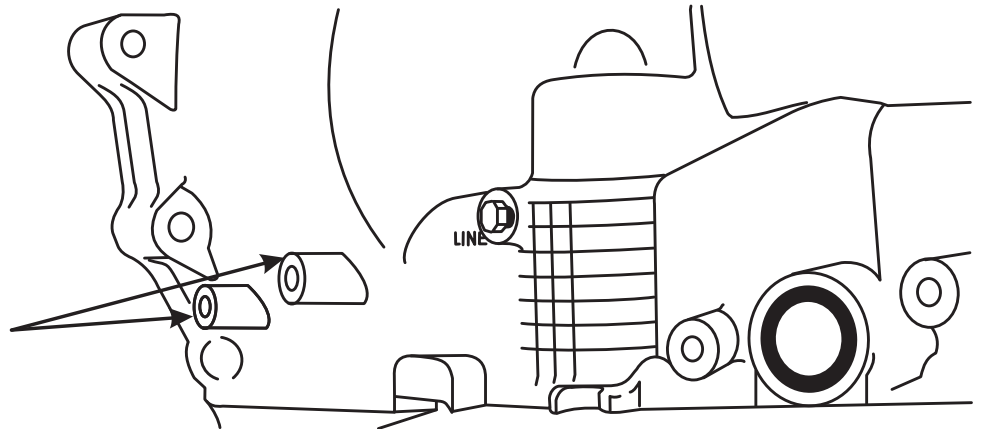
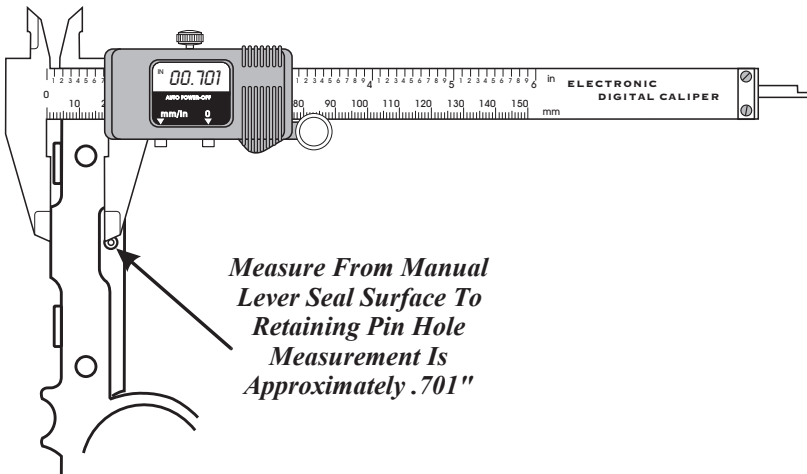
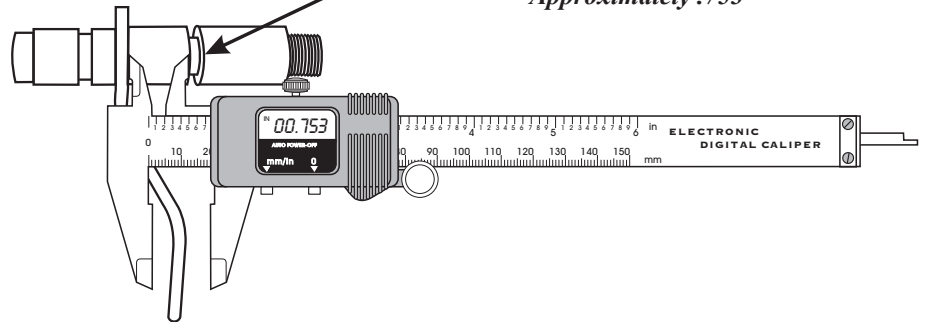
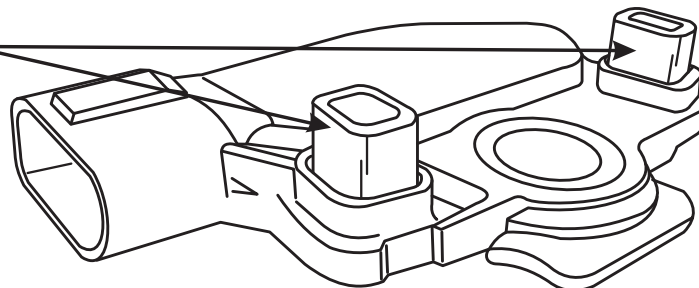
Figure 45

**Late Case** - The late case has Two threaded bosses on the lower left side of the case, as shown in Figure 45, and the measurement from the manual lever seal surface to the countersink in the manual lever retaining pin hole is approximately .701", which is also shown in Figure 45.

**Late Manual Shift Lever** - Measure from the back flange of shift lever to the first edge of the groove for the retaining pin, as shown in Figure 45. The Late lever will measure approximately .753".

**Late MLPS** - Has the *tall* torque limiters, as shown in Figure 45.

*Measure From Manual  
Lever Surface To  
Retaining Pin Groove  
Measurement Is  
Approximately .753"*

**MLPS HAS TALL  
TORQUE LIMITERS**

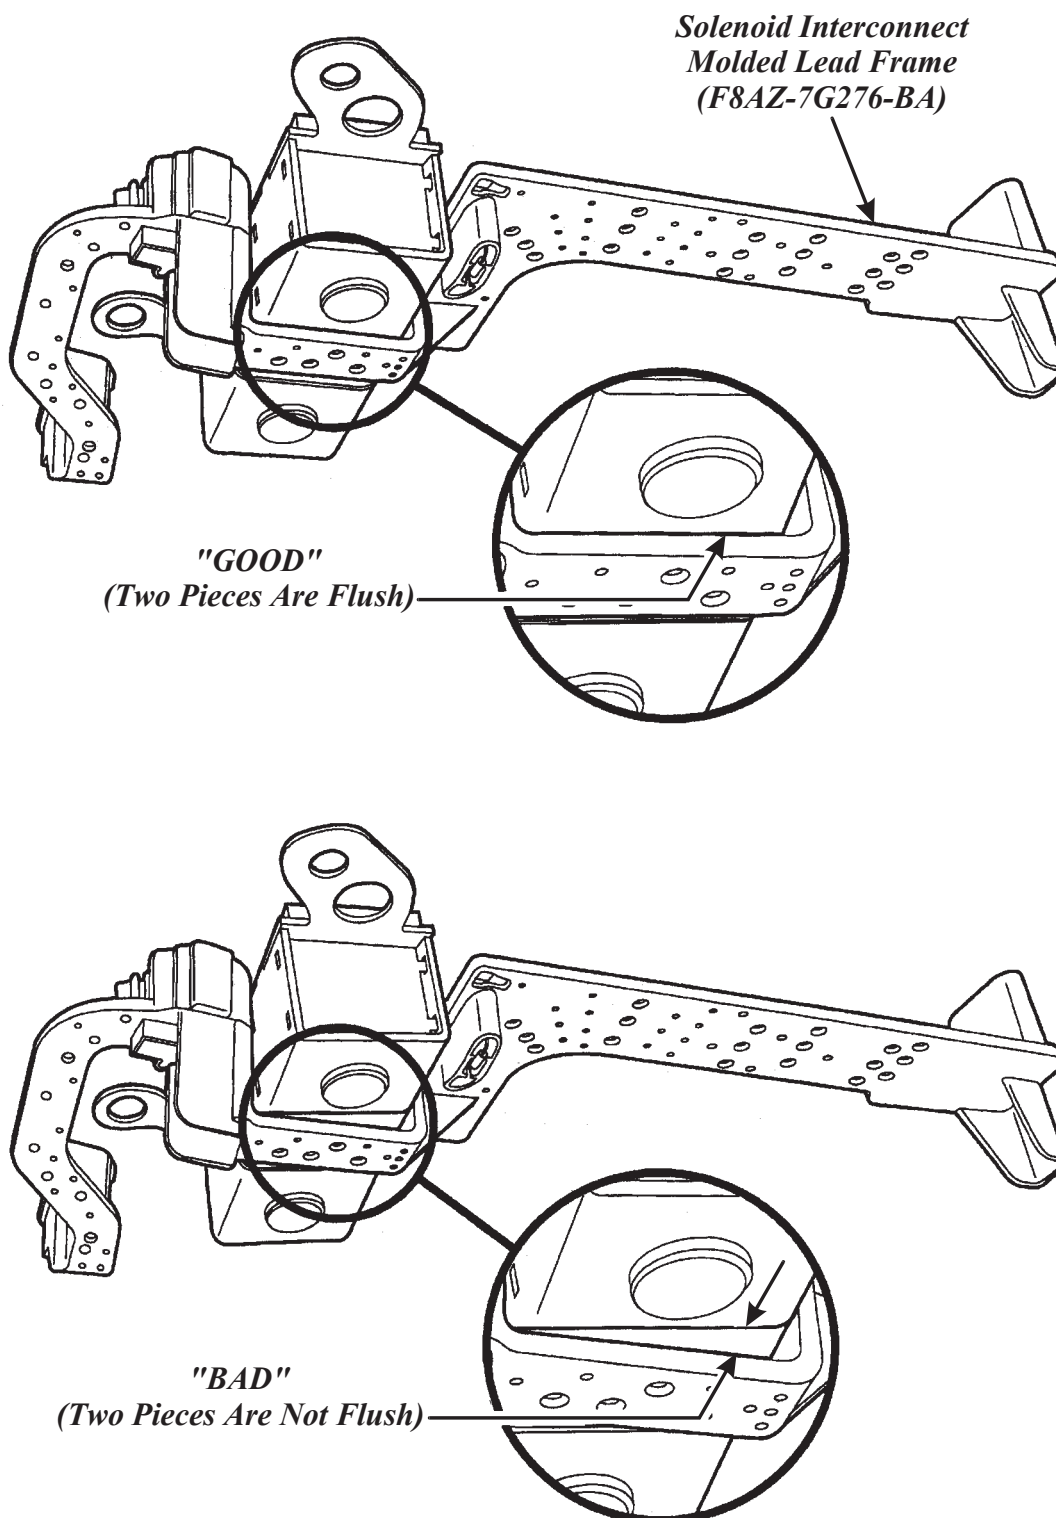
Figure 46

**CAUSE:** The cause may be, the solenoid interconnect molded lead frame not being fully seated on the solenoid pack or the bulkhead interconnect clips not being fully seated between the solenoid interconnect molded lead frame and bulkhead interconnect.

- (3) Verify that the solenoid interconnect molded lead frame is fully seated on all the solenoid connectors as shown in Figure 46. If the solenoid interconnect molded lead frame is fully seated, then gently remove the solenoid interconnect molded lead frame, valve body and the bulkhead interconnect.

- (5) Replace parts as necessary using the part numbers listed below and reassemble unit.

| Bulkhead Interconnect (Case Connector) ..... | F8AZ-7G276-AA |
| Solenoid Interconnect (Internal Molded Harness) ..... | F8AZ-7G276-BA |
