## UPDATE HANDBOOK AODE, 4R70W, 4R70E, 4R75E

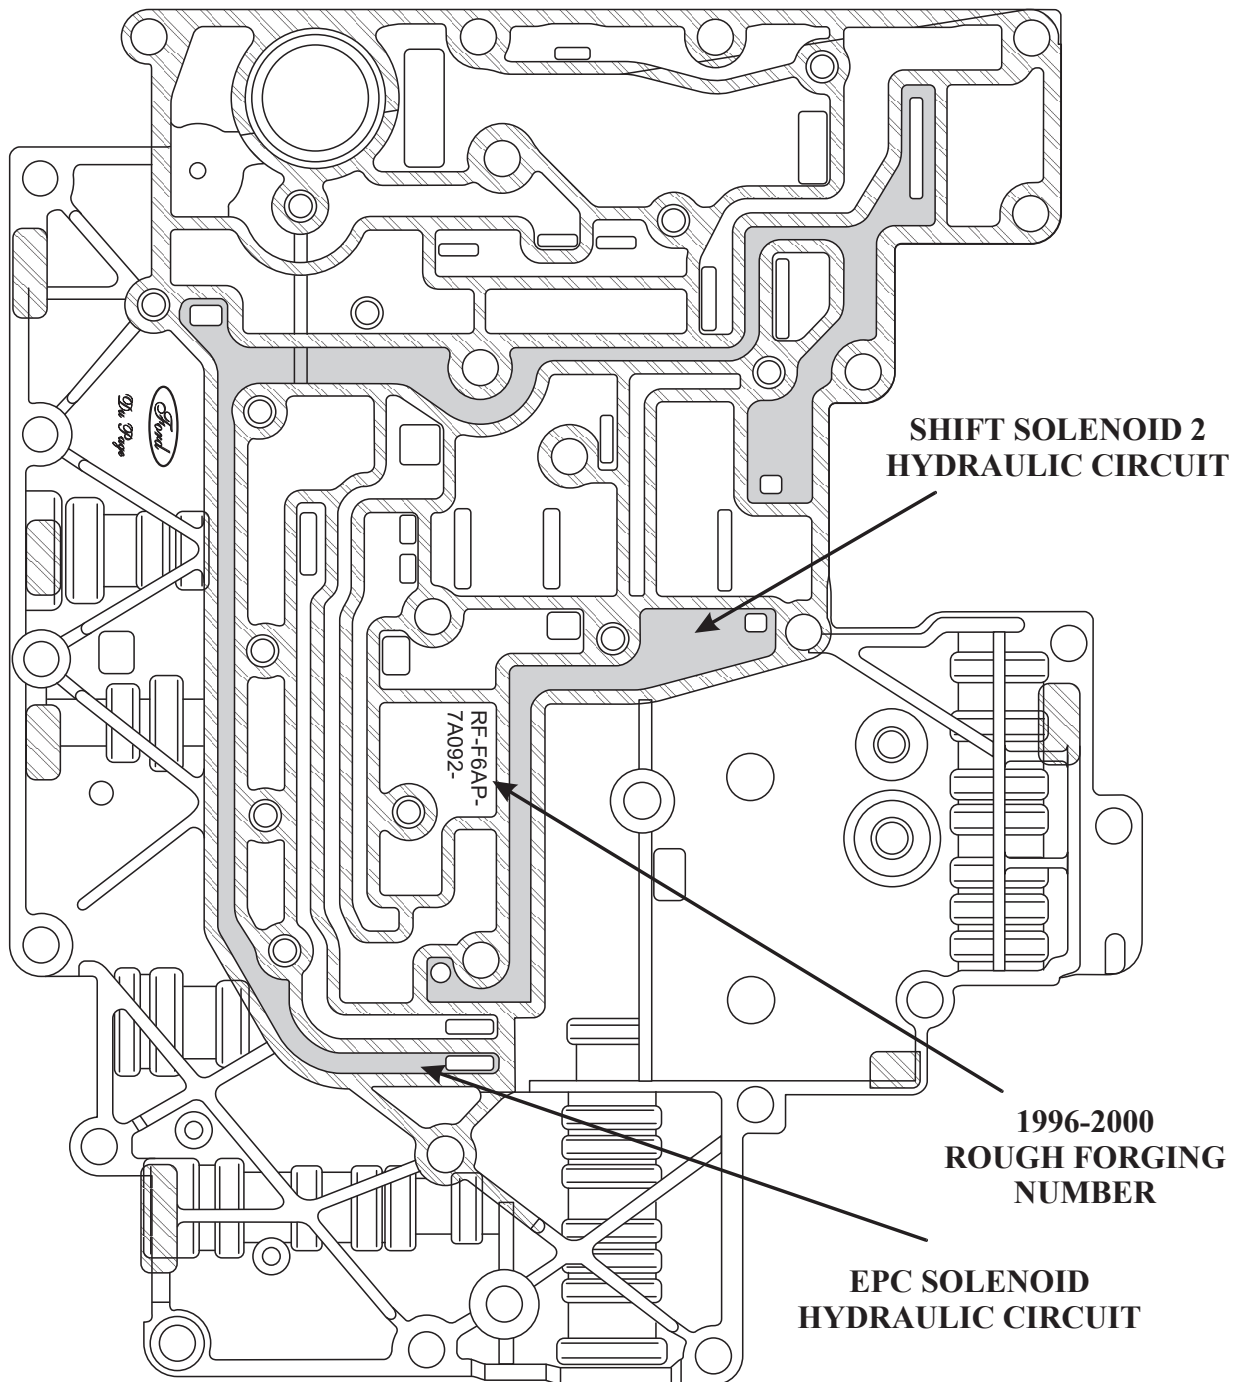
- (1) VALVE BODY CASTING (*Lower side*) - The Lower side of the valve body had casting changes to connect the 2-3 Backout Valve to the Shift Solenoid 2 hydraulic circuit, as shown in Figure 51. Figure 50 shows the previous design casting and identifies the EPC circuit that was connected to the 2-3 Backout Valve on the earlier models.

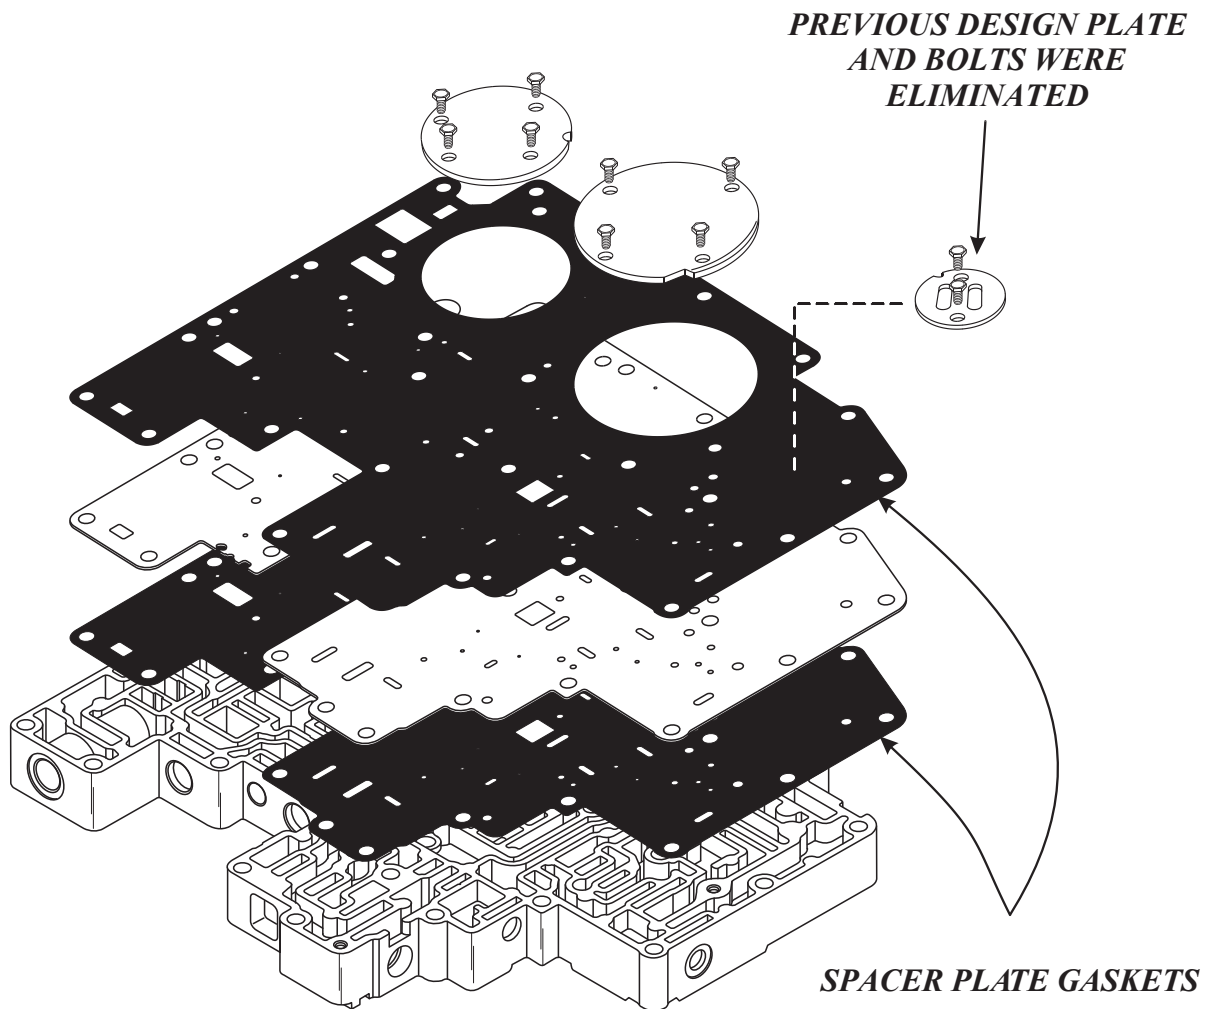
Figure 52

- (2) SPACER PLATE GASKETS - The 2001 and up design upper and lower spacer plate gaskets had numerous hole configuration changes, to accommodate the hydraulic changes with the valve body. The most obvious change is around the plate that was eliminated over the Direct Clutch Accumulator, as shown in Figure 52.

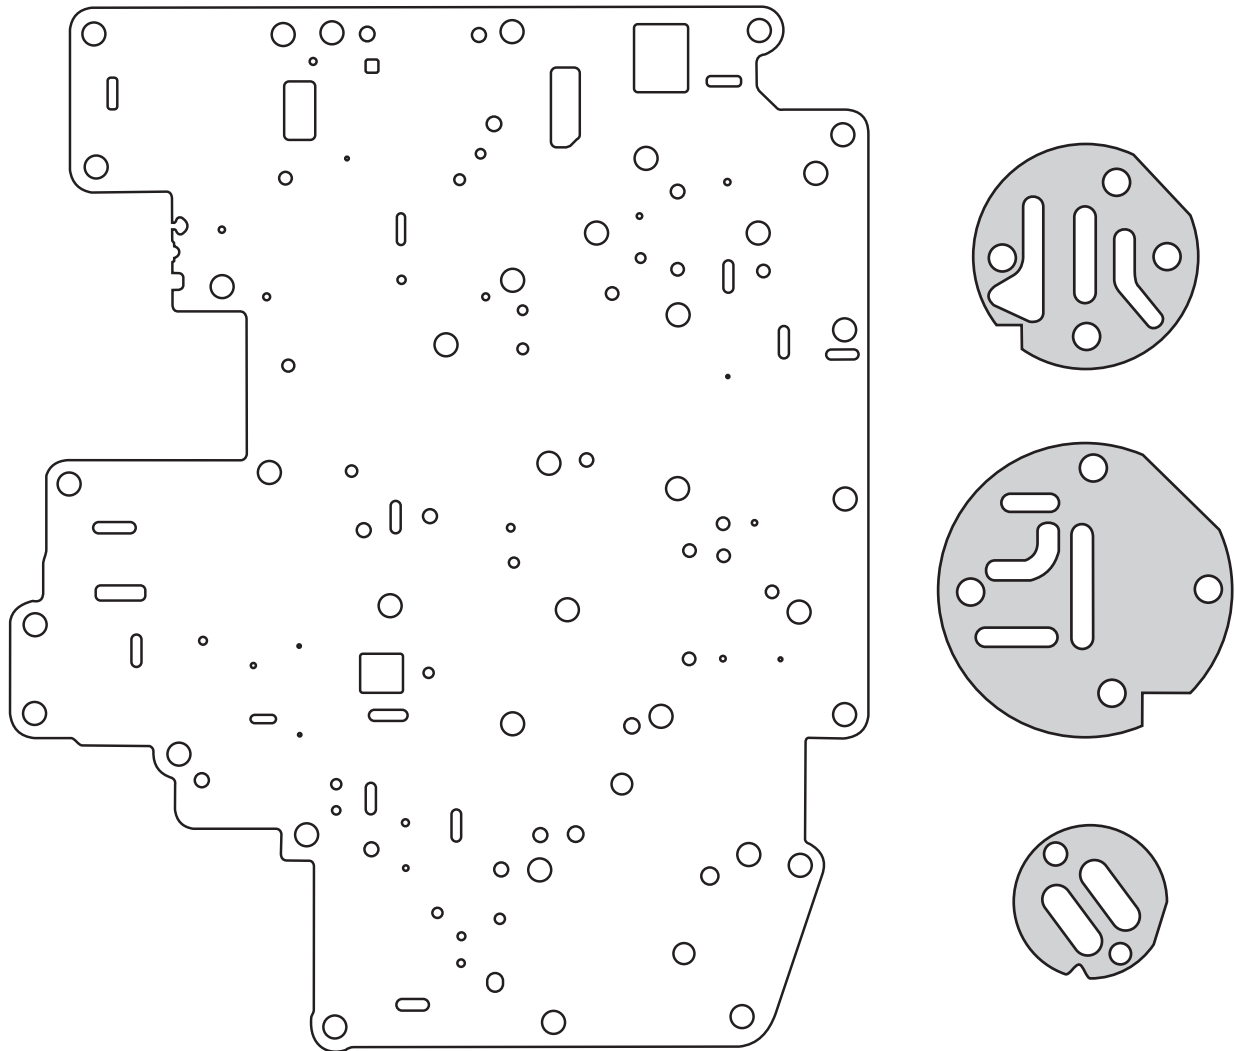
- (3) SPACER PLATE - The 2001 and up design spacer plate had hole changes to connect the added Overdrive Servo Regulator Valve Boost Valve and Sleeve to the EPC solenoid circuit, and to accommodate the changes in the 3-4 Capacity Modulator Valve. Figure 54 shows that a change also was made to the cover plate connecting the Forward Clutch Circuit to the 3-4 Capacity Modulator Valve. The bolt holes were removed from the Spacer plate along with the plate over the Direct Clutch Accumulator. Figure 53 shows a view of the previous design Spacer Plate.

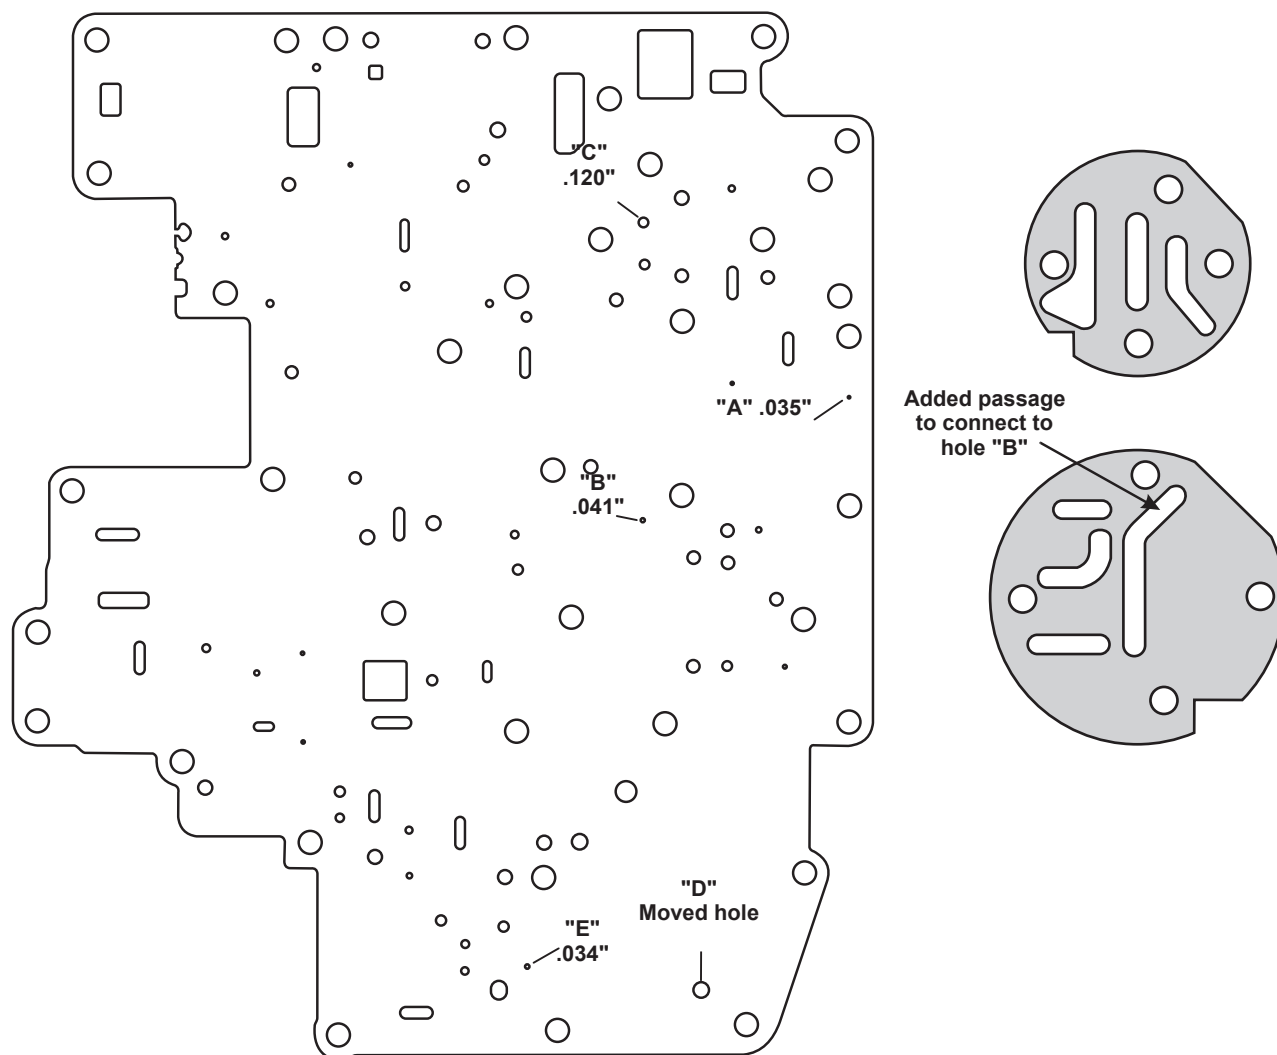
**"A"** = Added hole to connect the EPC circuit to the added Overdrive Servo Regulator Valve Boost Valve and Sleeve

**"B"** = Added hole to connect the Forward Clutch to the 3-4 Capacity Modulator Valve

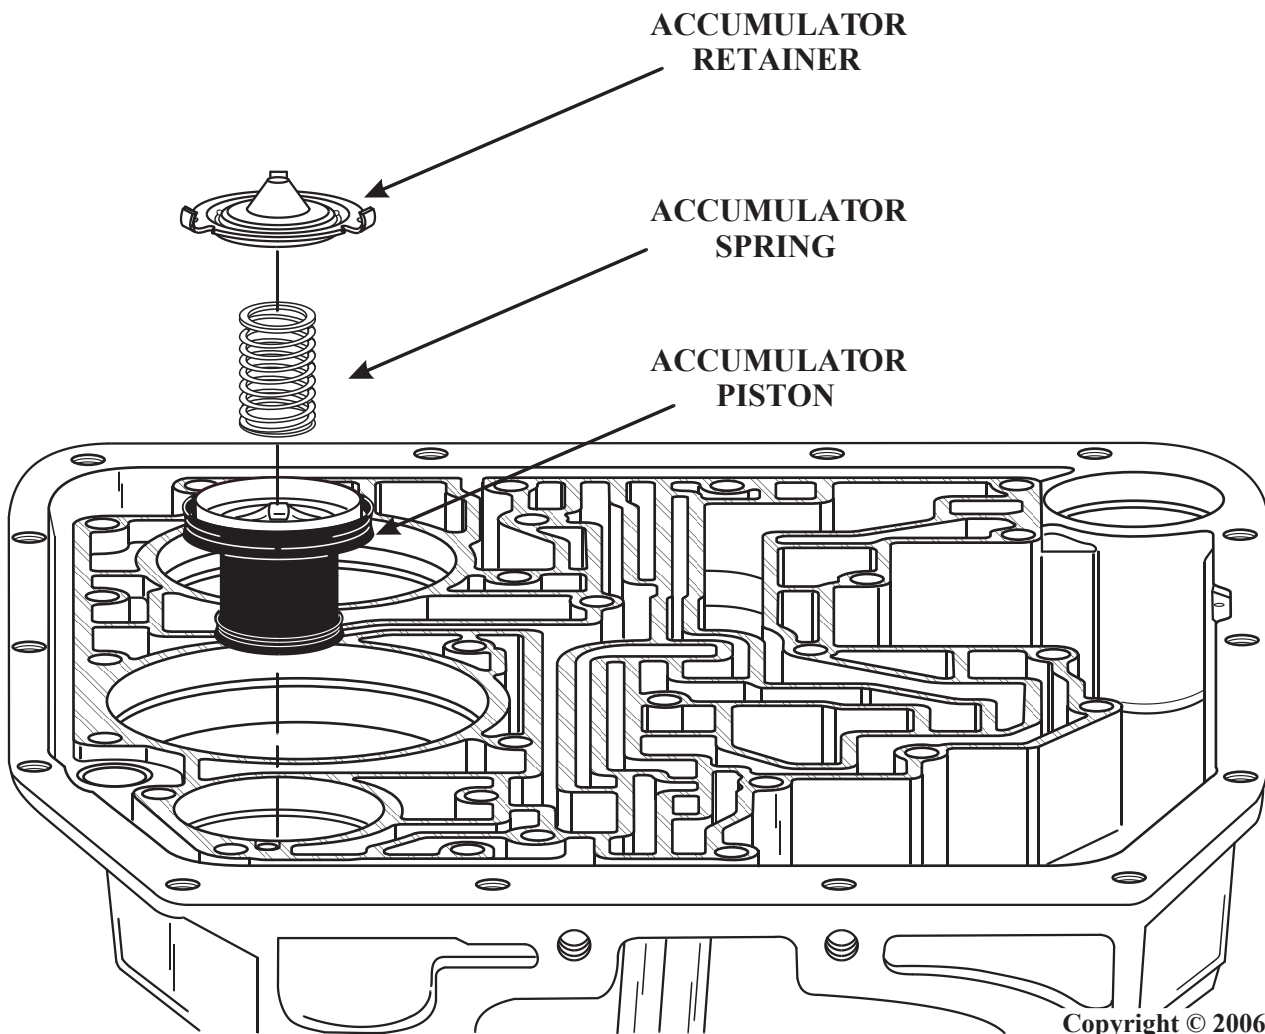
Figure 55

- (4) DIRECT CLUTCH ACCUMULATOR RETAINER - The retainer for the accumulator received a dimensional change to accommodate the elimination of the plate over the the Direct Clutch Accumulator, as shown in Figure 55.

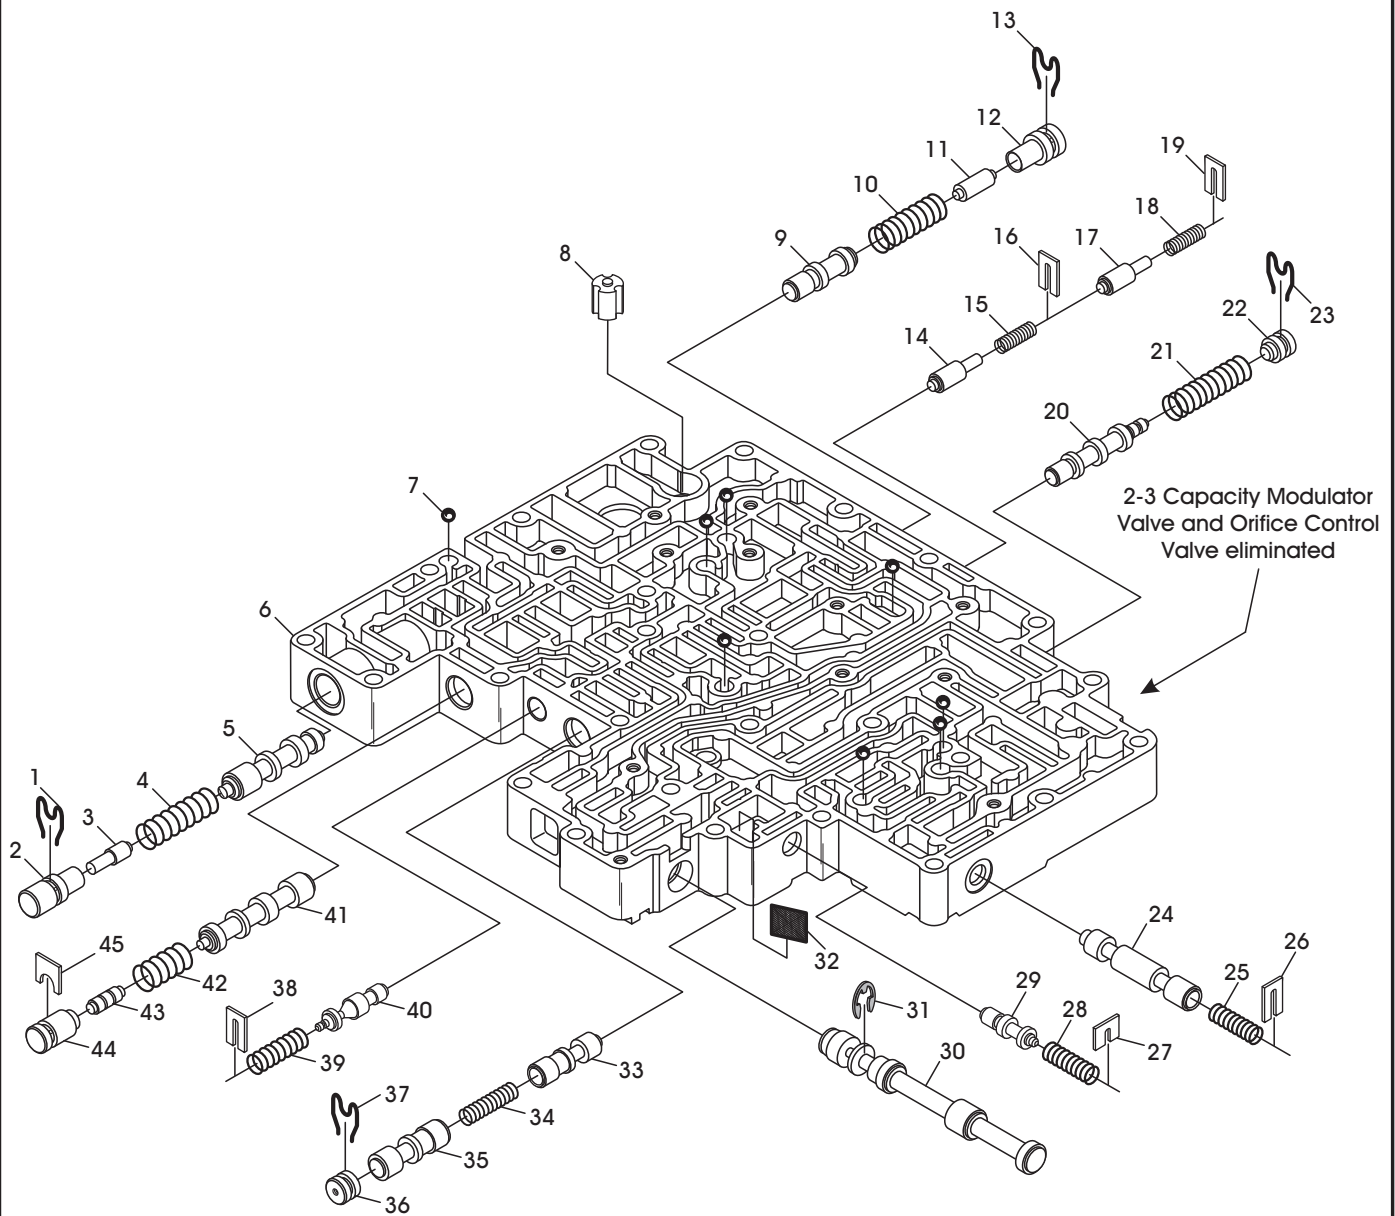
Figure 56

- (5) MAIN VALVE BODY - The main valve body received casting changes to accommodate the removal of the Orifice Control Valve and the 2-3 Capacity Modulator Valve, as shown in Figures 56, 57 and 58.

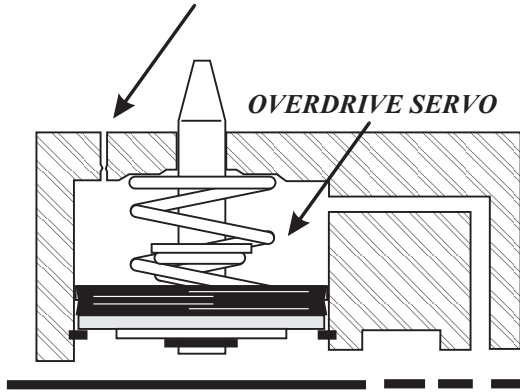
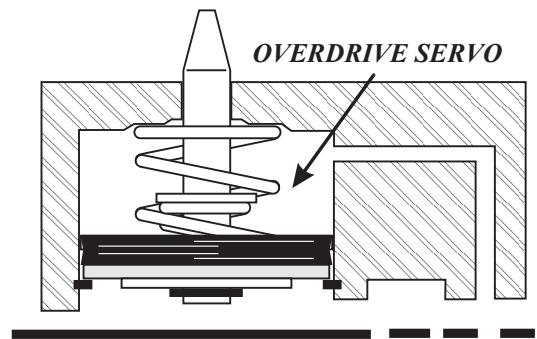
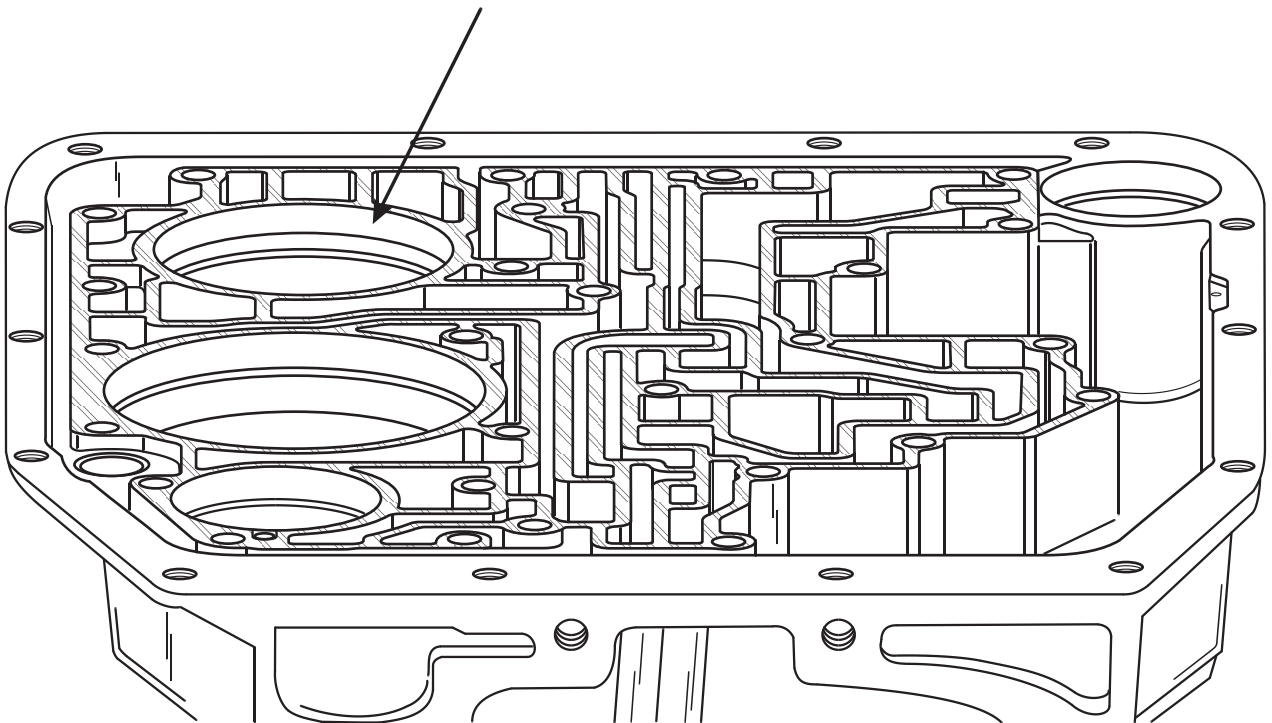
Figure 59

- (6) CASE - The Overdrive Servo Bleed orifice, as shown in Figure 59, was eliminated to accommodate the hydraulic circuit changes in the Overdrive Servo Regulator Valve. Refer to Figure 60 for a partial hydraulic circuit diagram identifying the 2001 and up hydraulic circuit.

**PREVIOUS DESIGN  
CASE "WITH" .020" BLEED ORIFICE**

**2001 & UP DESIGN  
CASE "WITHOUT" BLEED ORIFICE**

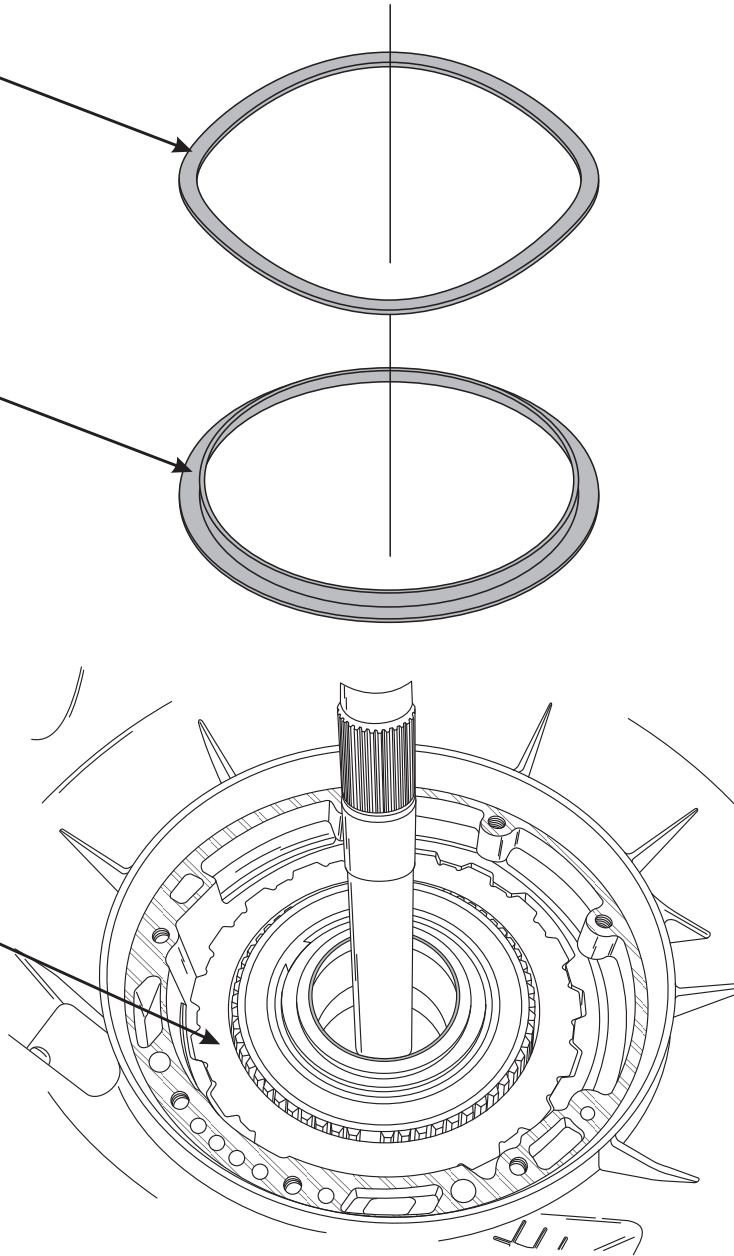
Figure 62

- (2) **INTERMEDIATE CLUTCH PISTON RETURN SPRING AND RETAINER**- A new design return spring and retainer was added and now installs into the case, as shown in Figure 62, to accommodate the new design level piston. Figure 63 shows cut-away views of both retainers.

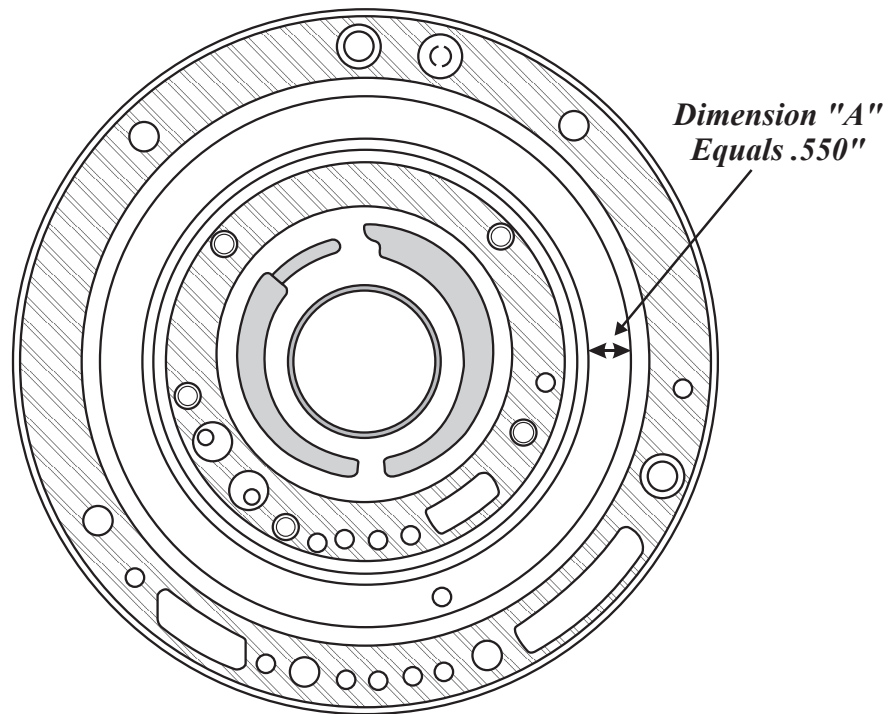
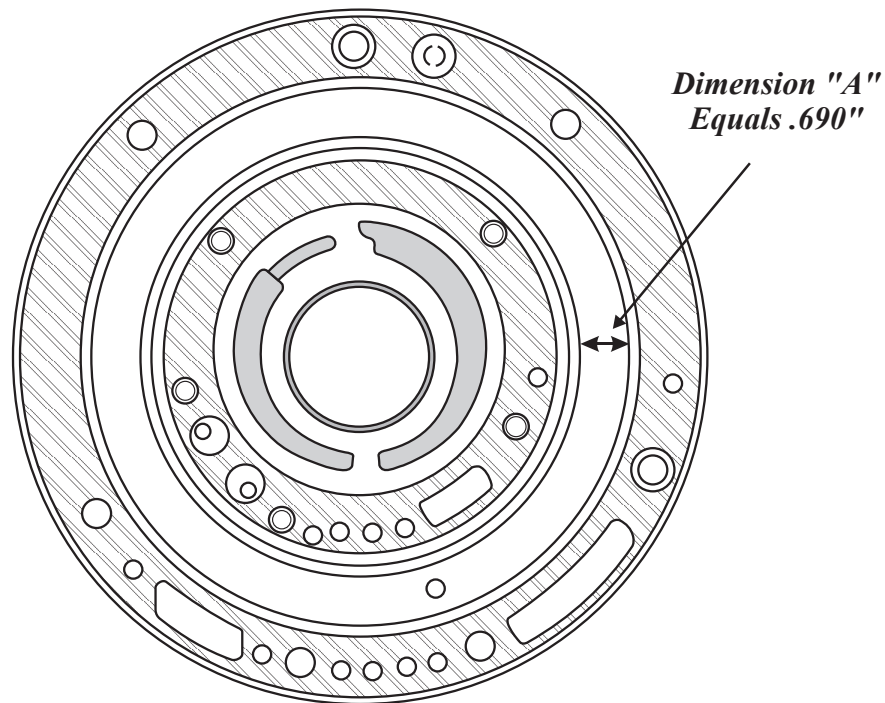
- (3) **OIL PUMP BODY** - The Oil Pump body was redesigned to accommodate the new larger piston and the elimination of the Spring retainer. Refer to Figure 64 for the dimensions to identify the new design level oil pump body from the previous design.

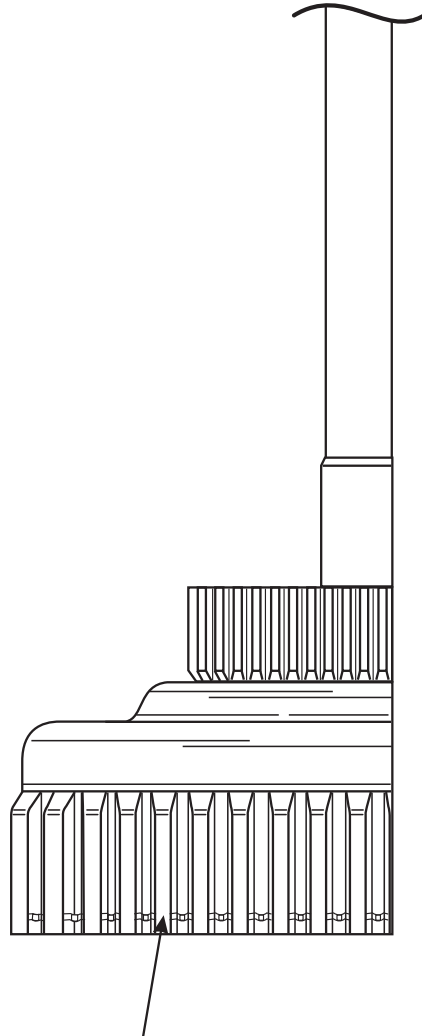
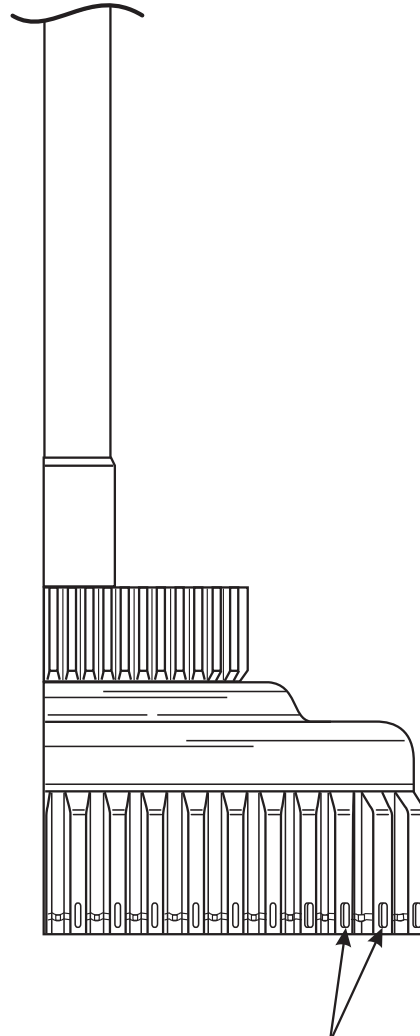
Figure 66

**FORWARD CLUTCH DRUM*****PREVIOUS DESIGN***

***NO PROJECTIONS******NEW DESIGN***

***34 STAMPED PROJECTIONS  
ON THE OUTSIDE OF THE DRUM  
THAT THE ADDED TURBINE SENSOR  
READS FROM***

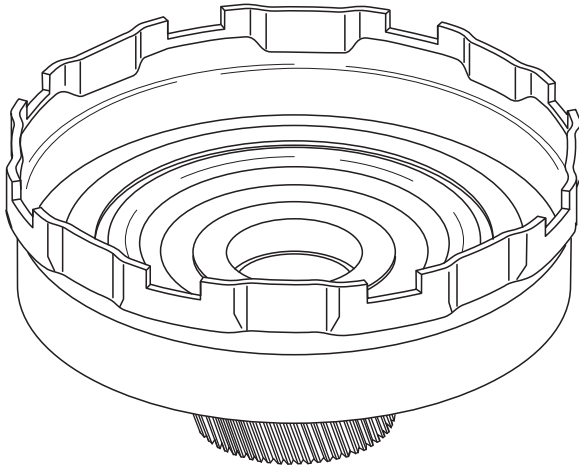
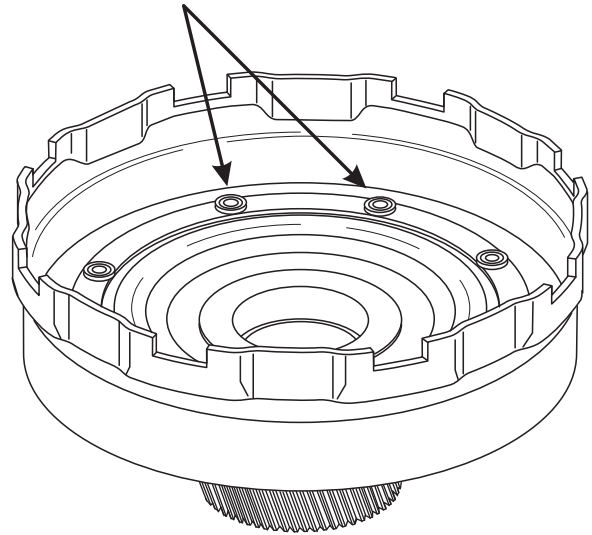
## SUN GEAR SHELL

*New Sun Shell Is Now Riveted To The Sun Gear And Hub*

*The New Design Sun Shell is manufactured using a non-magnetic material, so the Turbine Sensor can read the stamped projections on the New Design Forward Drum.*

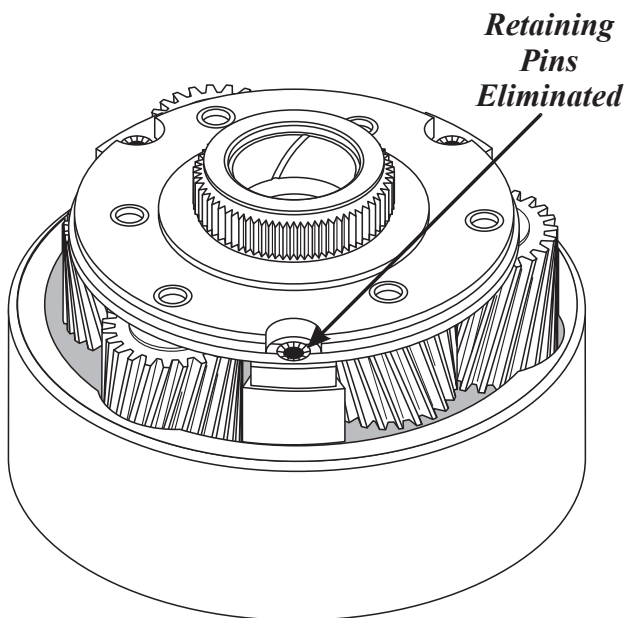
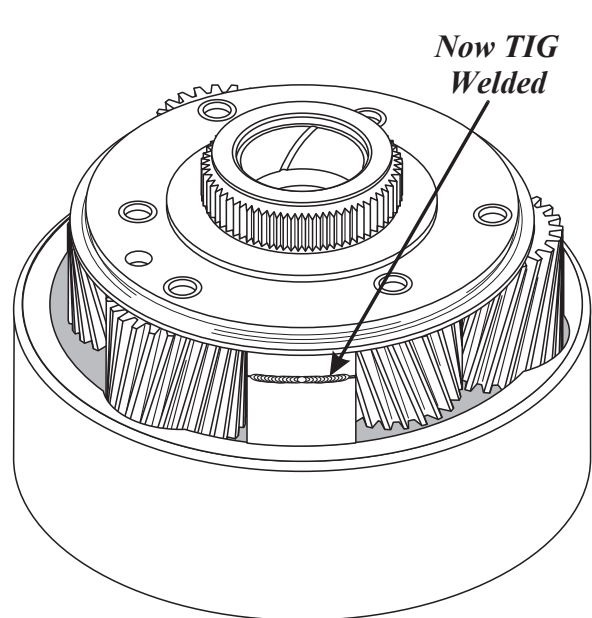
Figure 69

*Retaining Pins Eliminated*

*Now TIG Welded*

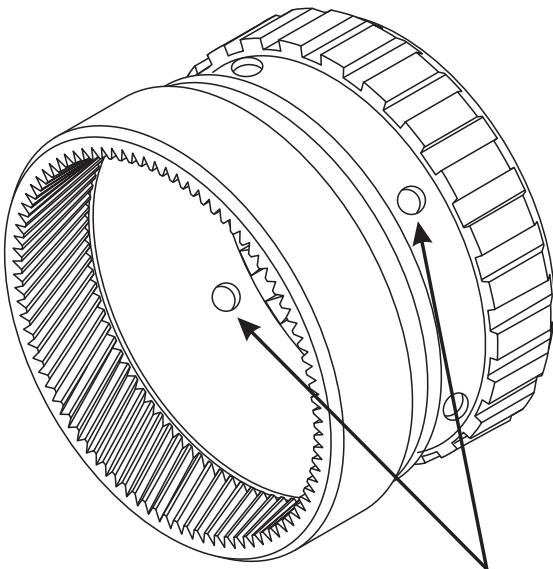
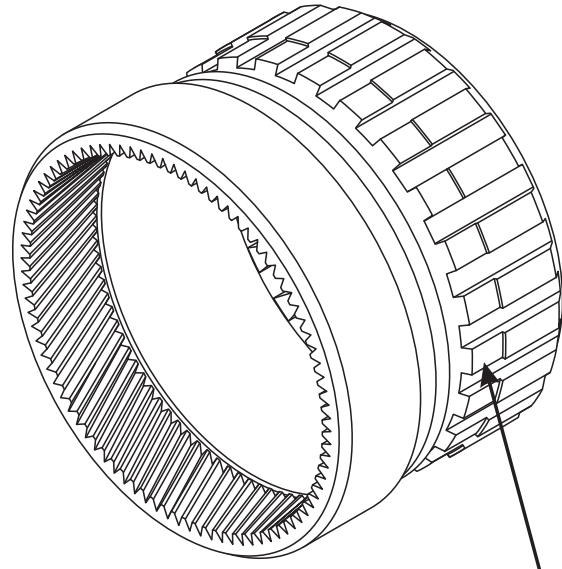
Figure 70

*Holes To Trigger  
Speed Sensor*

*Extended Lugs To Trigger  
Speed Sensor*

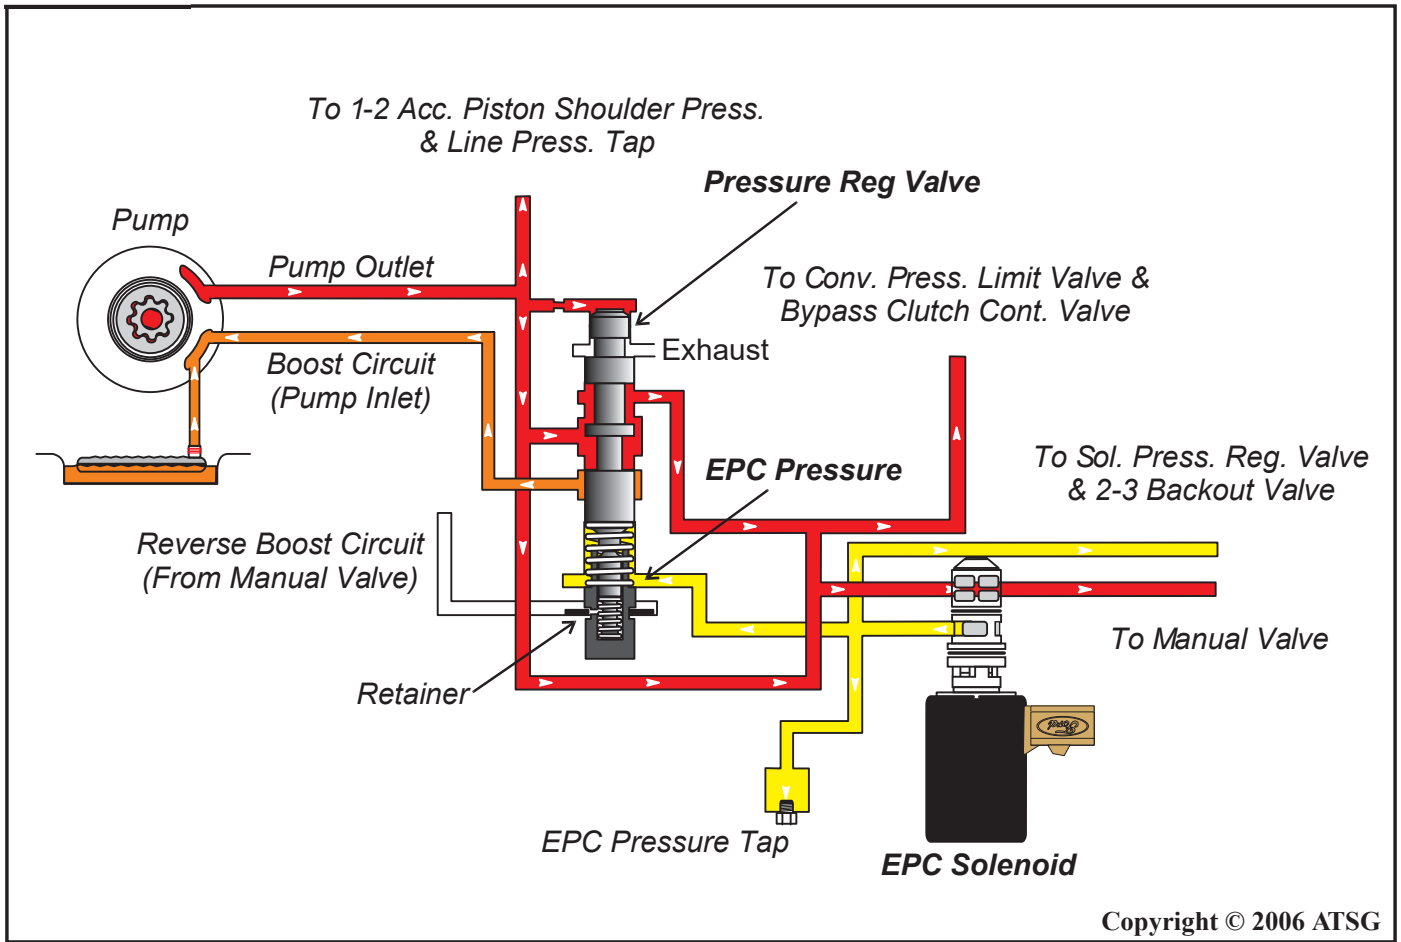
Figure 77

**CAUSE:** EPC pressure is routed to the Pressure Regulator Valve along side of a circuit that Ford identifies as the Boost Circuit. These oil passages can be identified in both the valve body and the case as seen in Figure 75 and 76. This is illustrated by the hydraulic schematic shown in Figure 77. This circuit is routed back to the inlet side of the pump. When the Pressure Regulator Valve or its bore is worn, (See Figure 78), EPC pressure is allowed to be sucked away by pump suction, (See Figure 79 and 80), preventing any line pressure rise from occurring when the throttle is opened.

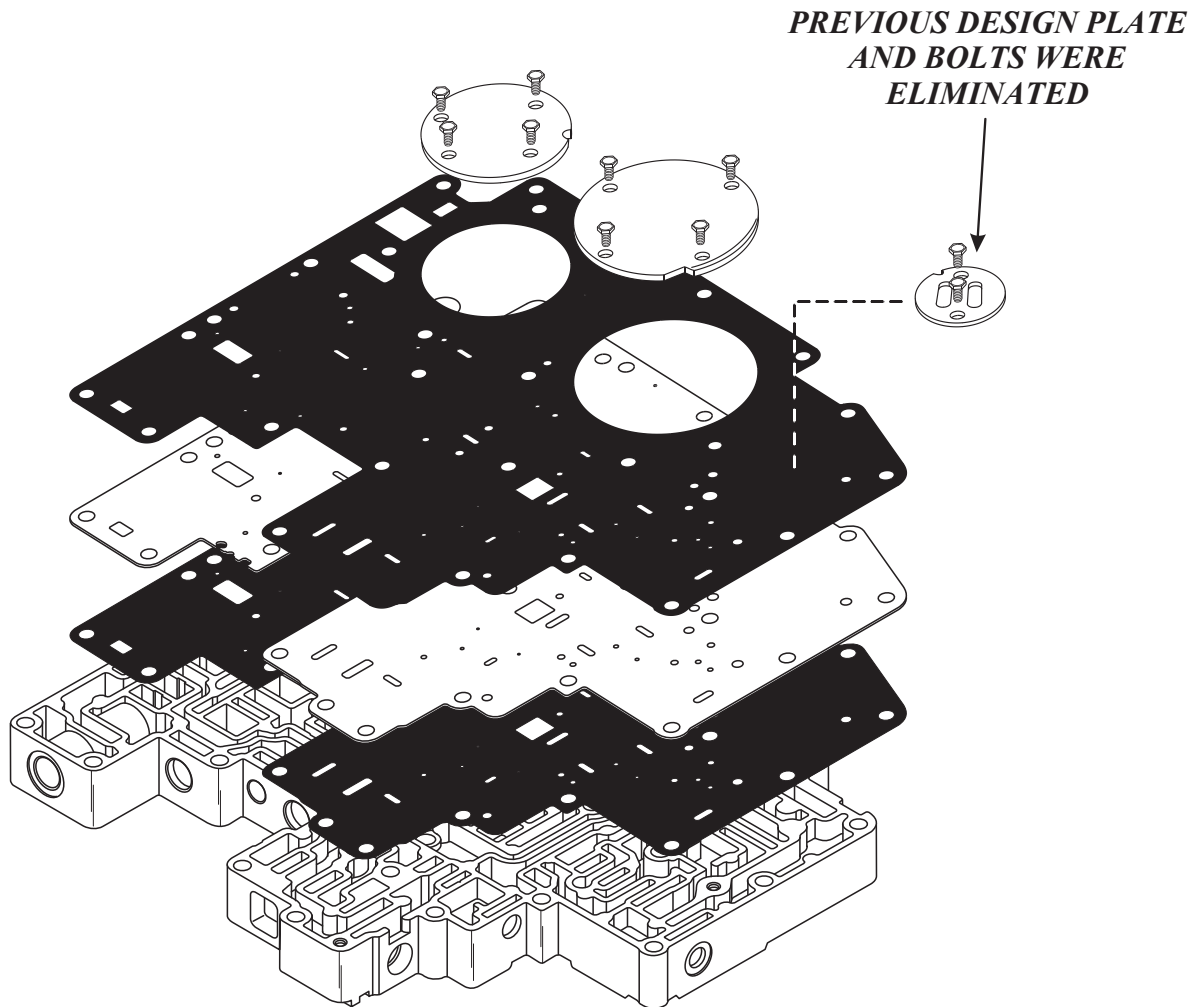
Figure 83

**CAUSE:** The cause may be, that a previous design 2-3 accumulator retainer was used, or the retainer was assembled upside down, when installing it into the case. **NOTE:** 2001 and up Valve Body assemblies, as shown in Figure 83, eliminated the small plate on the spacer plate side over the 2-3 accumulator retainer, which made a taller 2-3 accumulator retainer necessary for 2001 models, shown in Figure 82. When the early 2-3 accumulator retainer (shorter) is used, or if the retainer is installed upside down, the 2-3 accumulator piston may come out of its bore dumping Direct Clutch pressure to an exhaust. Refer to Figure 84 for a cutaway of the correct and incorrect assembly.

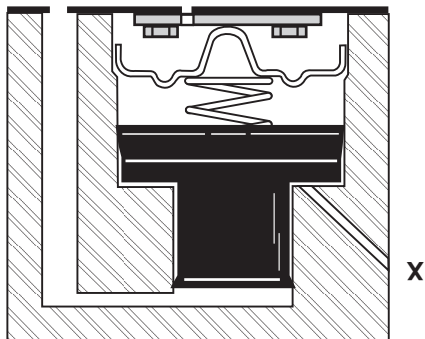
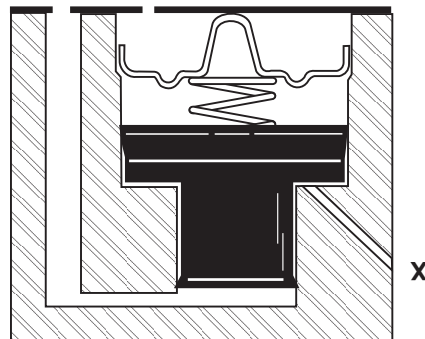
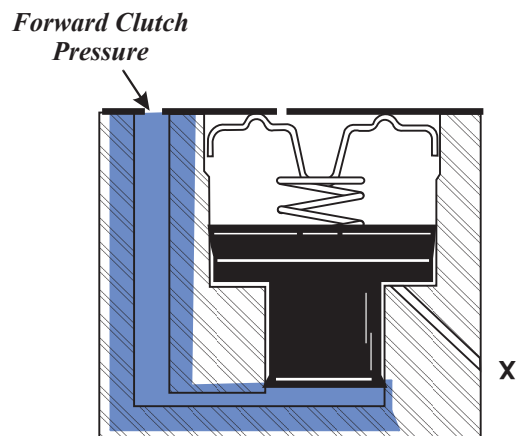
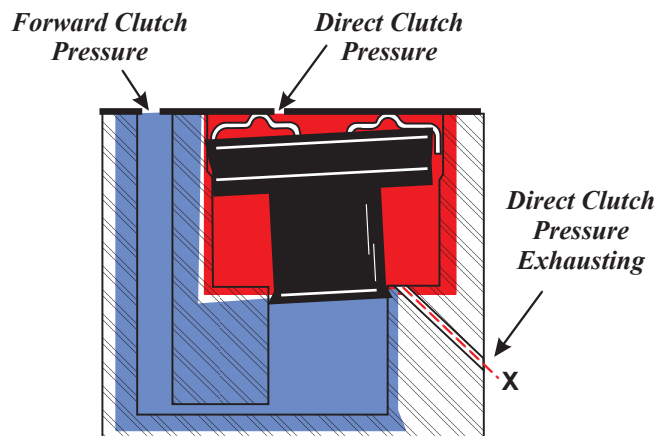
## 2-3 ACCUMULATOR AND RETAINER CUTAWAY

**Note:** When the 2-3 accumulator piston retainer is installed up-side down, as shown here, the accumulator piston may come out of it's case bore and connect the direct clutch to an exhaust.

**CORRECTION:** Refer to Figure 85 for the location and proper installation of the 2-3 accumulator retainer, piston and spring.

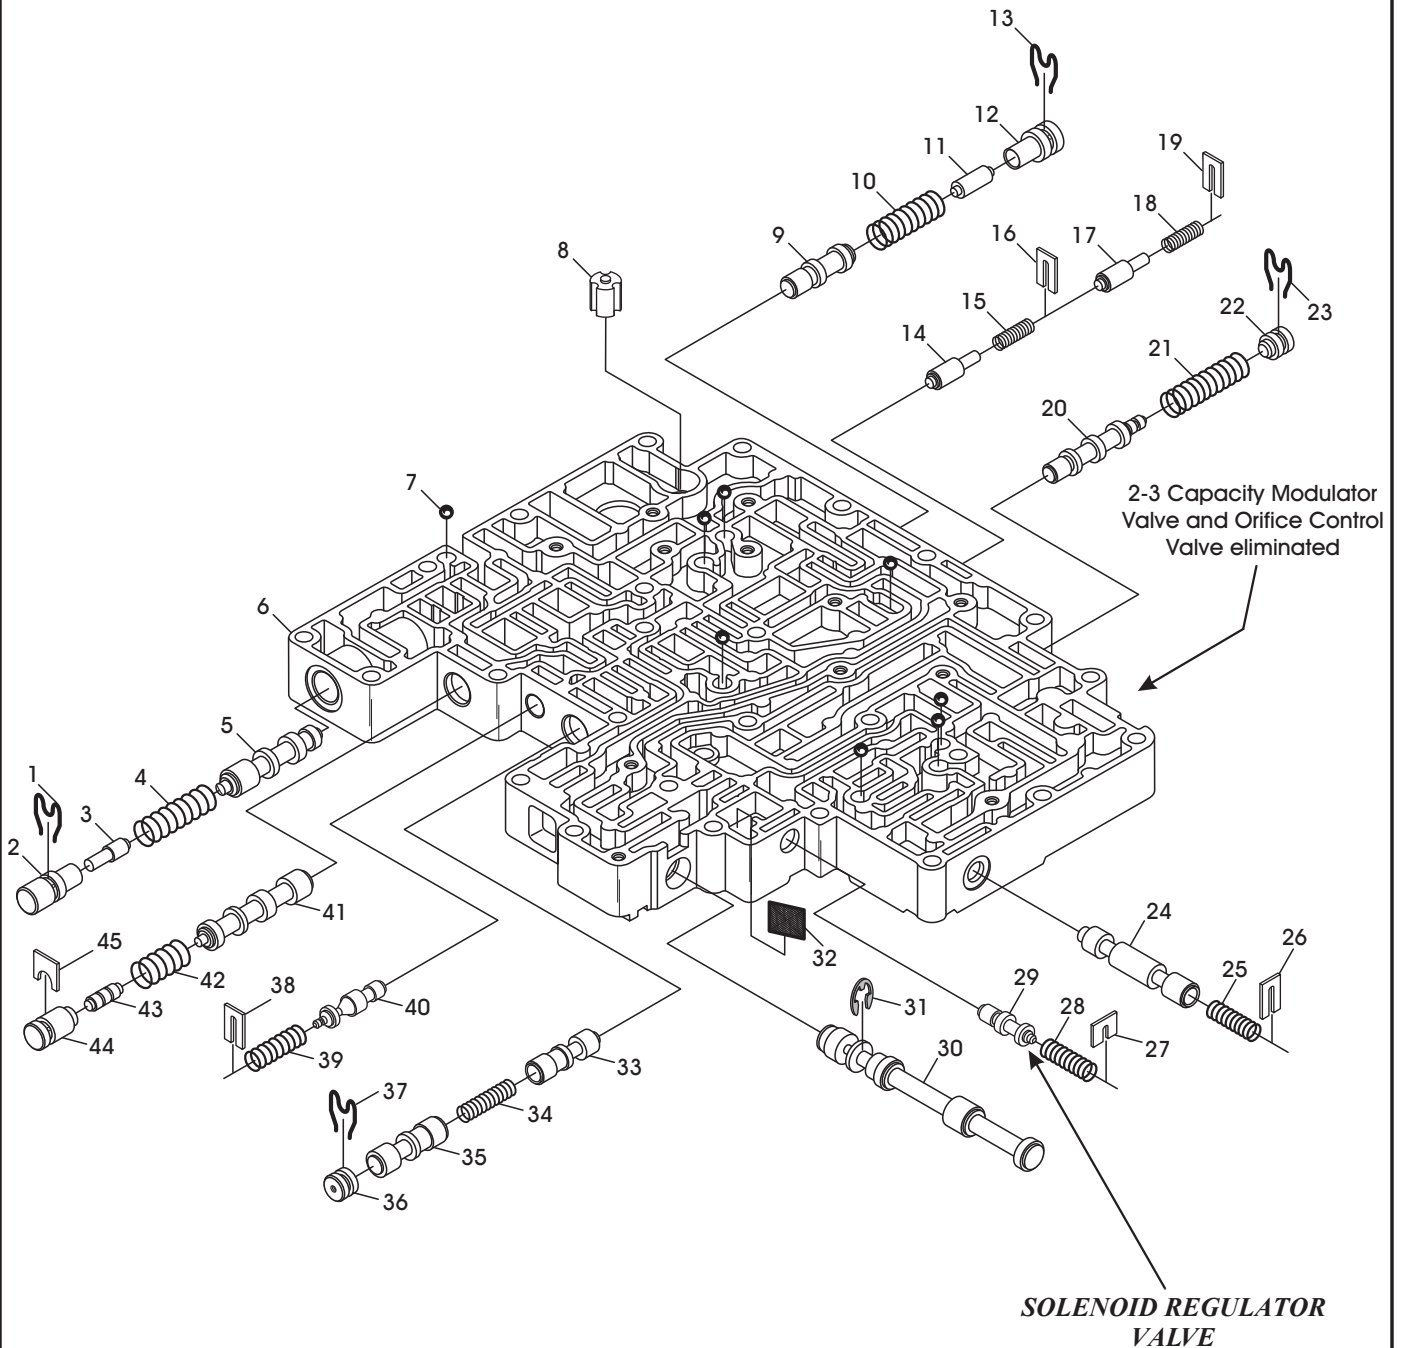
**CAUSE NO 2:** Another cause for this condition may be, the Solenoid Regulator Valve has become stuck down, in the bottom of the Valve Body bore, causing the pressure in the Solenoid Regulator Circuit to become higher than what the Shift Solenoid can exhaust. This will allow the Shift Solenoid 2 pressure to build up and stroke the 3-4 Shift Valve to the right exhausting the Forward Clutch oil, creating a neutral condition. Refer to Figure 87 for hydraulic schematic. No Diagnostic Trouble Codes will be stored. Refer to Figure 88 and 89 for valve identification.

- (1) Repair or replace the damaged Shift Solenoid 2 wire. Refer to Figure 92, for an index to locate the proper year and model vehicle that you are working on, and refer to schematic for that vehicle. Wire schematics have been provided in Figures 93, 94, 95 and 96.
- (2) Locate the Solenoid Regulator Valve in the Valve Body, as shown in Figure 88. To repair a sticking Solenoid Regulator Valve, it may become necessary to replace the valve assembly. There are replacement Solenoid Regulator Valve Kits available from aftermarket suppliers.
- (3) Replace the complete Shift Solenoid Assembly.
