## UPDATE HANDBOOK AODE, 4R70W, 4R70E, 4R75E

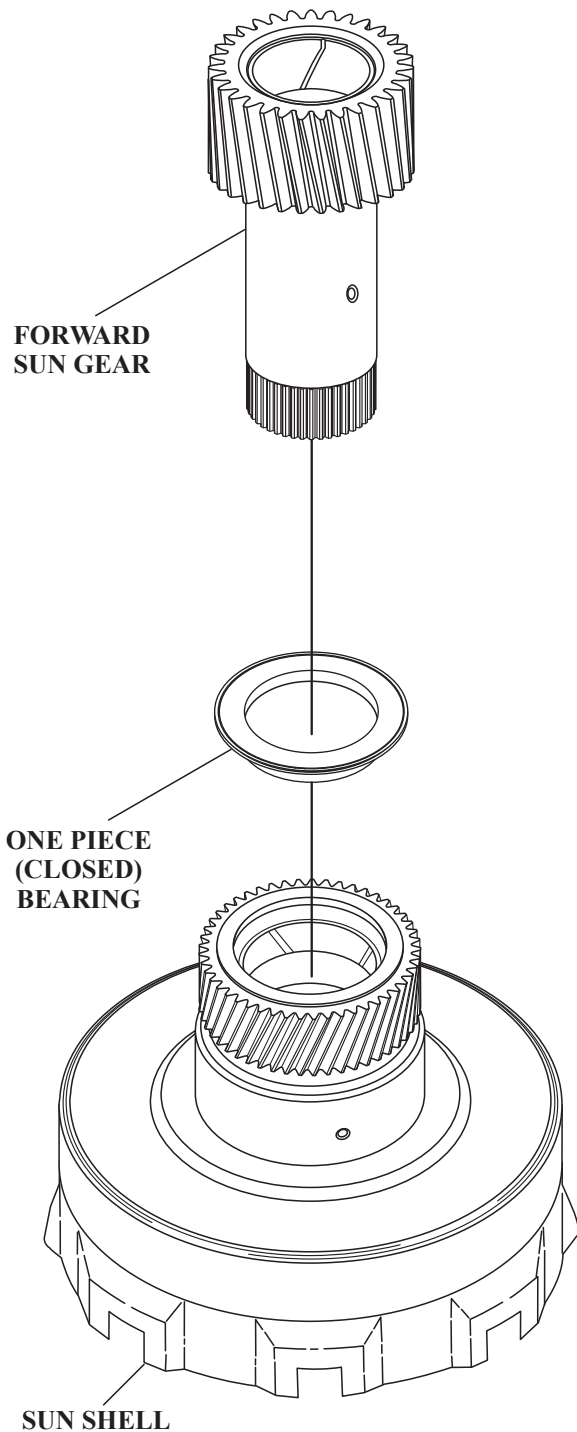
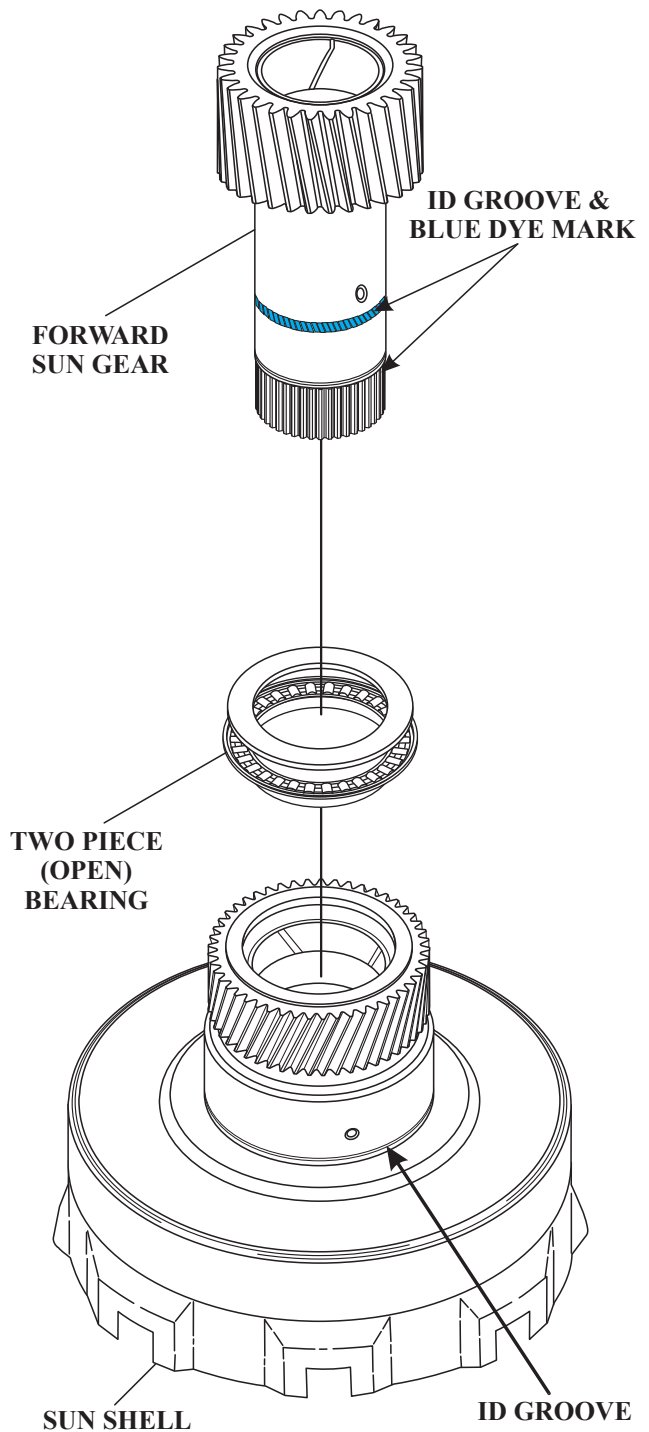
Figure 97

**CHANGE:** There is now available, for *1994-2003 models only*, equipped with the 4R70W transmission, a new service package that contains the forward sun gear, a new design number 5 bearing and new design sun gear shell, as illustrated in Figure 97.

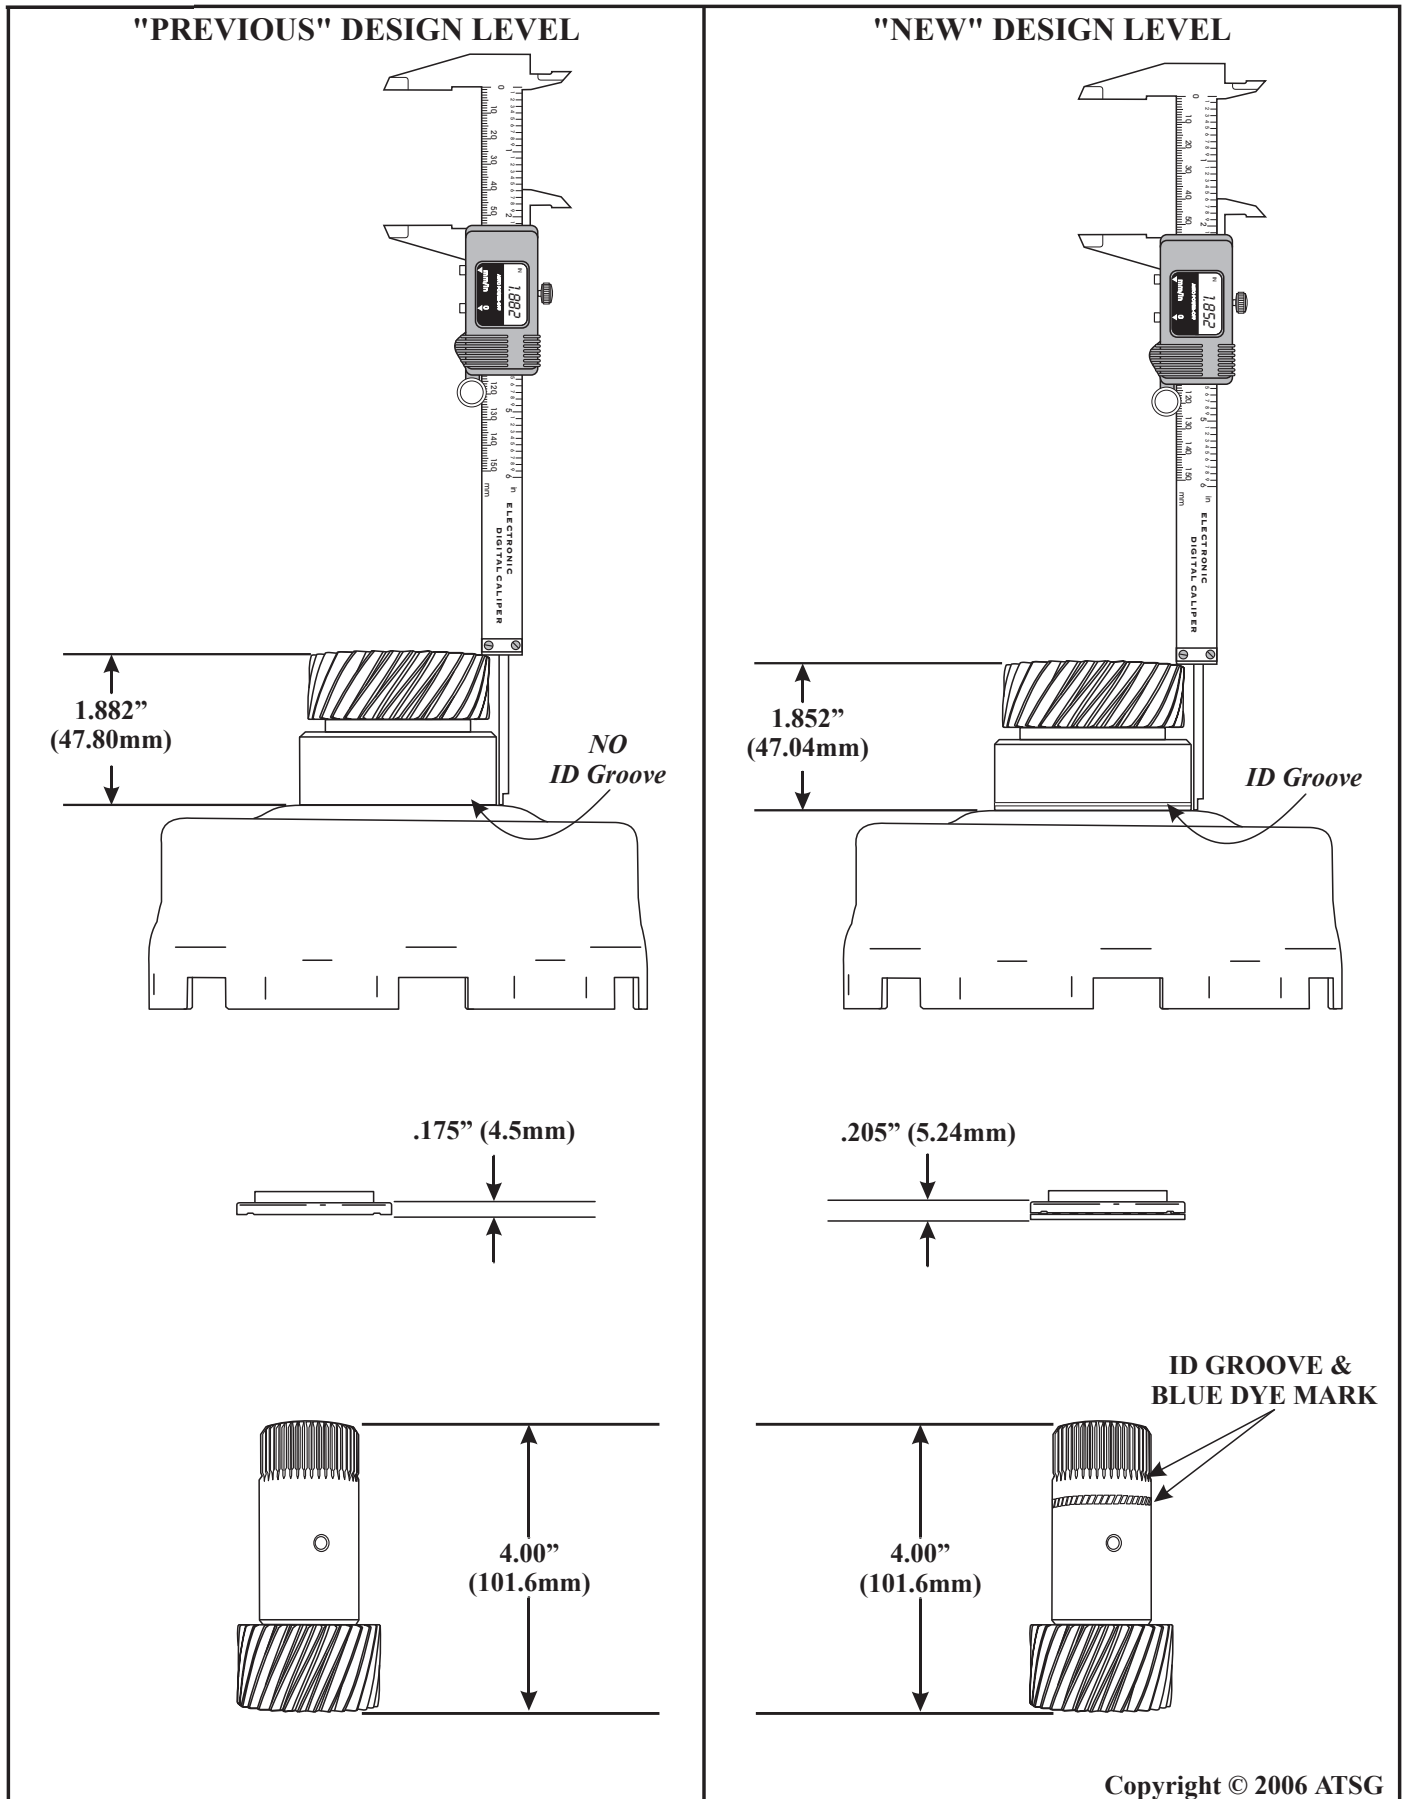
Figure 98

- (1) NUMBER 5 THRUST BEARING - The new design number five thrust bearing is now a "two piece open" design (needles exposed) and is .205" (5.24mm) in thickness, as shown in Figure 98. The previous design is a "one piece closed" bearing and is .175" (4.5mm) in thickness, as shown in Figure 98.

- (2) REVERSE SUN GEAR AND SHELL ASSEMBLY - The new Sun Gear Shell is shorter, 1.852" (47.04mm) as measured in Figure 98, to accommodate the thicker number 5 thrust bearing. It also has a small groove machined at the base of the bushing journal for identification, as shown in Figure 98. The previous Sun Gear Shell is 1.882" (47.80mm) and does not have an ID groove. Refer to Figure 98.

- (3) FORWARD SUN GEAR - Both previous and new Forward Sun Gears are the exact same length, 4.0" (101.6mm). The new design Forward Sun Gear has a groove machined at the base of the splines, and a blue dye stripe for identification purposes, as shown in Figure 98, and appears to have a different hardening process.

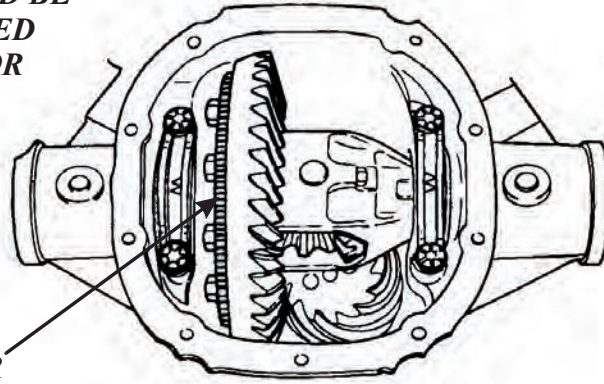
Figure 100

**EXCITER RING SHOULD BE  
TIGHT AND CENTERED  
WITH SPEED SENSOR**

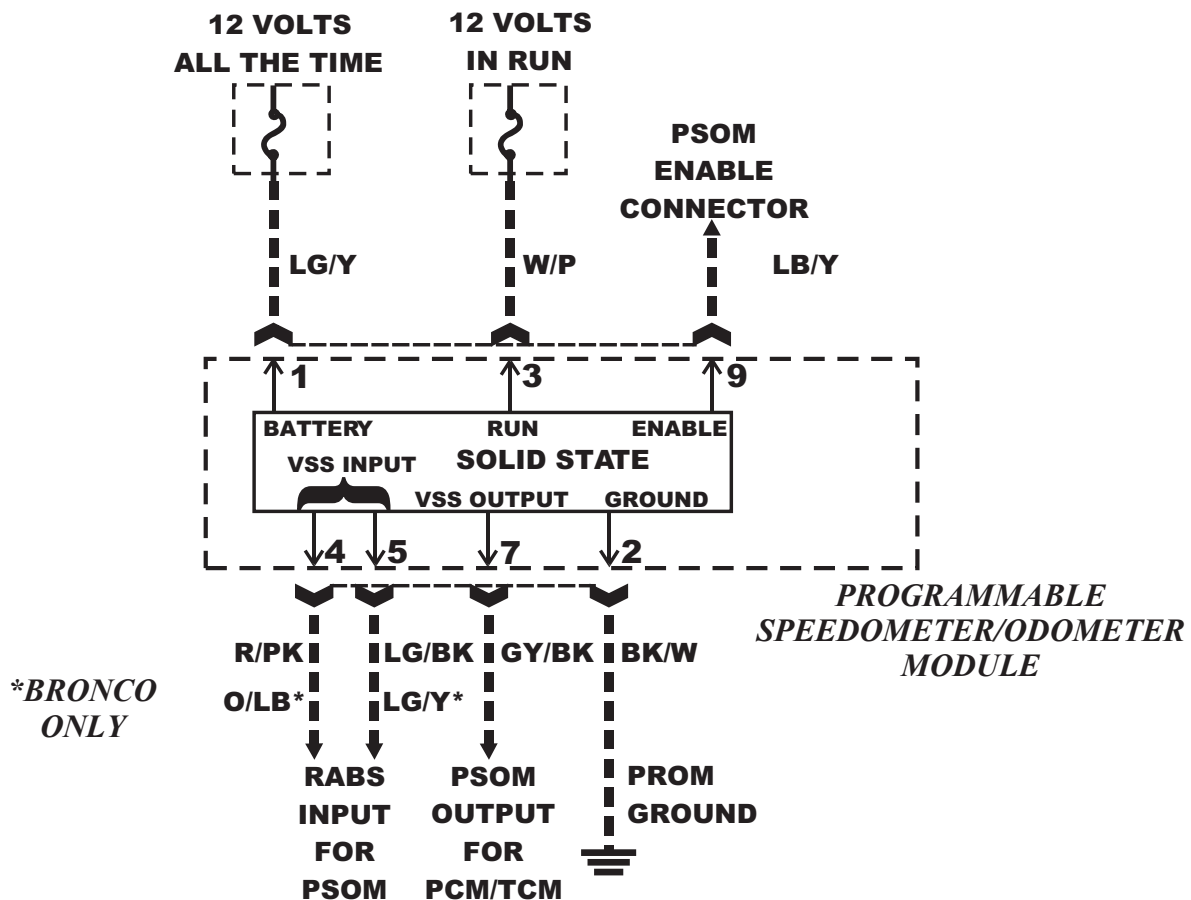
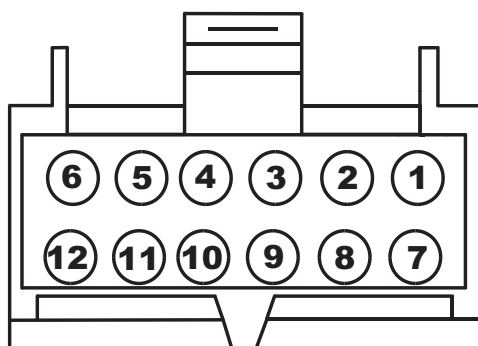
## PSOM CONNECTOR PIN IDENTIFICATION

- PIN 1** 12 Volts all the time
- PIN 2** Ground .1 volt or less
- PIN 3** 12 Volts run only
- PIN 4** RABS signal input
- PIN 5** RABS signal return
- PIN 6** NOT USED
- PIN 7** Speed output to instrument cluster  
Cruise Control & PCM/TCM
- PIN 8** NOT USED
- PIN 9** PSOM dealer enable
- PIN 10** NOT USED
- PIN 11** NOT USED

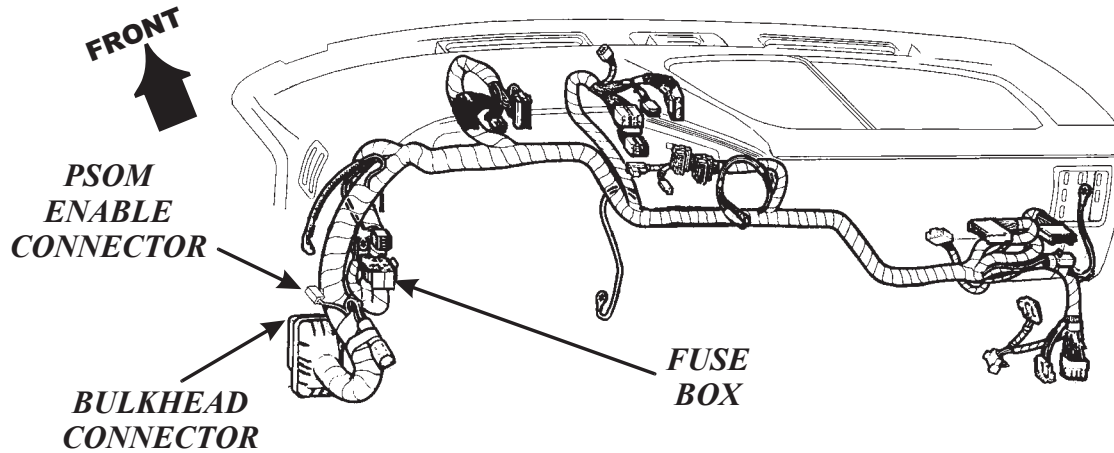
Figure 110

Locate the enable circuit 567 wire connector. This is a *light blue wire with a yellow tracer* coming from the PSOM connector pin 9 to a single connector. It is located under the left side of the dash, below the fuse box, near the bulkhead connector on "E" series vans as seen in Figure 110, and under the center of the dash below the glove box on "F" series trucks (See Figure 111). **NOTE: The letters PSOM should be printed on the enable connector. Once found, use the following procedures to reprogram the PSOM.**

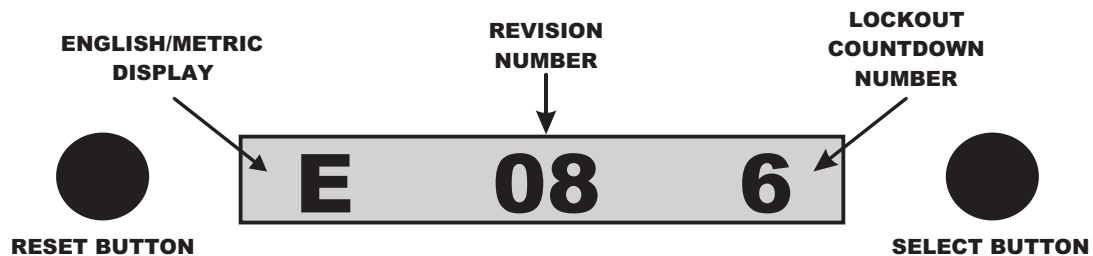
Figure 112

**Do not start the engine.** Once in the ON position, release the trip odometer reset button.
- (3) At this time the speedometer needle should sweep across the face of the speedometer and back again. This sweep indicates that the PSOM has been put into the enable mode. Looking into the LCD odometer window, you should now see the English/Metric display, the revision level number and the lockout countdown number, which indicates how many times the PSOM can be reprogrammed (See Figure 112).

- (1) With the ignition in the "OFF" position, ground the enable connector with a jumper wire.
- (2) While pushing in on the trip odometer reset button (See Figure 112), turn ignition to the "ON" position.

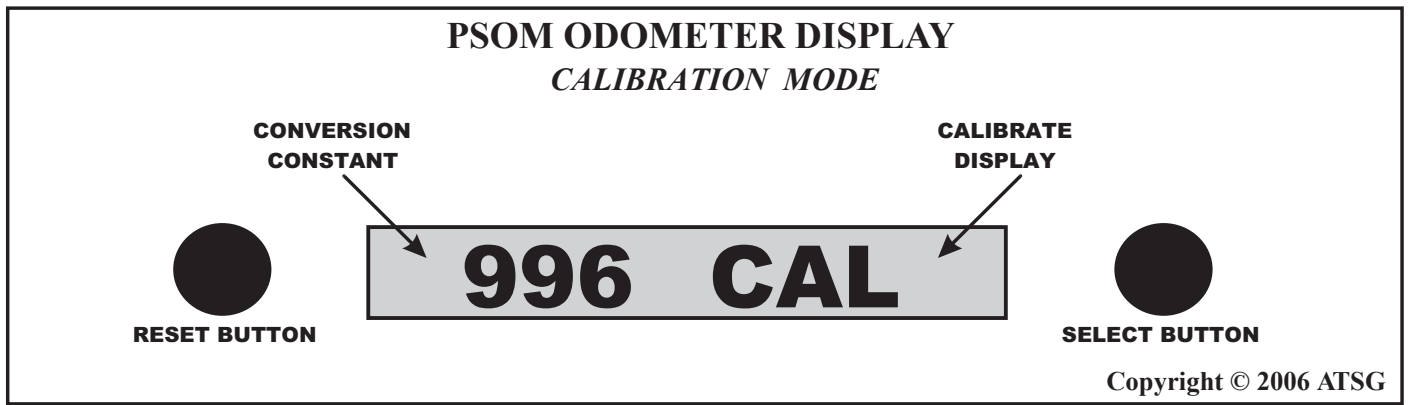
Figure 113

- (4) Press the odometer reset button once again. Now you will see inside of the odometer window, the **conversion constant** number without the decimal point, followed by the abbreviation "CAL". Refer to Figure 113.

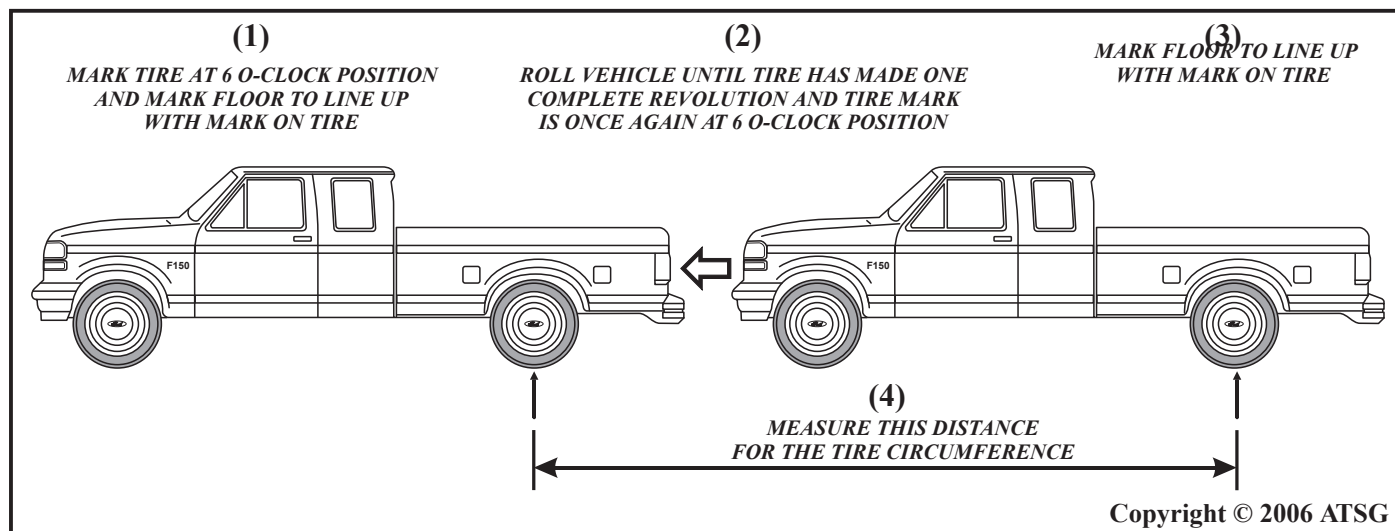
Figure 118

**Formula 4 in Figures 117 and 118 are used when tire size or gear ratios are questionable.**
