2002 AUTOMATIC TRANSMISSIONS Servicing - Saturn Vue (AF33-5)

Servicing - Saturn Vue (AF33-5)

Application	Transaxle Model (RPO Code)
3.0L (AWD)	AF33-5 (M45)

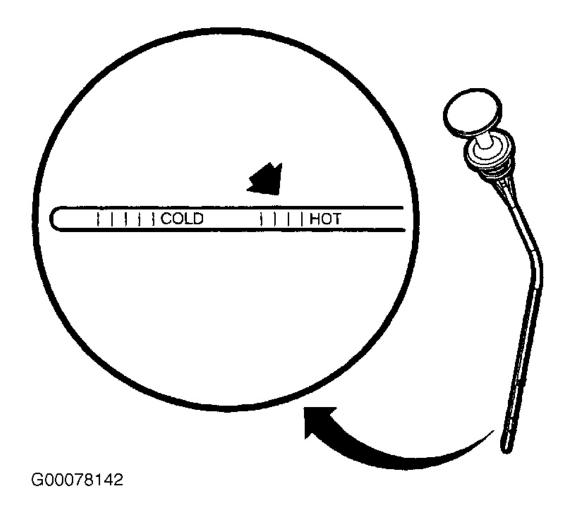
Fig. 1: Identifying Dipstick Marks
Courtesy of GENERAL MOTORS CORP.

- 4. Pull level gauge out, wipe off fluid with a clean cloth and reinsert.
- 5. Pull level gauge out again and check if fluid level is within the HOT range.
- 6. Check condition of transmission fluid. Refer to check fluid color.
- 7. If fluid is not within the correct level, adjust accordingly. If fluid is below the HOT range, add enough fluid to bring it up to correct level. If fluid is above the HOT range, drain excess fluid. If check is necessary at a low oil temperature 86-104°F (30°-40°C), perform check using the COLD range on level gauge. However, the fluid must be re-checked at the proper fluid temperature.

- 7. Pull level gauge out again and check if fluid level is within the HOT range. See <u>Fig. 1</u>. If fluid is not within the correct level, adjust accordingly. If fluid is below the HOT range, add enough to bring it up to the correct level. If fluid is above HOT range, drain excess fluid. If the check is necessary at a low oil temperature 86-104°F (30-40°C), perform check using the COLD range on the level gauge. However, the fluid must be re-checked at the proper fluid temperature.

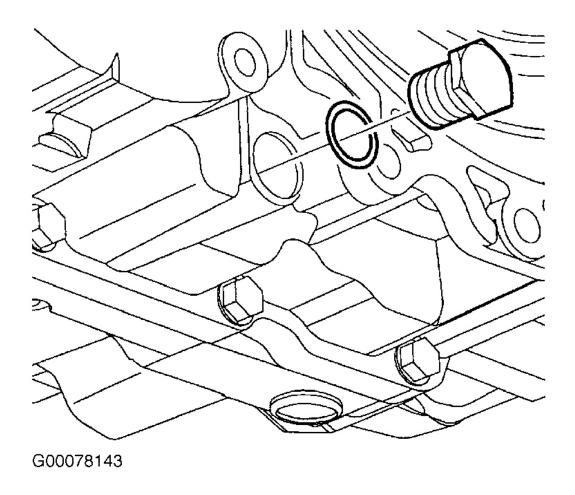
Fig. 2: Removing & Installing Transaxle Drain Plug Courtesy of GENERAL MOTORS CORP.

- 1. Position vehicle on a hoist and raise vehicle. Remove drain plug and drain fluid. Allow at least 5 minutes for fluid to drain completely.
- 2. Remove gasket from drain plug and discard. Install a new gasket onto drain plug. See Fig. 2.

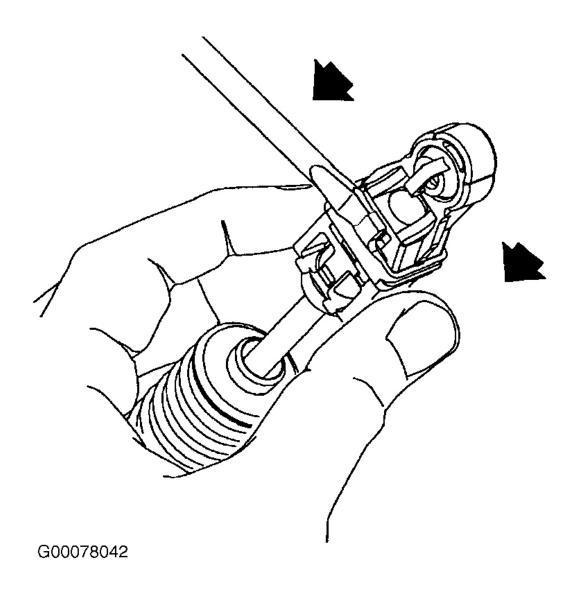
<u>Fig. 3: Releasing Control Cable Adjustment Lock (1 Of 2)</u> Courtesy of GENERAL MOTORS CORP.

- 1. Move control assembly into Neutral position. Using Fascia Retainer Remover tool (J36346), disconnect control cable from transaxle range switch lever.
- 2. Disconnect control cable from control cable bracket by depressing control cable retainer clip tabs and pulling up. Release control cable assembly adjustment lock. Slide Black tab back. Insert screwdriver into slot under White tab and pull up on White tab. See Fig. 3 and Fig. 4.
- 3. Install control cable into control cable bracket. Secure with control cable retainer clip. An audible snap will be heard when properly installed. Snap cable end fitting onto ball stud of transaxle range switch lever. An audible snap will be heard when properly installed.
- 4. Lock control cable adjustment tab. Push down on White tab to secure in place. Slide Black tab over White tab to lock in place. Verify proper operation.

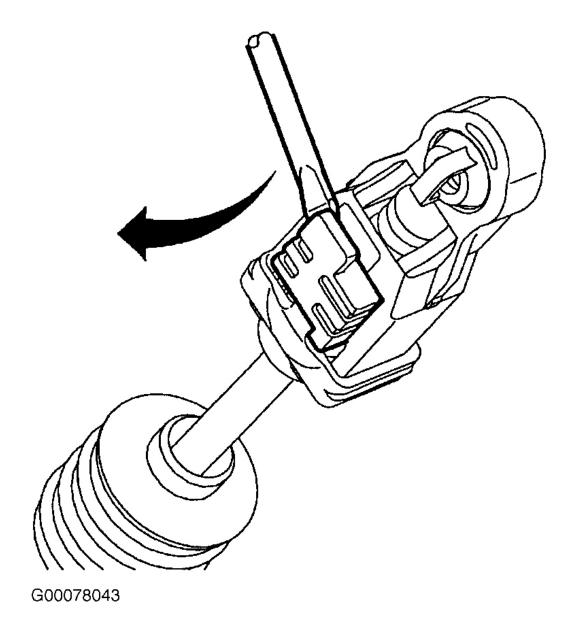
Fig. 4: Releasing Control Cable Adjustment Lock (2 Of 2) Courtesy of GENERAL MOTORS CORP.

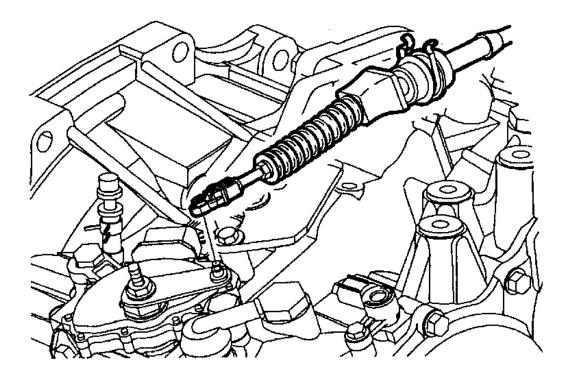
G00078144

<u>Fig. 5: Removing & Installing Control Cable</u> Courtesy of GENERAL MOTORS CORP.

- 1. Remove control cable assembly from transaxle range switch lever. See <u>Fig. 5</u>. Loosen transaxle range switch bolts. See <u>Fig. 7</u>. Remove control cable assembly from transaxle range switch lever. Loosen transaxle range switch bolts.
- 2. Install Transaxle Range Switch Alignment tool (J45404) and align the Transaxle Range Switch Alignment tool pointer to the neutral basic line. See **Fig. 6**. Install transaxle range switch lever and nut,

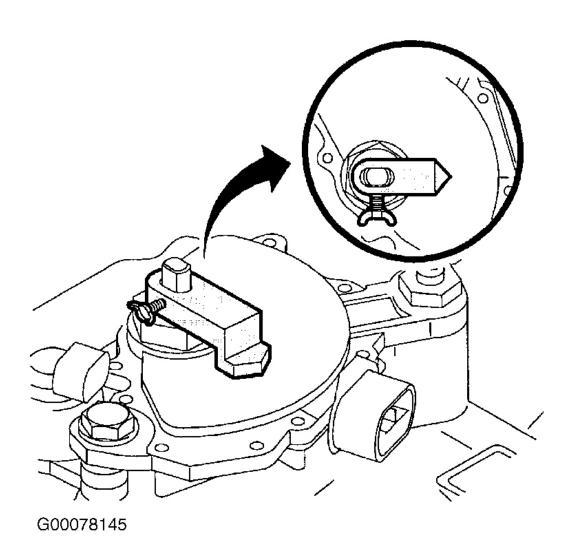
<u>Fig. 6: Identifying Transaxle Range Switch Alignment Tool</u> Courtesy of GENERAL MOTORS CORP.

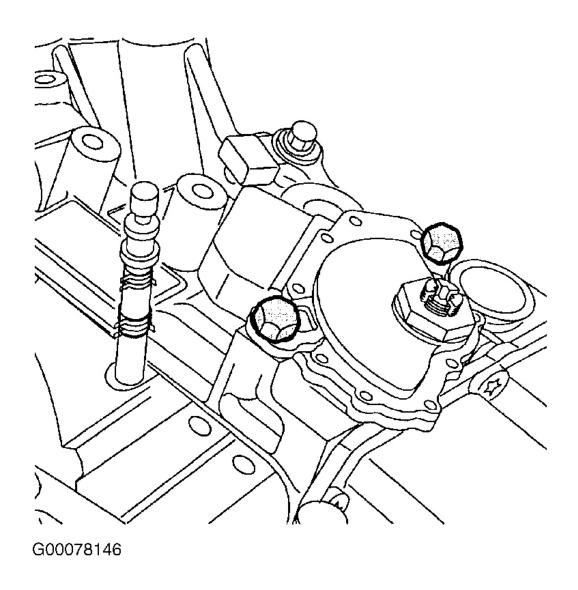
Fig. 7: Identifying Transaxle Range Switch Bolts Courtesy of GENERAL MOTORS CORP.

- then tighten to specification. See **TORQUE SPECIFICATIONS**.
- 3. Remove alignment tool. Tighten transaxle range switch bolts to specification. After adjusting switch, verify engine only starts in Park or Neutral. If engine starts in any other position, readjust switch.

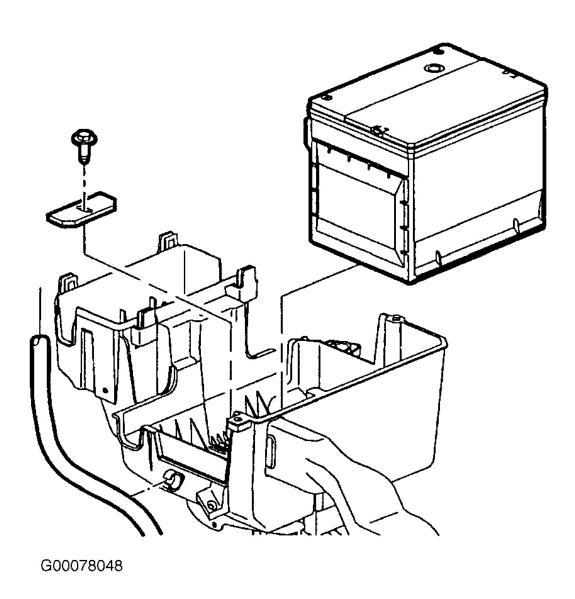
Fig. 8: Removing & Installing Battery Hold Down Screw Courtesy of GENERAL MOTORS CORP.

1. Remove battery cover. Disconnect negative battery cable. Disconnect positive battery cable. Loosen battery hold-down screw and remove battery. See <u>Fig. 8</u>. Remove underhood fuse box cover. Remove positive battery cable and EPS wire from positive battery terminal at underhood fuse box. Open all retainer clips and remove all cables, lines and harnesses from battery cooling box.

- 3. Attach positive battery cable and EPS wire to positive battery terminal at underhood fuse box and tighten nut to specification. Insert battery and tighten battery hold-down screw to specification. See <u>Fig. 8</u>. See <u>TORQUE SPECIFICATIONS</u>. Connect positive battery cable to battery and tighten to specification.

- 1. Move control assembly into Neutral position. Remove battery cover. Disconnect negative battery cable. Disconnect positive battery cable. Loosen battery hold-down screw and remove battery. See <u>Fig. 8</u>. Remove battery cooling box. See **BATTERY COOLING BOX**.
- 2. Loosen battery tray bracket screws and remove bracket. See <u>Fig. 15</u>. Remove console. See <u>CONSOLE</u>. Using Fascia Retainer Remover Tool (J36346), disconnect control cable from control assembly lever. Depress control cable retainer clip tabs and remove cable from control assembly. See <u>Fig. 16</u>.

5. Insert battery and tighten battery hold-down screw to specification. See <u>Fig. 8</u>. Connect positive battery cable to battery and tighten to specification. Connect negative battery cable to battery and tighten to specification. Install battery cooling box cover and tighten screws to specification. See <u>TORQUE</u> <u>SPECIFICATIONS</u>.

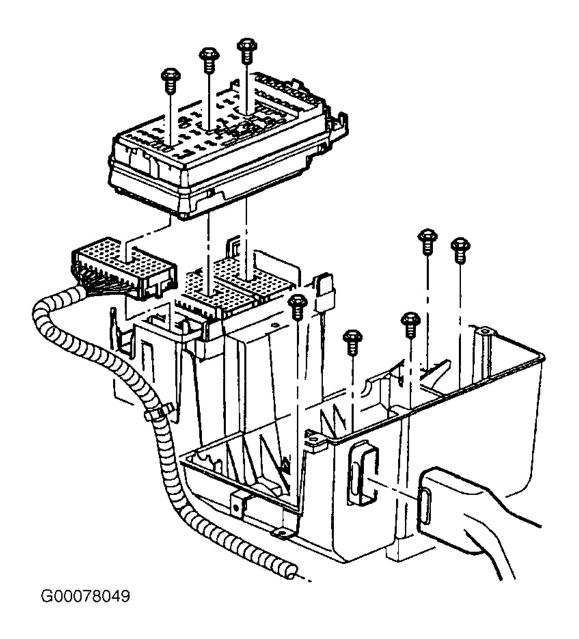
Fig. 9: Removing & Installing Underhood Fuse Box Courtesy of GENERAL MOTORS CORP.

2. Loosen underhood fuse box connector retaining screws. Unfasten underhood fuse box from its housing and disconnect forward lamp harness. See <u>Fig. 9</u>. Remove battery cooling box screws. Remove battery cooling box side support screw. Pull inlet duct away from battery cooling box. Rotate underhood fuse box out of way and remove battery cooling box.

- 2. Connect forward lamp harness to underhood fuse box and attach underhood fuse box into housing. See <u>Fig. 9</u>. Tighten underhood fuse box connector retaining screws to specification. Secure all cables, lines and harnesses into retaining clips.

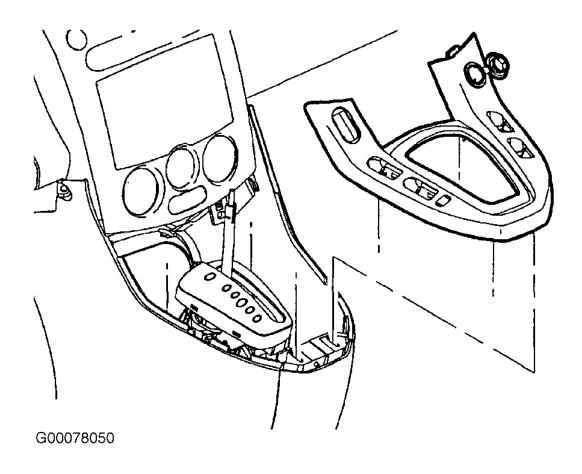
<u>Fig. 10: Removing & Installing Shifter Bezel</u> Courtesy of GENERAL MOTORS CORP.

- 1. Disable Supplemental Inflatable Restraint (SIR) system. See AIR BAG DEACTIVATION PROCEDURES article in GENERAL INFORMATION. Move shifter to Neutral position. Pull up at rear edge of shifter bezel, disengaging retention clips. See <u>Fig. 10</u>. Disconnect window switches, mirror switch and cigar lighter and remove shifter bezel.

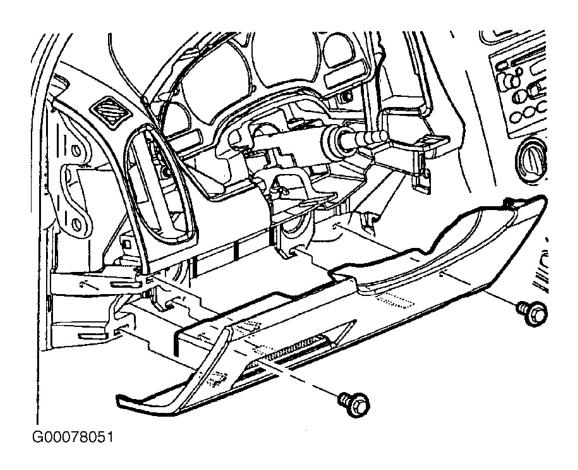
Fig. 11: Removing & Installing Knee Bolster Courtesy of GENERAL MOTORS CORP.

- 3. Remove screws and pull rearward at clip locations to remove knee bolster. See <u>Fig. 11</u>. Open glove box and turn door stops 1/4 turn and remove door stops. See <u>Fig. 12</u>. Push center pin portion of glove box door pins toward center of instrument panel compartment and remove glove box assembly.

- 2. Install instrument panel glove box door stops by inserting with 1/4 turn to lock into position. Install instrument panel knee bolster by aligning retention clips with corresponding slots in retainer and snapping into place by applying light force at clip locations. See <u>Fig. 11</u>. Install screws and tighten. Connect power outlet harness connector. Connect wiring harnesses to window switches, mirror switch and cigar lighter.

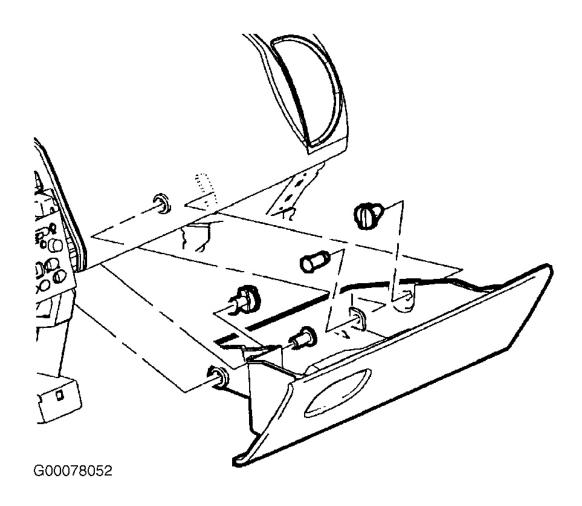
Fig. 12: Removing & Installing Glove Box Door Courtesy of GENERAL MOTORS CORP.

- 1. Install right trim panel and align left trim panel over alignment pins in right trim panel and install screws. See <u>Fig. 14</u>. Install panel-to-HVAC module push pins and trim panel-to-instrument panel retainer screws. Align retention clips with slots in side trim panels and press center trim panel forward at clip locations to snap into place. See <u>Fig. 13</u>. Position glove box door to instrument panel retainer assembly and install door pins. See <u>Fig. 12</u>.

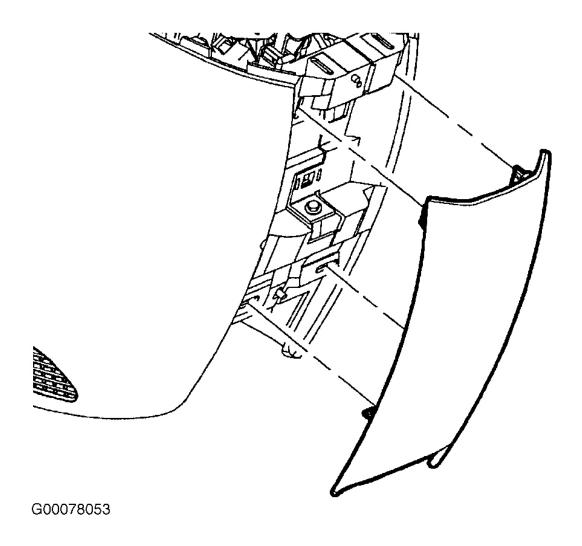
Fig. 13: Removing & Installing Center Trim Panel Courtesy of GENERAL MOTORS CORP.

- 4. Pull rearward at clip locations to remove center trim panel. See <u>Fig. 13</u>. Remove front screws holding left and right console trim panels. Remove panel-to-HVAC module push pins and trim panel-to-instrument panel retainer screws and remove panels. See <u>Fig. 14</u>.

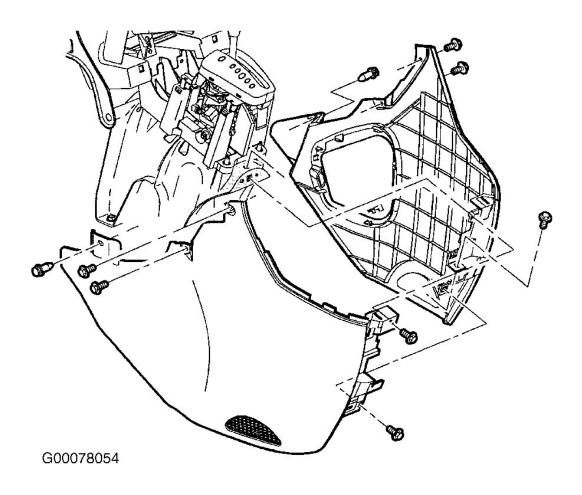
<u>Fig. 14: Removing & Installing Console Trim Panels</u> Courtesy of GENERAL MOTORS CORP.

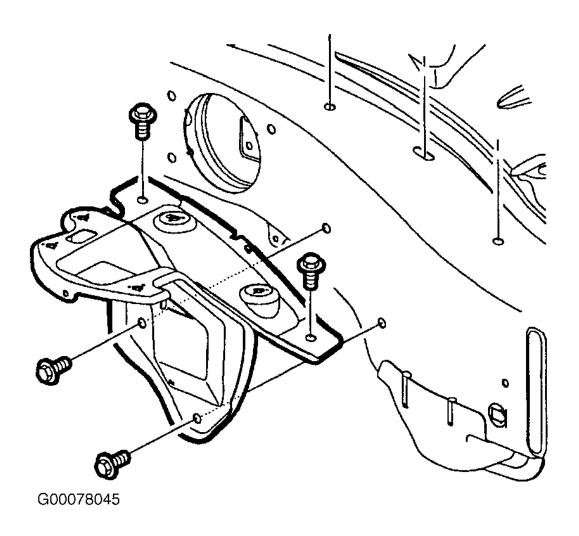
Fig. 15: Removing & Installing Battery Tray Bracket Courtesy of GENERAL MOTORS CORP.

- 4. Position battery tray bracket and tighten screws to specification. See <u>Fig. 15</u>. See <u>TORQUE</u> <u>SPECIFICATIONS</u>. Install battery cooling box. See <u>BATTERY COOLING BOX</u>.

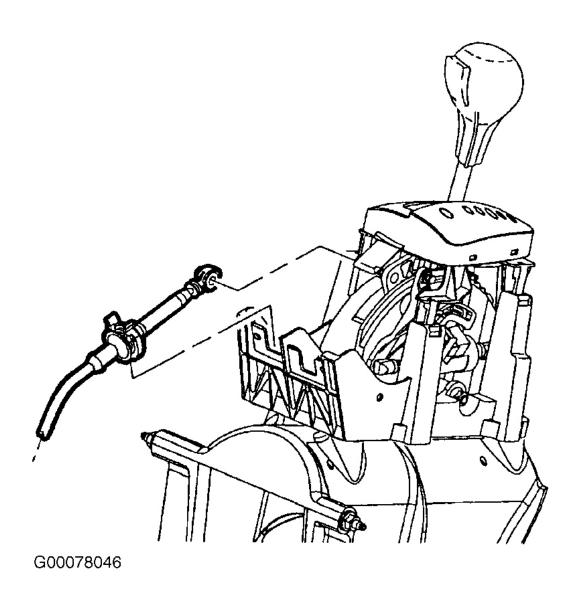
Fig. 16: Removing & Installing Control Cable At Shift Controller Courtesy of GENERAL MOTORS CORP.

- 3. Connect control cable to control assembly. Secure with control cable retainer clip. Install control cable onto control assembly lever. See <u>Fig. 16</u>. Adjust control cable assembly. See <u>CONTROL CABLE</u> under ADJUSTMENTS. Install console. See <u>CONSOLE</u>.

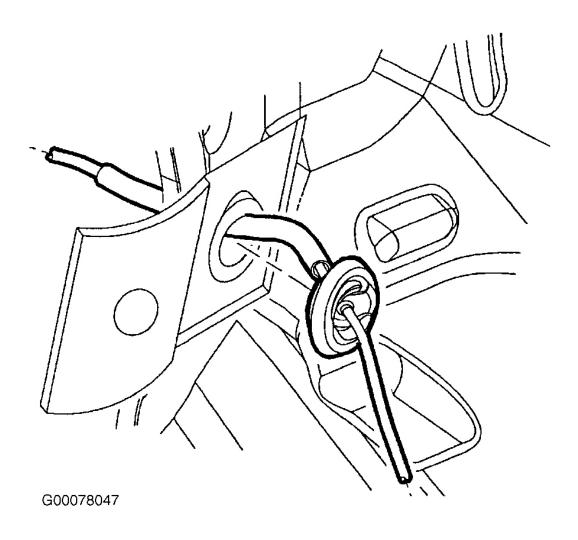
Fig. 17: Removing & Installing Control Cable Grommet Courtesy of GENERAL MOTORS CORP.

- 3. Using fascia retainer remover, disconnect control cable from transaxle range switch lever. Depress control cable retainer clip tabs and remove cable from control cable bracket.
- 4. Position vehicle on hoist and raise vehicle. Remove control cable from cable-to-steering gear assembly retaining clip. Lower vehicle. Remove control cable grommet from dash panel. See <u>Fig. 17</u>. Remove control cable from vehicle.

- 2. Position vehicle on hoist and raise vehicle. Route cable along steering gear assembly into clip and up into dash panel. Lower vehicle. Secure control cable grommet by pressing cable into pass-through hole in dash panel. See <u>Fig. 17</u>. Make sure control assembly is in Neutral position.

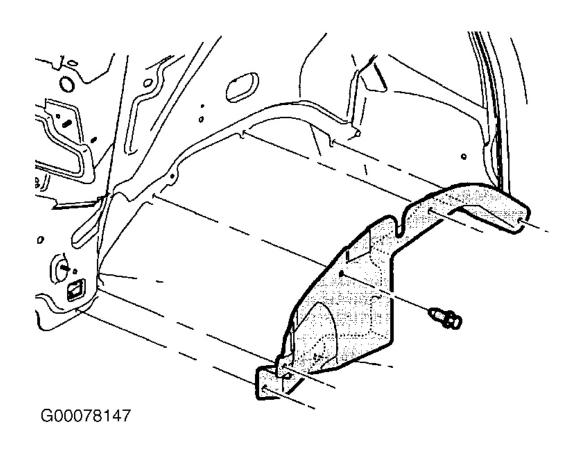
<u>Fig. 18: Removing & Installing Left Front Splash Shield</u> Courtesy of GENERAL MOTORS CORP.

9. Install left-hand splash shield. See <u>Fig. 18</u>. Install splash shield push pins. Lower vehicle. Add fluid to transaxle. See <u>CHECKING FLUID LEVELS</u>.

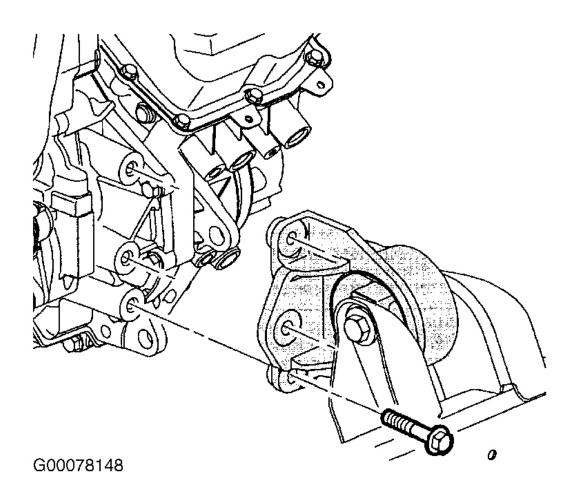
Fig. 19: Removing & Installing Front Pitch Restrictor-To-Transaxle Bolts Courtesy of GENERAL MOTORS CORP.

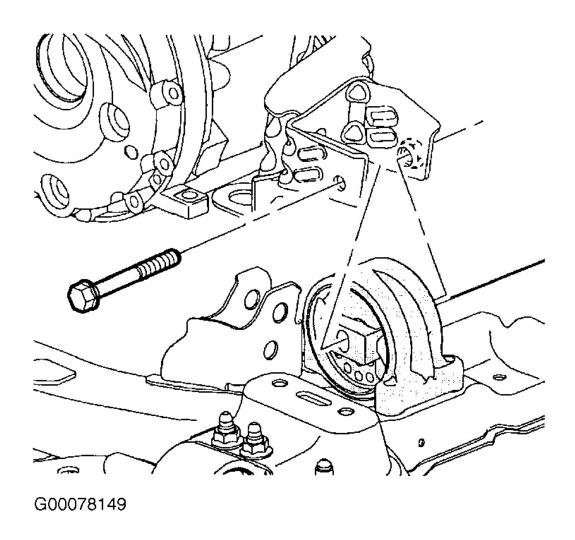
<u>Fig. 20: Removing & Installing Front Pitch Restrictor</u> Courtesy of GENERAL MOTORS CORP.

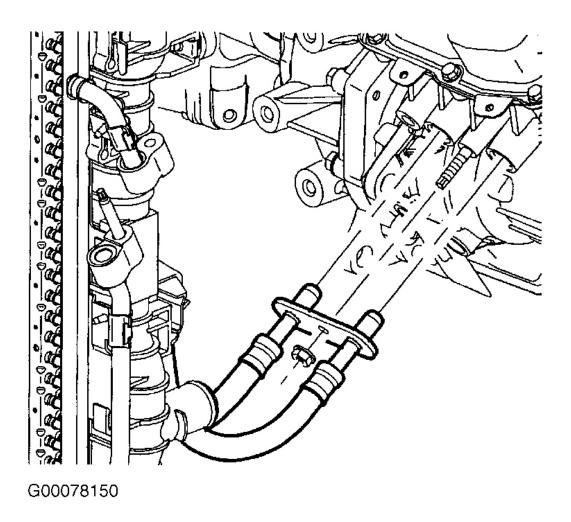
Fig. 21: Removing & Installing Transaxle Oil Cooler Lines From Transaxle Courtesy of GENERAL MOTORS CORP.

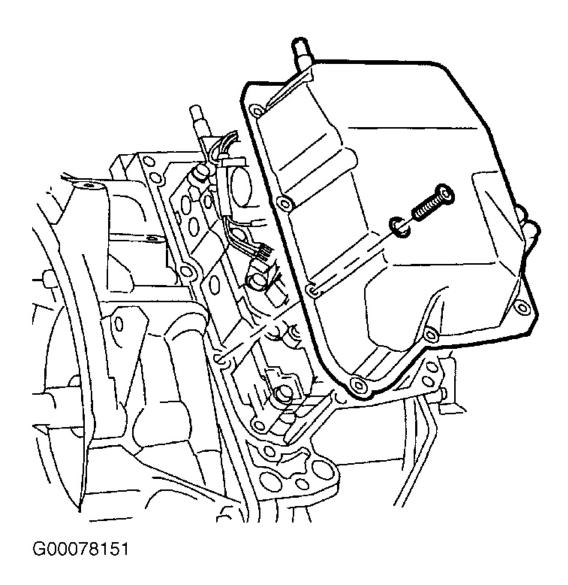
<u>Fig. 22: Removing & Installing Control Valve Body Cover</u> Courtesy of GENERAL MOTORS CORP.

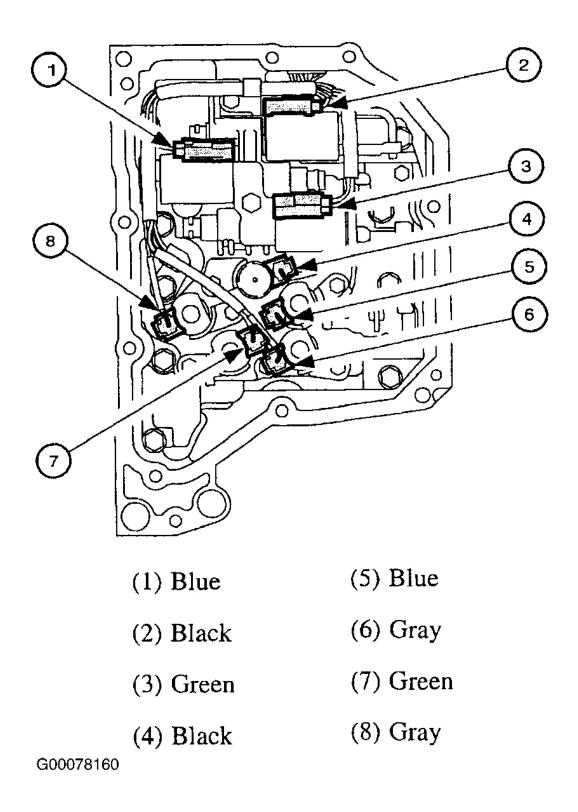
Fig. 23: Removing & Installing Harness Connectors For Solenoids Courtesy of GENERAL MOTORS CORP.

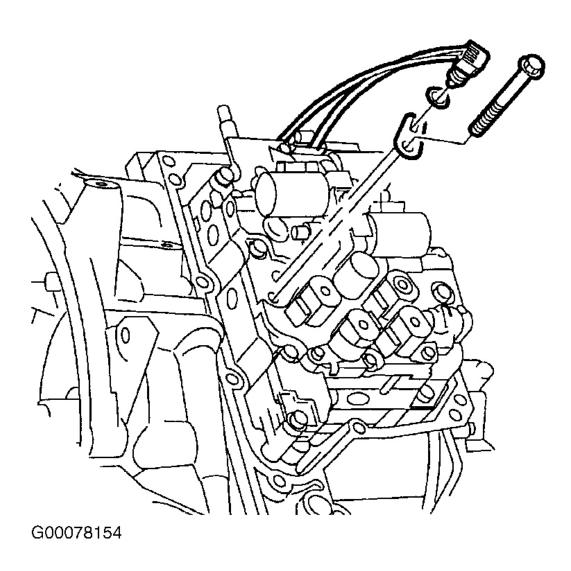
<u>Fig. 24: Removing & Installing Fluid Temperature Sensor</u> Courtesy of GENERAL MOTORS CORP.

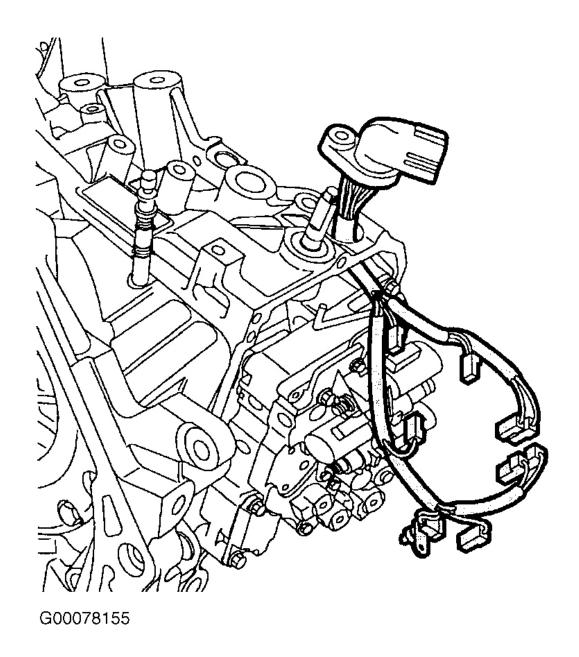
Fig. 25: Removing & Installing Wiring Harness Assembly Courtesy of GENERAL MOTORS CORP.

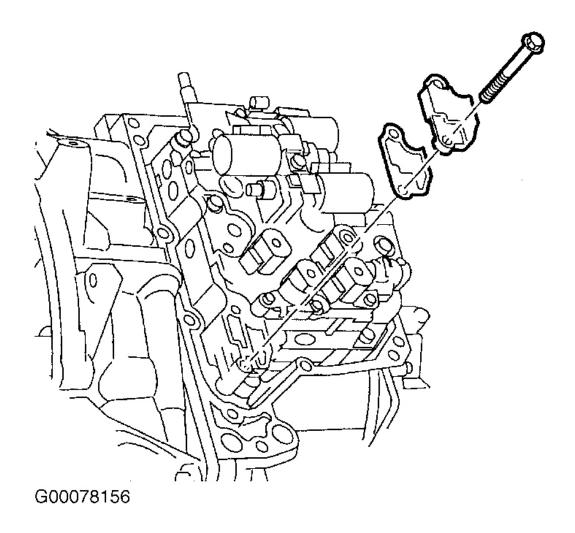
Fig. 26: Removing & Installing Fluid Passage Cover & Fluid Passage Cover Gasket Courtesy of GENERAL MOTORS CORP.

- 7. Remove bolts, control valve body fluid passage cover and gasket. Discard fluid passage cover and fluid passage cover gasket. See <u>Fig. 26</u>. Remove valve body assembly-to-transaxle case bolts. See <u>Fig. 27</u>.
- 8. While holding the valve body assembly, disconnect manual shift detent lever assembly from manual valve link. See Fig. 28.
- 9. Move detent lever assembly clockwise for ease of removing manual valve. Remove valve body assembly. Remove case fluid passage seals and discard. See <u>Fig. 29</u>.

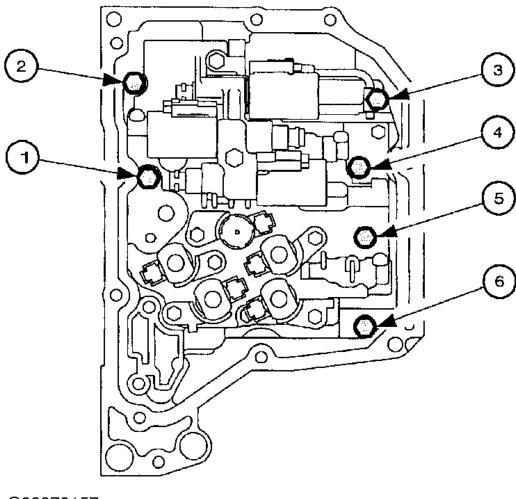
G00078157

<u>Fig. 27: Removing & Installing Valve Body Assembly-To-Transaxle Case Bolts</u> Courtesy of GENERAL MOTORS CORP.

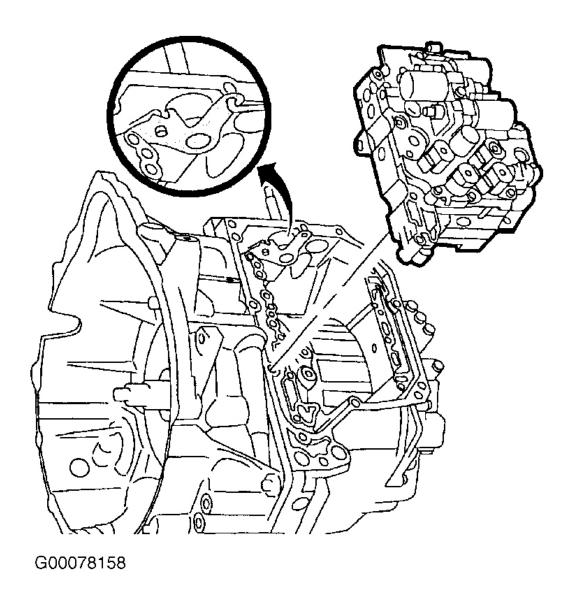
Fig. 28: Removing & Installing Manual Shift Detent Lever Assembly Courtesy of GENERAL MOTORS CORP.

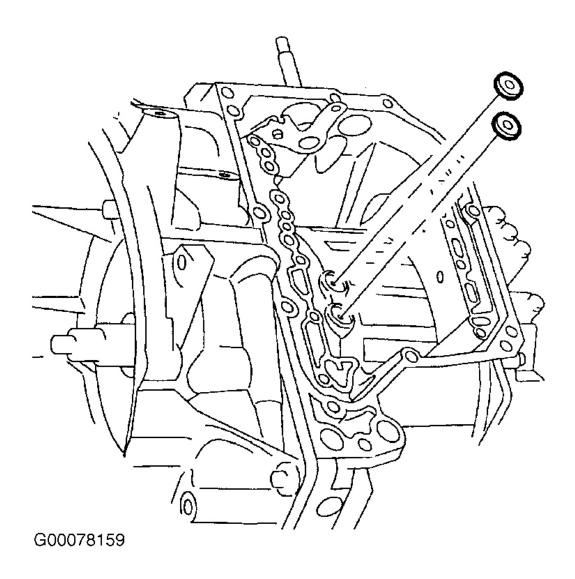
Fig. 29: Removing & Installing Case Fluid Passage Seals Courtesy of GENERAL MOTORS CORP.

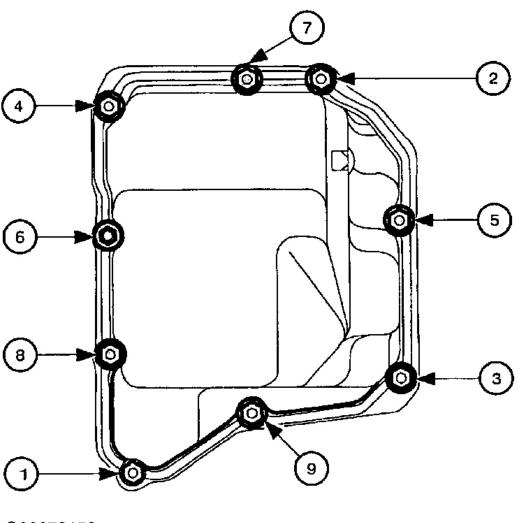
G00078152

Fig. 30: Valve Body Cover Torque Sequence Courtesy of GENERAL MOTORS CORP.

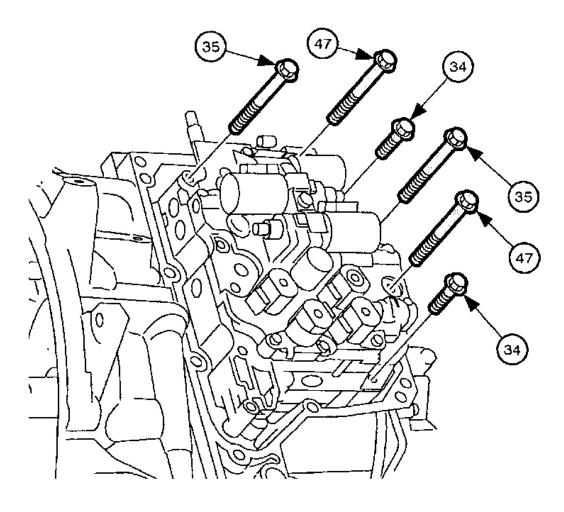
G00078153

- (34) M6 X 16 mm
- (35) M6 X 50 mm
- (47) M6 X 55 mm

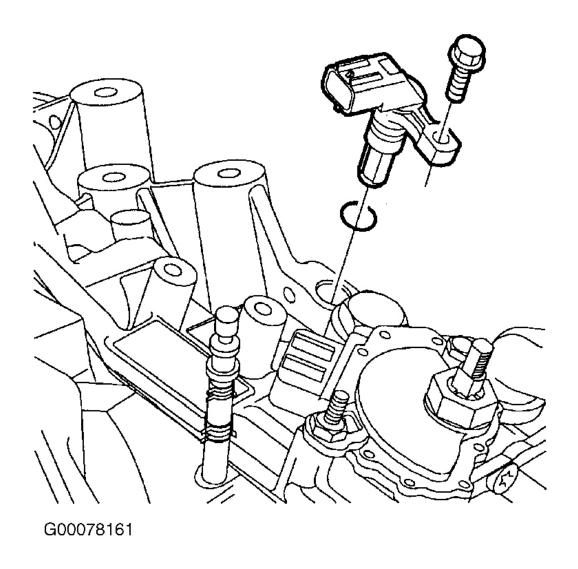
Fig. 34: Removing & Installing Input Speed Sensor Courtesy of GENERAL MOTORS CORP.

- 1. Record preset radio stations. Remove battery. Remove battery cover. Disconnect negative battery cable. Disconnect positive battery cable.
- 2. Loosen battery hold-down screw and remove battery. Remove battery cooling box. See **BATTERY COOLING BOX**.
- 3. Remove battery tray bracket. Loosen battery tray bracket screws and remove bracket. See Fig. 15.
- 4. Remove input speed sensor. Remove input speed sensor O-ring and discard. Fig. 34.

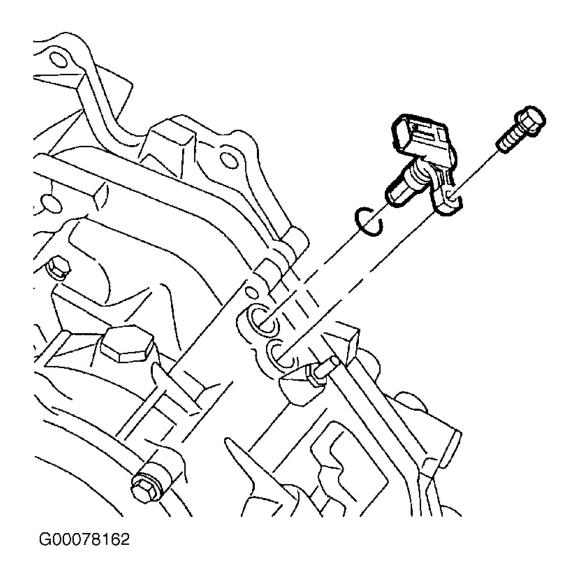
Fig. 35: Removing & Installing Output Speed Sensor Courtesy of GENERAL MOTORS CORP.

- 1. Record preset radio stations. Remove battery. Remove battery cover. Disconnect negative battery cable. Disconnect positive battery cable.
- 2. Loosen battery hold-down screw and remove battery. Remove battery cooling box. See **BATTERY COOLING BOX**.
- 3. Remove battery tray bracket. Loosen battery tray bracket screws and remove bracket. See Fig. 15.
- 4. Remove output speed sensor. Remove output speed sensor O-ring and discard. See Fig. 35.

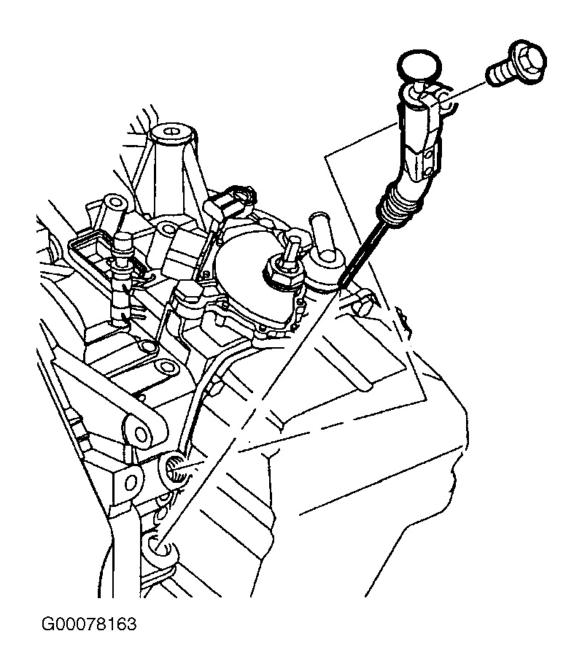
<u>Fig. 36: Removing & Installing Fluid Level Indicator</u> Courtesy of GENERAL MOTORS CORP.

Remove transmission fluid level indicator assembly fastener from transaxle. Remove transmission fluid level indicator assembly from vehicle. See $\underline{Fig. 36}$. Wipe away any excess fluid from transaxle. To install, install transmission fluid level indicator assembly onto vehicle. Install transmission fluid level indicator fastener onto transaxle and tighten to specification. See \underline{TORQUE} $\underline{SPECIFICATIONS}$.

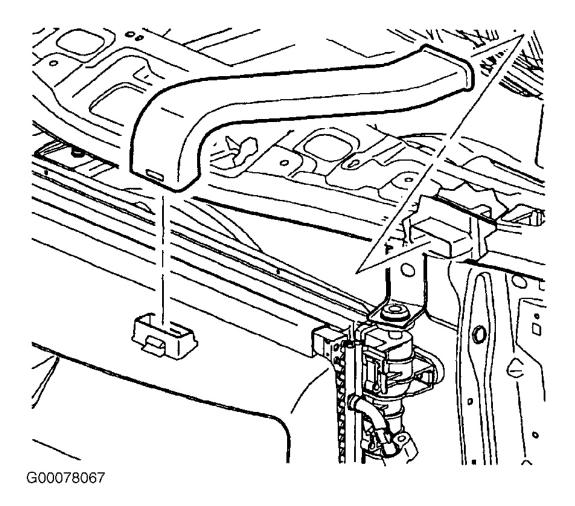
Fig. 37: Removing & Installing Air Inlet Courtesy of GENERAL MOTORS CORP.

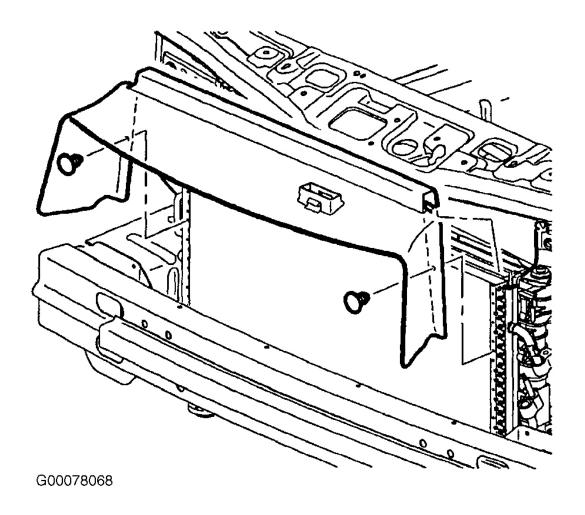
<u>Fig. 38: Removing & Installing Condenser Splash Shield</u> Courtesy of GENERAL MOTORS CORP.

2. Remove condenser splash shield. See <u>Fig. 38</u>. Remove upper Condenser Radiator Fan Module (CRFM) bracket assemblies. See <u>Fig. 39</u>. Unclip condenser from radiator. See <u>Fig. 40</u>. Unclip transaxle oil cooler from radiator and remove transaxle oil cooler.

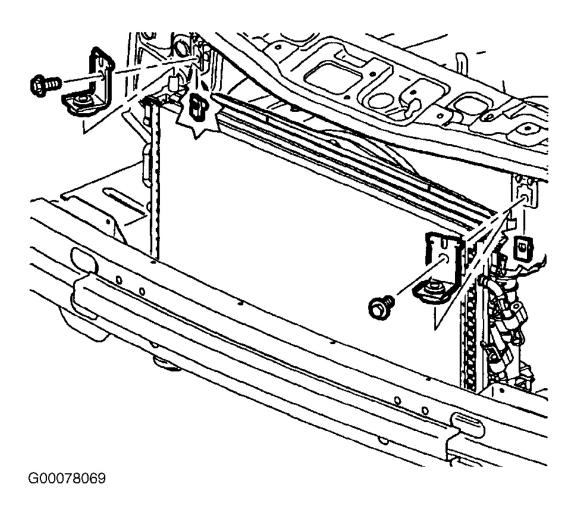
<u>Fig. 39: Removing & Installing Condenser Radiator Fan Module Bracket Assemblies</u> Courtesy of GENERAL MOTORS CORP.

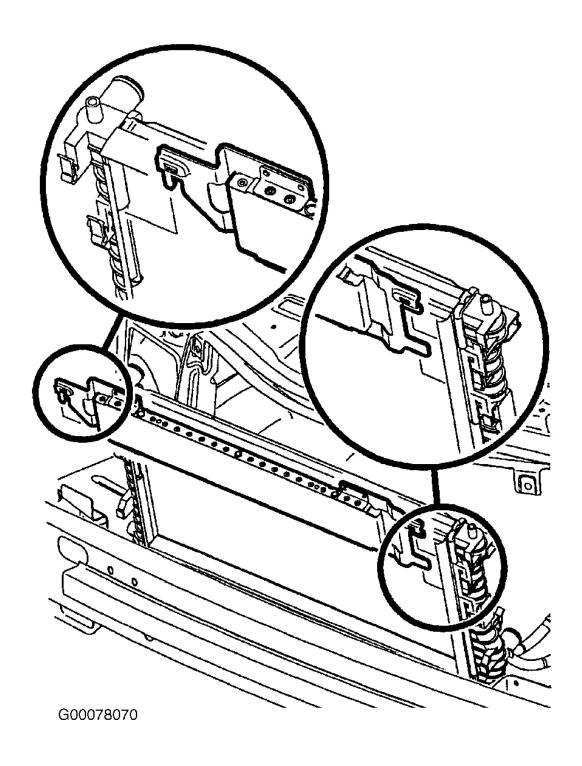
<u>Fig. 40: Identifying Transaxle Oil Cooler Retaining Clips</u> Courtesy of GENERAL MOTORS CORP.

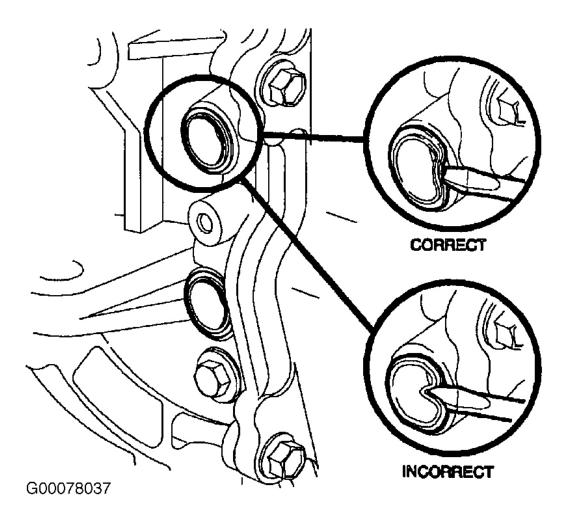
Fig. 41: Removing Transaxle Oil Cooler Seals Courtesy of GENERAL MOTORS CORP.

- 1. Place drain pan or suitable container under vehicle. Position vehicle on a hoist. Raise vehicle. Remove transaxle oil cooler line assembly nut from transaxle. Remove transaxle oil cooler lines from transaxle. See TRANSAXLE OIL COOLER LINE ASSEMBLY.
- 2. Use a long chisel with a 1/4" blade to partially collapse seal in one place only. See <u>Fig. 41</u>. Clamp Cooler Line Seal Remover/Installer (J41239) onto transaxle cooler line seal on outside of the case bore. See <u>Fig.</u> 42. Remove transaxle cooler line seal by prying and rotating seal out of case with attached tool.

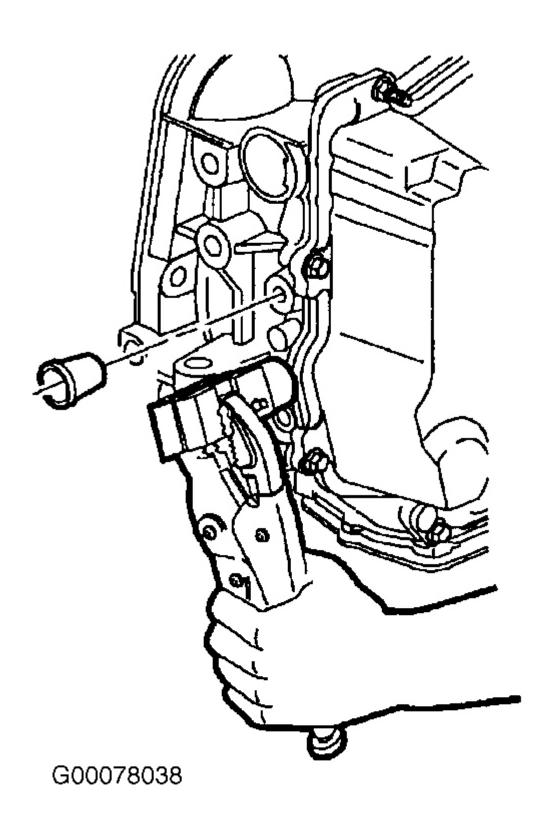
Fig. 42: Identifying Cooler Line Seal Remover Courtesy of GENERAL MOTORS CORP.

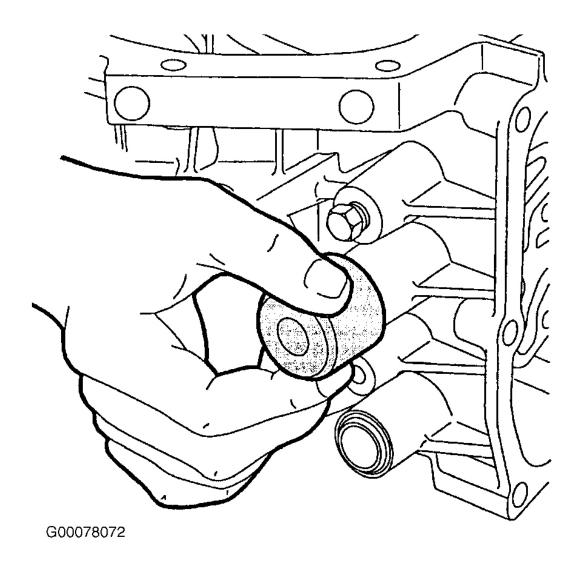
Fig. 43: Installing Transaxle Cooler Line Seal Courtesy of GENERAL MOTORS CORP.

- 1. Place a new transaxle cooler line seal in case bore. Remove nub from Cooler Line Seal Installer (J-41239). Install nub of cooler line seal installer on transaxle cooler line seal. See <u>Fig. 43</u>. Tap in a new transaxle cooler line seal into case bore. Install transaxle oil cooler line assembly to transaxle.
- Install transaxle oil cooler line assembly nut and tighten to specification. See <u>TORQUE</u>
 <u>SPECIFICATIONS</u>. Lower vehicle. Add fluid to transaxle. See <u>CHECKING FLUID LEVELS</u> under LUBRICATION. Start engine and check for leaks.

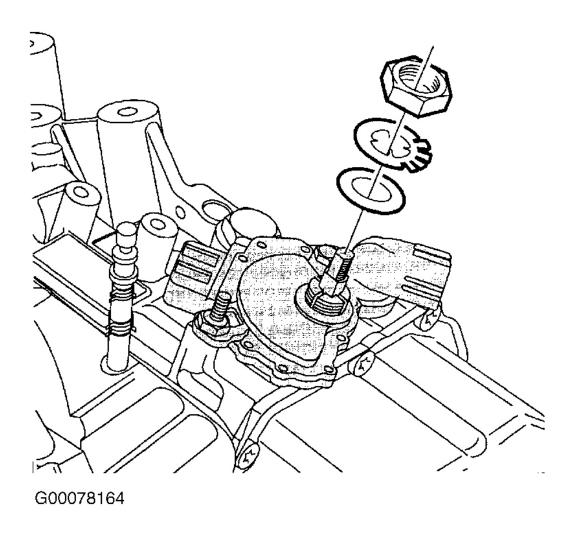
<u>Fig. 44: Removing & Installing Transaxle Range Switch Nut</u> Courtesy of GENERAL MOTORS CORP.

- 1. Install transaxle range switch to the manual valve lever. Install transaxle range switch bolts, then hand tighten. Install flat washer, lock tab washer and nut, then tighten to specification. See <u>Fig. 44</u>. Place the manual valve lever in Neutral position.

- Make sure transaxle manual shaft is in Neutral position. Install transaxle range switch to the manual valve lever. Align flats on transaxle shift shaft with flats on transaxle range switch and install switch. Tighten transaxle range switch bolts to specification. See <u>TORQUE SPECIFICATIONS</u>. Install flat washer, lock tab washer and nut and tighten to specification. See <u>Fig. 44</u>. Move lock tab washer into place by bending tabs up with pliers.

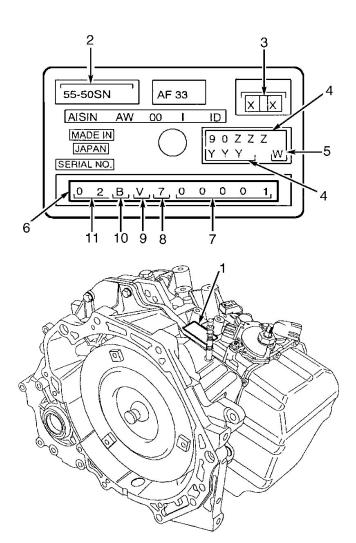
G00113870

- 1. Transaxle Identification Plate
- 2. Model Number
- 3. GM Identification Code
- 4. GM Part Number
- 5. Calibration Code
- 6. Aisin-Warner Production Unit Number
- 7. Serial Number (during month of manufacture)
- 8. Assembly Line Code
- 9. Transaxle Mode
- 10. Month Of Manufacture
- 11. Year Of Manufacture

Fig. 1: Locating Transaxle Identification Information Courtesy of GENERAL MOTORS CORP.

Transaxle has a metal identification plate attached to top of transaxle case. See <u>Fig. 1</u>. The RPO code for the AF33-5 transaxle is M45.

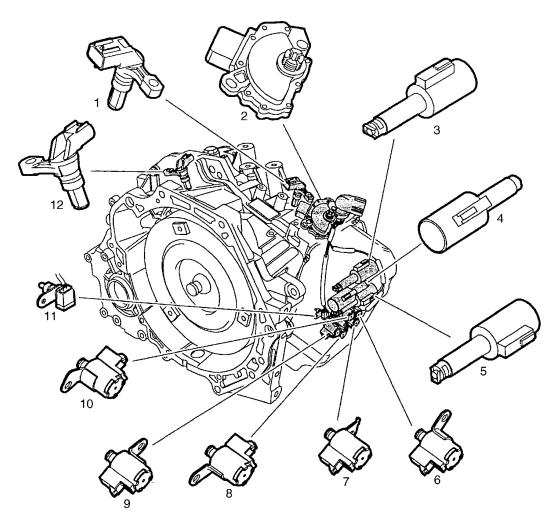
- 1. Input Speed Sensor
- 2. Transaxle Range Switch
- 3. TCC Lock-Up Pressure Control Solenoid (Black)
- 4. Line Pressure Control Solenoid (Blue)
- 5. Shift Pressure Control Solenoid (Green)
- 6. Shift Solenoid "4" (Blue)

- 7. Shift Solenoid "3" (Dark Gray)
- 8. Shift Solenoid "5" (Green)
- 9. Shift Solenoid "2" (Light Gray)
- 10. Shift Solenoid "1" (Black)
- 11. Transmission Fluid Temperature Sensor
- 12. Output Speed Sensor

Fig. 2: Locating Transaxle Electronic Components Courtesy of GENERAL MOTORS CORP.

NOTE: For transaxle electronic component locations, refer to illustration. See Fig. 2.

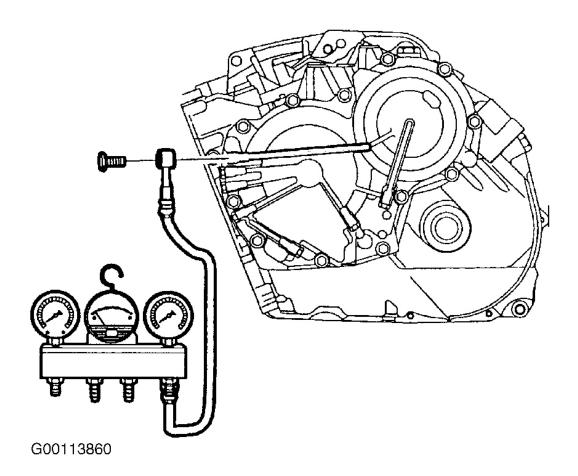
<u>Fig. 4: Installing Oil Pressure Gauge</u> Courtesy of GENERAL MOTORS CORP.

- 1. Turn front wheels to the left.
- 2. Raise vehicle.
- 3. Remove left front splash shield.
- 4. Remove the "B5" fluid pressure test hole plug and install pressure gauge to the "B5" port. See Fig. 4.
- 5. Connect a scan tool.
- 6. Place transaxle in Park and apply parking brake.
- 7. Start engine and allow to idle.
- 8. Select FUNCTIONAL LINE PC SOLENOID TEST from scan tool OUTPUT CONTROLS menu.
- 9. Increase and decrease line pressure solenoid reference current. Record the corresponding line pressure shown on pressure gauge.
- 10. Exit the FUNCTIONAL LINE PC SOLENOID TEST on scan tool.
- 11. Firmly depress brake pedal, and place transaxle in Drive. Allow engine to idle.
- 12. Record the line pressure shown on the pressure gauge.

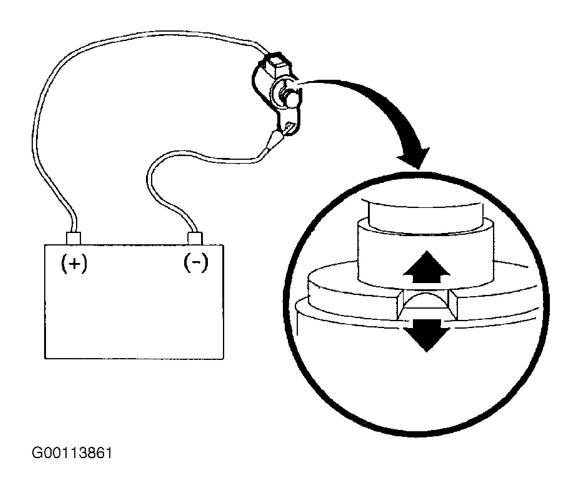
Fig. 5: Testing Shift Solenoid Courtesy of GENERAL MOTORS CORP.

- 2. Repeatedly connect and disconnect 12 volts to the shift solenoid. See **Fig. 5**.
- 3. Observe the shift solenoid pintle.
- 4. If the shift solenoid pintle does not move, replace the shift solenoid.

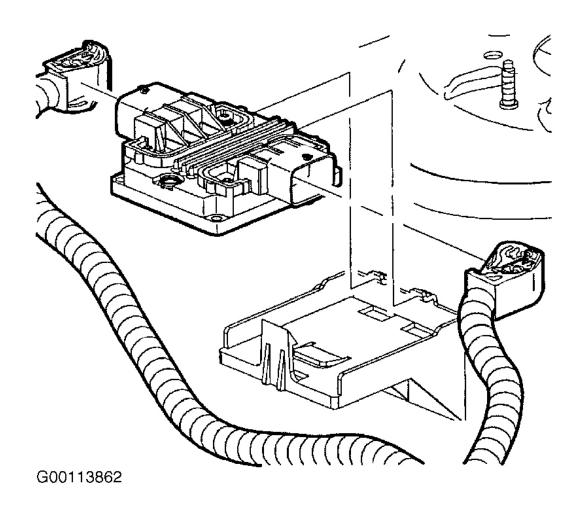
Fig. 6: Removing & Installing TCM Courtesy of GENERAL MOTORS CORP.

The ECM is mounted on the rear of engine, below battery box. The TCM is located in front of the right front strut tower. See <u>Fig. 6</u>. ECM and TCM control ignition, fuel and emission devices related to engine and transaxle upshifts and downshifts.

Turn ignition off. Pull retaining tang from the TCM and rotate the TCM up. Remove the TCM from bracket. Disconnect TCM harness connectors. See **Fig. 6**.

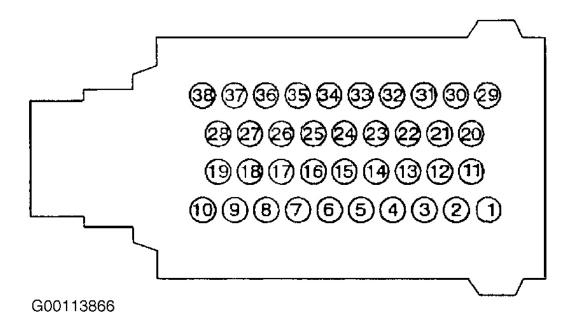
Fig. 7: Identifying Transaxle Control Module "J1" & "J2" (Black) 38-Way Harness Connector Terminals
Courtesy of GENERAL MOTORS CORP.

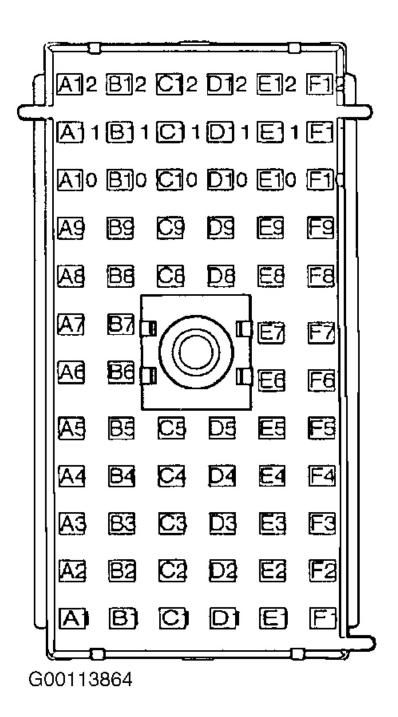
Fig. 8: Identifying Underhood Fuse Block "J2" (Gray) 68-Way Harness Connector Terminals Courtesy of GENERAL MOTORS CORP.

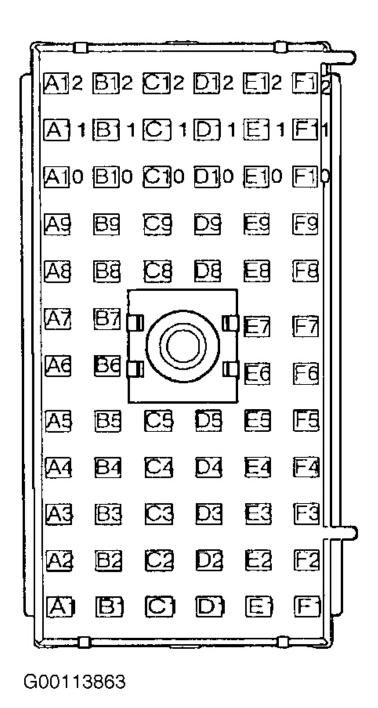
Fig. 9: Identifying Underhood Fuse Block "J3" (Black) 68-Way Harness Connector Terminals

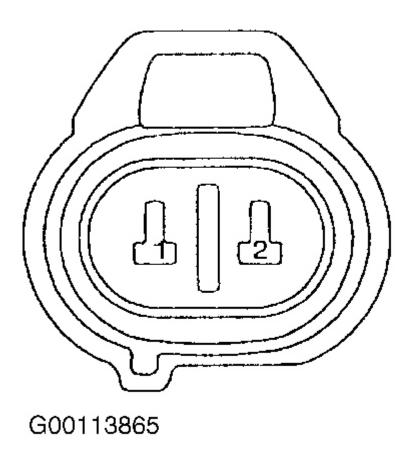
Fig. 10: Identifying Input & Output Speed Sensor (Blue) 2-Way Harness Connector Terminals Courtesy of GENERAL MOTORS CORP.

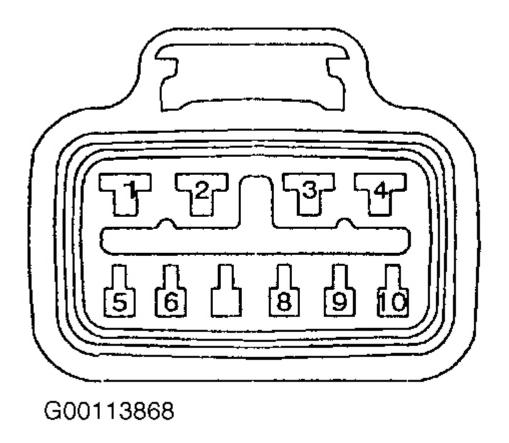
<u>Fig. 11: Identifying Transaxle Range Switch (Black) 10-Way Harness Connector Terminals Courtesy of GENERAL MOTORS CORP.</u>

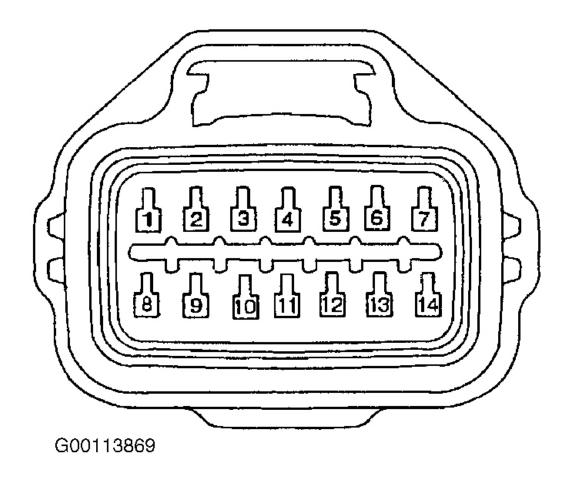
Fig. 12: Identifying Transaxle "J1" (Gray) 14-Way Harness Connector Terminals Courtesy of GENERAL MOTORS CORP.

Connect DVOM between specified terminals at component or at transaxle connector. See <u>Fig. 12</u>. Measure individual component resistance at specified temperature. See <u>COMPONENT RESISTANCE</u> <u>SPECIFICATIONS</u> table. If resistance is not as specified, replace appropriate component.
