41TE & 42LE CODE BOOK

41TE & 42LE DIAGNOSTIC CODE BOOK

INTRODUCTION

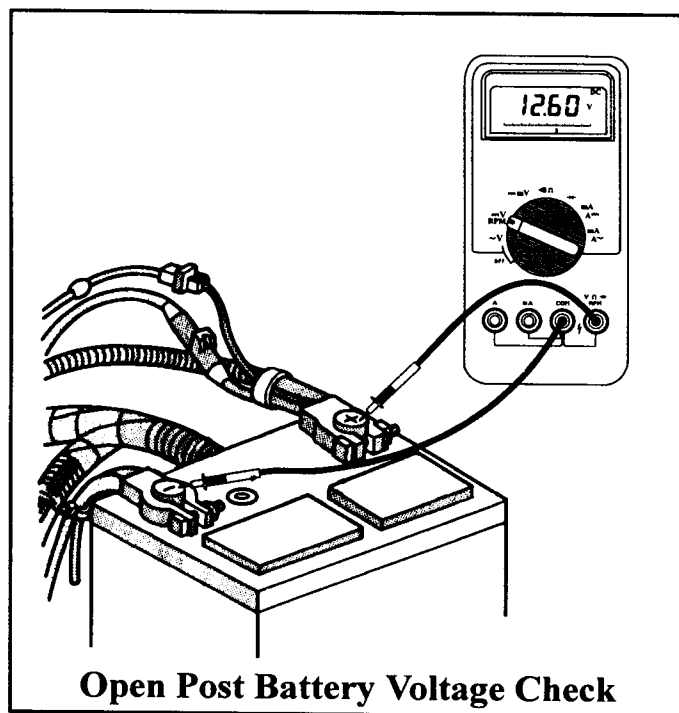
Figure 1

Using a DVOM set to DC volts, measure the open post battery voltage by placing the negative lead to the negative battery post and the positive meter lead to the positive battery post as shown in Figure 1.

With the volt meter connected to the battery as shown in Figure 1, start the vehicle. Turn on the headlights and blower motor to put a load on the voltage system. Approximately 13.5 to 14.4 volts should be seen (See Figure 3). If 15 volts or higher is seen, this may indicate an overcharging alternator which may result in erratic computer behaviour. This problem needs to be rectified before going to the next step.

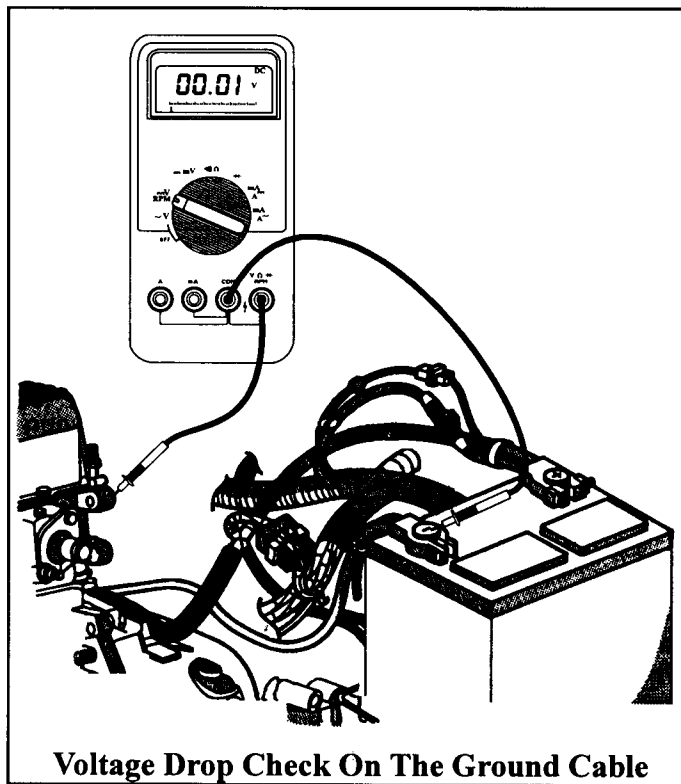
Figure 4

The next step is to perform a voltage drop test across the ground cable. This checks for corrosion or bad connections with the main ground cable itself. To do this, keep the vehicle running and turn on as many accessories as possible, i.e. headlights, AC, radio, etc. With the meter set to DC volts, place the negative lead of the meter to the negative post of the battery. Place the positive lead of the meter to either the body or engine block (See Figure 4). No more than 0.10 volts should be seen. A good ground will usually show 0.00 or 0.01 volts. If 0.20 or more is seen, clean and/or replace the main ground cable to obtain a 0.00 or 0.01 reading.

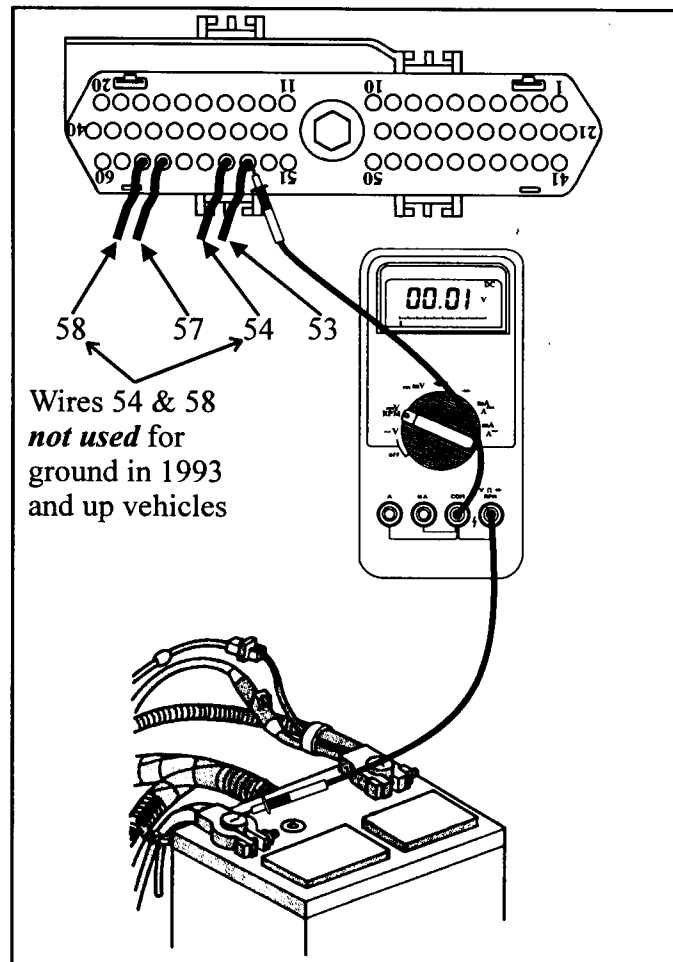
Figure 5

Locate the transaxle controller (See Pages 6 and 7). Once the controller is located, pop the plastic harness cover away from the wires going into the connector (Do not remove the center bolt). Once the cover is removed and the 60 way connector can be viewed from the wire side, locate the ground wires. 1989 to 1992 use wires 53, 54, 57 and 58 for ground (See Figure 5).

Start the vehicle and turn on several accessories. Set the meter to DC volts and place the positive lead of the meter to the negative battery post. Using the negative lead, carefully back probe each ground wire as shown in Figure 5. No more than 0.10 volts can be seen. If more than 0.10 volts is seen, that ground wire is bad.

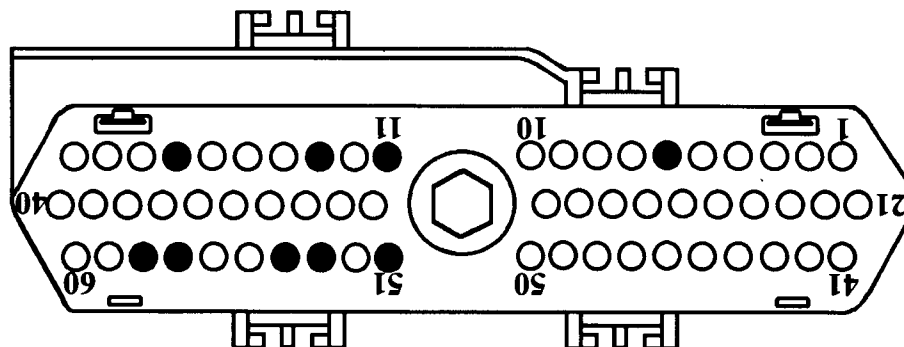
YEAR AND MAKE OF VEHICLE	WIRE # →	6	11	13	17	51	53	54	57	58
1989 - 1992 ALL VEHICLES							✓	✓	✓	✓
1993 DAYTONA		✓					✓		✓	
1993 DYNASTY		✓				✓	✓		✓	
1993 5th AVENUE						✓	✓		✓	
1993 IMPERIAL						✓	✓		✓	
1993 NEW YORKER						✓	✓		✓	
1993 - 1994 SHADOW		✓					✓		✓	
1993 - 1994 SUNDANCE		✓					✓		✓	
1993 - 1994 SPIRIT		✓				✓	✓		✓	
1993 - 1994 ACCLAIM		✓				✓	✓		✓	
1993 - 1994 LEBARON SEDAN		✓				✓	✓		✓	
1993 - 1995 LEBARON CONV/COUPE		✓					✓		✓	
1993 - 1995 CARAVAN (3.0L)		✓					✓		✓	
1993 - 1995 VOYAGER (3.0L)		✓					✓		✓	
1993 - 1995 GRAND CARAVAN (3.3 & 3.8L)							✓		✓	
1993 - 1995 GRAND VOYAGER (3.3 & 3.8L)							✓		✓	
1993 - 1995 TOWN & COUNTRY (3.3 & 3.8L)							✓		✓	
1995 - 1996 AVENGER & SEBRING			✓	✓	✓		✓			
1995 - 1996 CIRRUS & STRATUS						✓	✓		✓	
1995 - 1996 TALON			✓	✓	✓		✓			
1996 CARAVAN & GRAND CARAVAN						✓	✓		✓	
1996 VOYAGER & GRAND VOYAGER						✓	✓		✓	
1996 TOWN & COUNTRY						✓	✓		✓	
1996 SEBRING CONVERTIBLE				✓		✓	✓		✓

1996 BREEZE						✓	✓		✓	
1993 - 1997 ALL LH VEHICLES						✓	✓		✓

Special Note: 1993 and later vehicles do not use terminals 54 and 58 for ground wires. Refer to Figure 6 for the controllers main ground wires per vehicle year and application.

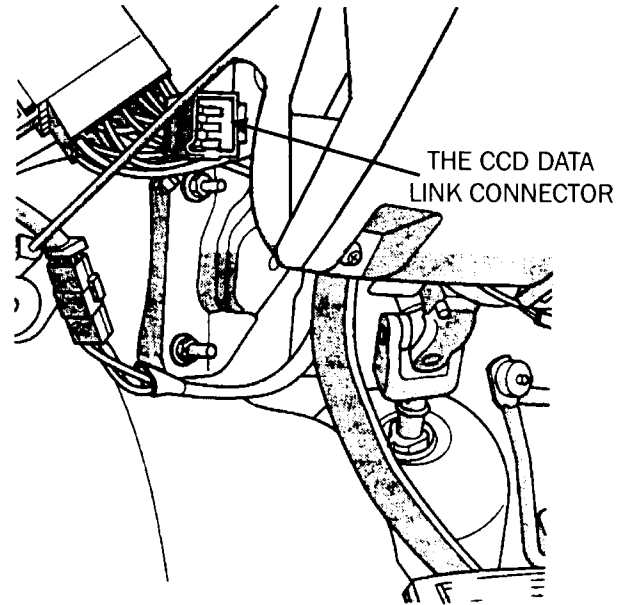
88-92 AA, AC, AY, AG, AJ
89-95 AS
93-95 AC, AY

Early 89 vehicles utilized only 4 pins in the light blue CCD data link connector. Midyear the connector went to the full 6 pins and remained light blue in color

In 1995 the CCD data link connector was replaced by an 8 pin black connector. The previous 6 way scan tool connector will still link up.

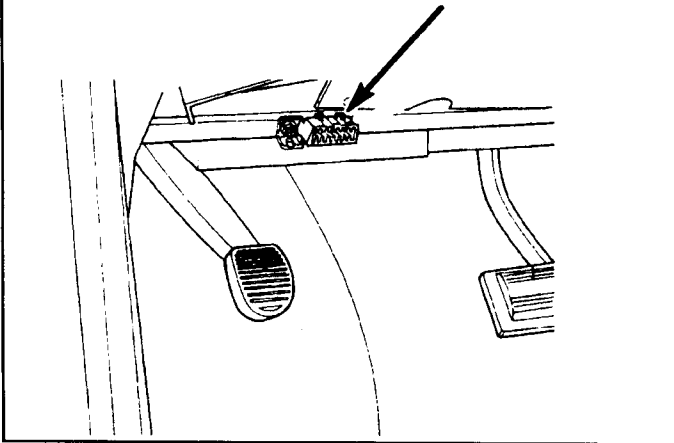
DATA LINK CONNECTOR

89-94 AA, AS 89-93 AC 93-94 AP
90-93 AY, AG 90-95 AJ 93-95 LH

- 1....SCI Receive (Vehicle with ABS)
- 2....Battery (12V)
- 3....Serial Data Bus (-) (2.5 V)
- 4....Serial Data Bus (+) (2.5 V)
- 5....SCI Transmit (Vehicle with ABS)
- 6....Ground (0.1 V or less)

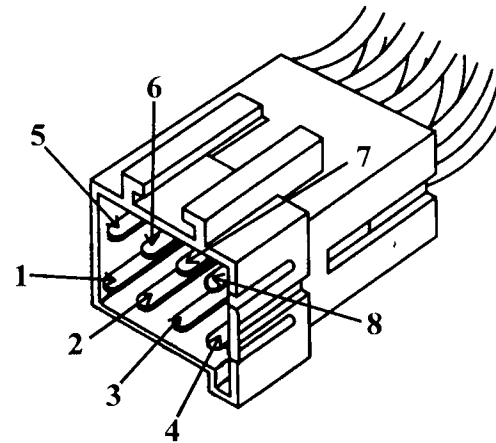
8 WAY DATA LINK TERMINAL I.D.

94-95 AS
95 AA

- 1....SCI Receive (Engine)
- 2....SCI Receive (Vehicle with ABS)
- 3....Battery (12V)
- 4....Serial Data Bus (-) (2.5 V)
- 5....SCI Transmit (Engine)
- 6....Serial Data Bus (+) (2.5 V)
- 7....SCI Transmit (Vehicle with ABS)
- 8....Ground (0.1 V or less)

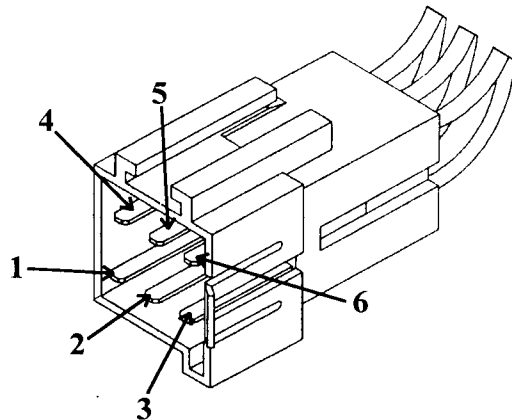
4 & 6 WAY DATA LINK TERMINAL I.D.

89-94 AA, AS 89-93 AC 93-94 AP
90-93 AY, AG 90-95 AJ 93-95 LH

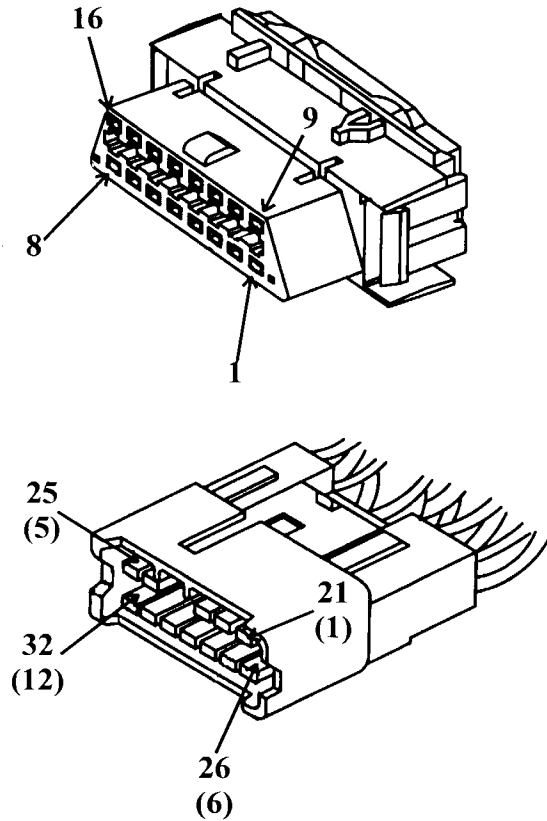
12 & 16 WAY DATA LINK TERMINAL I.D.

95-96 FJ22/F24S

16 WAY

- 1...Diagnostic Control Signal
- 4...Ground (0.1 V or less)
- 5...Ground (0.1 V or less)
- 6...Transmission Control
- 7...SCI Transmit
- 8...Brake Control
- 9...Transmission Control Module
- 12..SRS Air Bag Control
- 13..Speed Control CTRL
- 14..Simulated VSS
- 16..Battery (12V)

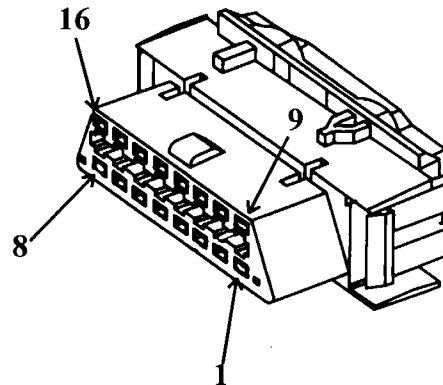
95-97 JA, JX
96-97 NS
96-97 LH

16 WAY

- 3...Serial Data Bus (+) (2.5 V)
- 4...Ground (0.1 V or less)
- 5...Ground (0.1 V or less)
- 6...SCI Receive
- 7...SCI Transmit/ISO 9141K
- 11..Serial Data Bus (-) (2.5 V)
- 14..TCM SCI Receive (96-97 JA, JX, NS)
- 16..Battery (12V)

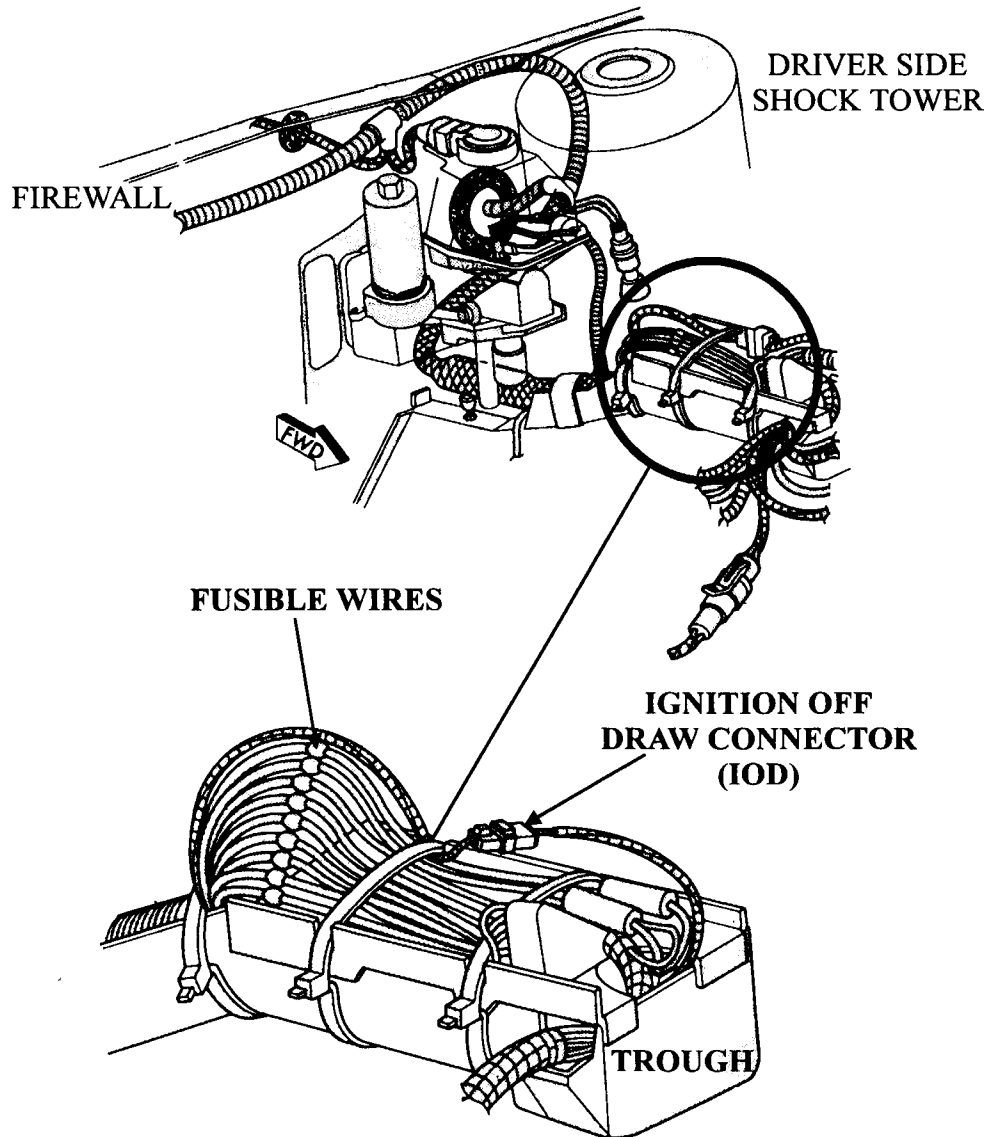
Typical view of both fusible link and IOD connector location. Not all vehicles have an IOD connector or a trough that the fusible links sit into. All fusible links are located behind and below the battery tray towards the driver side shock tower.

- With the connector unplugged, check cavity # 56 for battery voltage (See Figure 13). While checking for voltage, wiggle the main wiring from the battery to the controller. If battery voltage is lost during this wiggle test, a bad fusible link or a break in the wire has occurred (See Figure 8 for fusible wire location). In Figures 9 and 10 a Fusible Wire Chart can be found showing vehicle application and fusible wire color. In some applications a typical fuse is used and is noted. If a broken wire is in the harness, a continuity check is required at different points across the wire to locate the break.

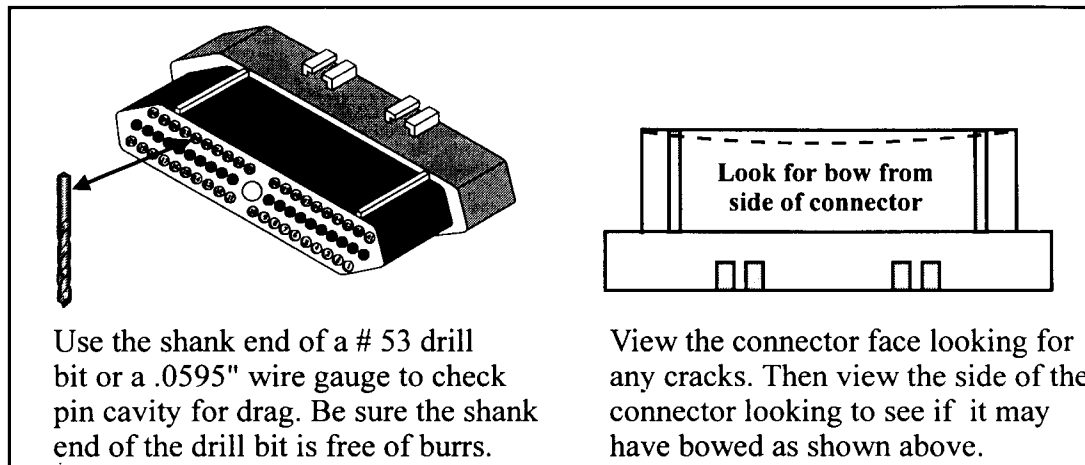
Figure 12

- Perform the *Preliminary Electrical Checks* outlined starting on page 3. Be sure to use the chart on page 5 when testing the controller's main ground wires.
- Inspect the 60 way controller connector for corrosion, distortion and/or cracks in the connector, pushed back or spread pin cavities. Particularly the power and ground wire pins (See Figure 12).
- If the above checks prove good, the controller will need to be replaced.

- Unplug the 60 way connector and check for pin drag at the # 56 cavity using the shank end of a # 53 drill bit or .0595" wire gauge as shown in Figure 12. Repair if necessary.

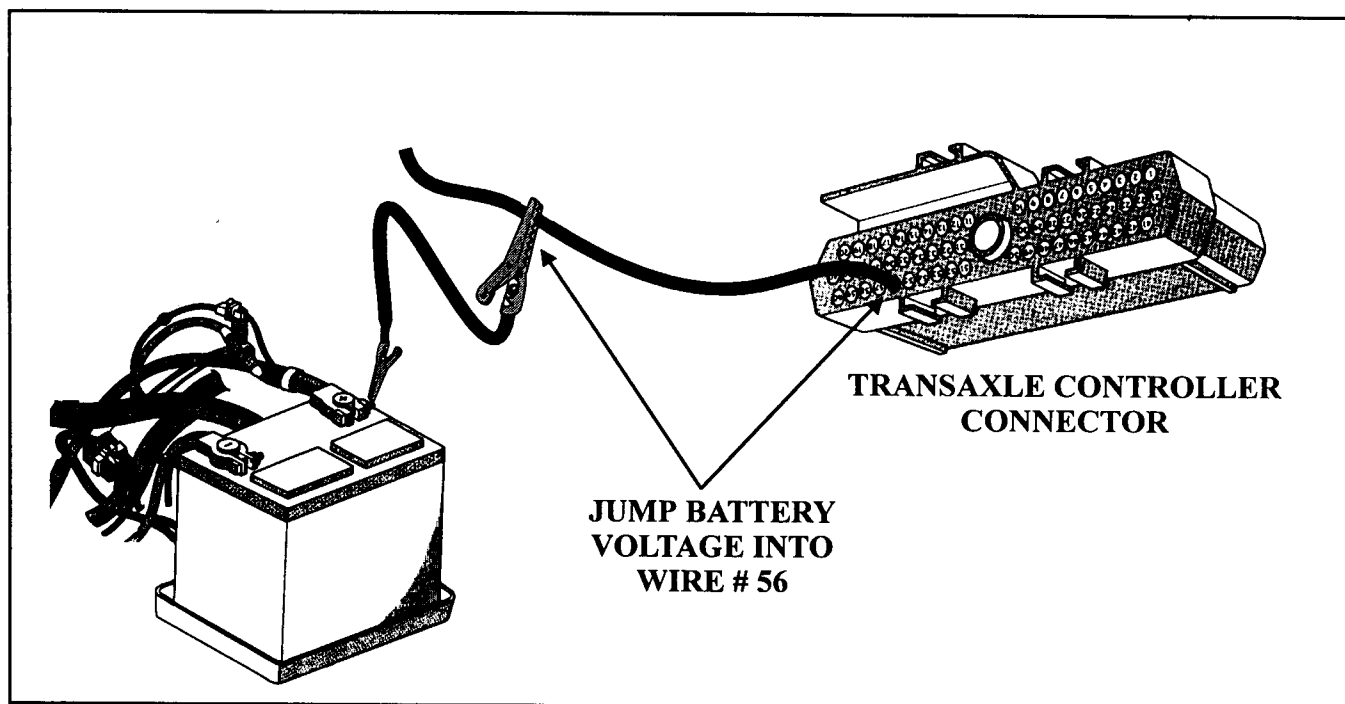
Figure 14

- CORRECTION:** First replace the EATX relay with a known good relay (Refer to pages 8-10 for relay location). If the problem remains, a quick method to verify a bad fuse or fusible wire is to locate wire 56 at the TCM. Carefully remove some of the insulation from the wire and connect battery voltage to the wire with a jumper wire (See Figure 14). Once connected, if all symptoms are removed, a defective fuse or fusible wire is the problem. To assist on locating the defective fusible link, all fusible links are color coded and can be found below and between the battery and driver side spring tower (See Figure 8). Refer to the chart in Figures 9 and 10 which cross references the fusible link color identification to the vehicle make and year.

Fusible links are ordered by color and wire gauge.

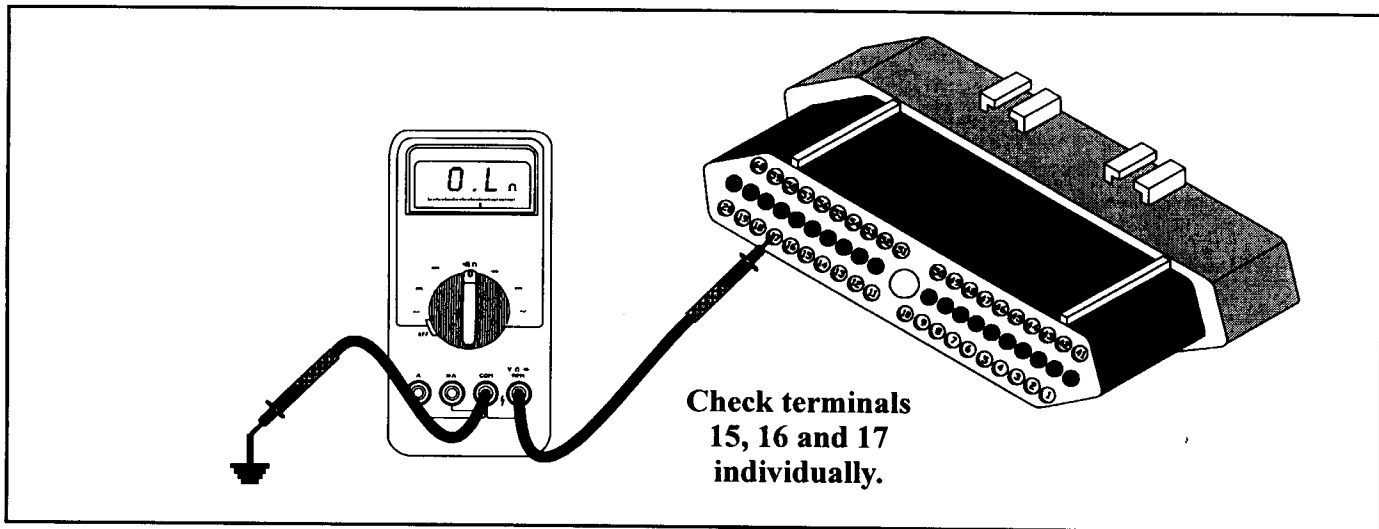
Figure 16

- Keep the EATX relay unplugged. Unplug both the TCM and solenoid body connector. Place the DVOM to an ohm setting. Maintain the negative meter lead to a good known ground. With the positive meter lead carefully probe terminals 15, 16 and 17 in the controller connector as shown in Figure 16. An open circuit should be seen on all three wires. If an ohm reading is seen, a short to ground has occurred on the wire revealing the reading and will need to be repaired. If an open circuit is seen on all three wires, go to the next step.
- Check for continuity between the EATX relay connector and terminal 15 in the TCM connector as shown in Figure 17. If an open is seen, repair the break in the wire. If continuity is seen, go to the next step.

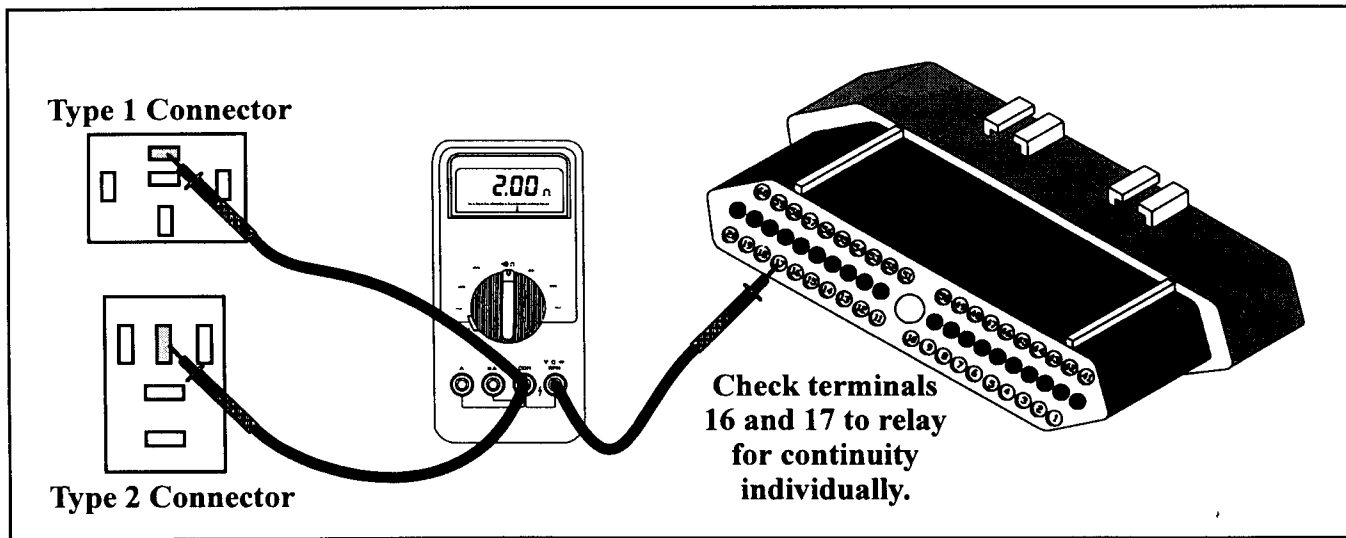
Figure 18

- Check for continuity between the relay connector and terminals 16 and 17 in the controller connector as shown in Figure 18. If an open is seen, repair the break in the wire that shows the open circuit. If continuity is seen, go to the next step.
- Check for continuity between the ground terminal on the battery to the terminal in the relay connector as shown in Figure 19. If an open is seen, repair the wire. If an open is not seen, go to the next step.
- Replace the TCM.

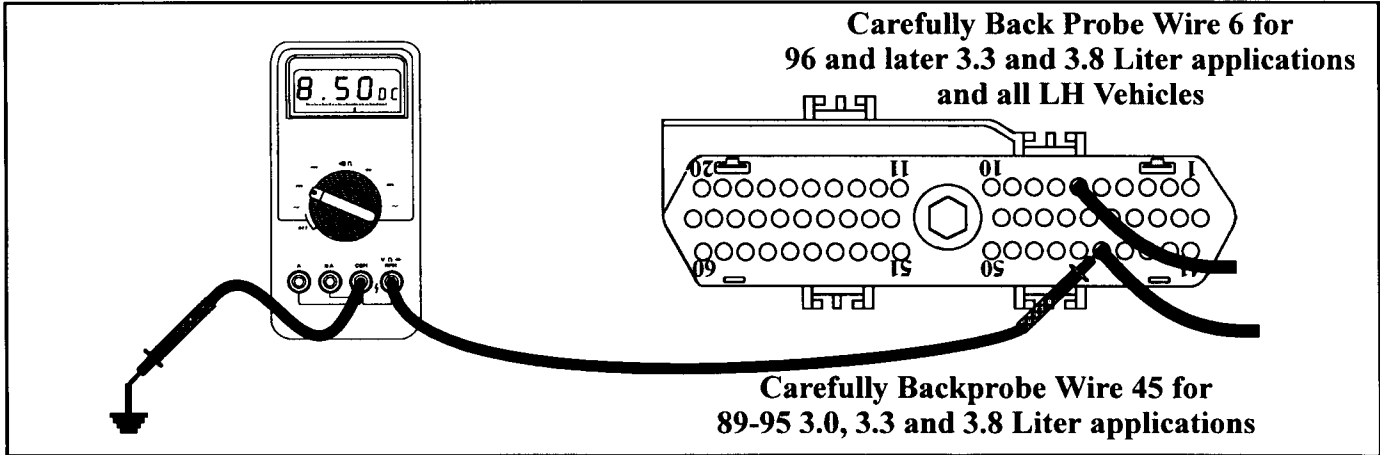
Figure 21

- With a DVOM set to DC volts, carefully back probe wire 45 at the TCM with the positive meter lead and place the negative meter lead to a good known ground (See Figure 21). With the key on and engine off, an 8 to 9 volt pulse should be seen as the crank shaft is turned by hand. If a voltage pulse is observed, the TCM needs to be replaced. If no volts are observed, go to the next step. *Note:* A square wave form is shown in Figure 22 for those that have oscilloscope testing capabilities (Test is performed with vehicle running).

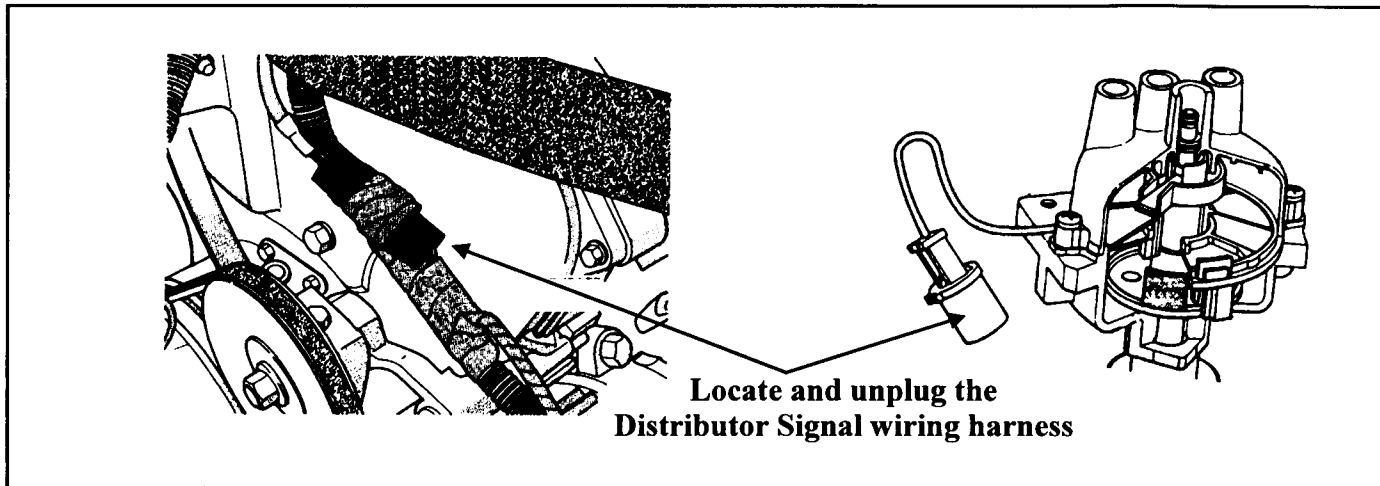
Figure 23

- Go to the distributor and locate a wiring harness coming out from the bottom of the distributor. Trace the harness downstream away from the distributor until you locate the round 4 wire plug as shown in Figure 23. Unplug this 4 way connector and the TCM connector. Perform a continuity check across terminal 2 in the distributor vehicle harness connector to the number 51 wire in the TCM connector as indicated in Figure 24. If there is no continuity, repair or replace the wire. If continuity is seen, go to the next step.

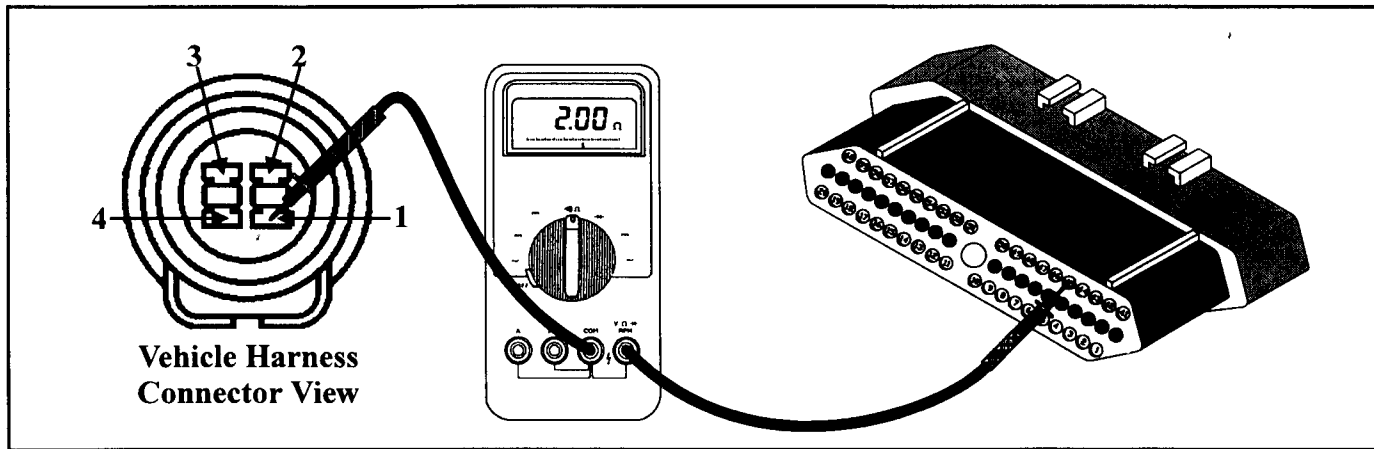
Figure 25

- Perform a continuity check across terminal 1 in the distributor vehicle harness connector to the number 45 wire in the TCM connector as indicated in Figure 25. If there is no continuity, repair or replace the wire.

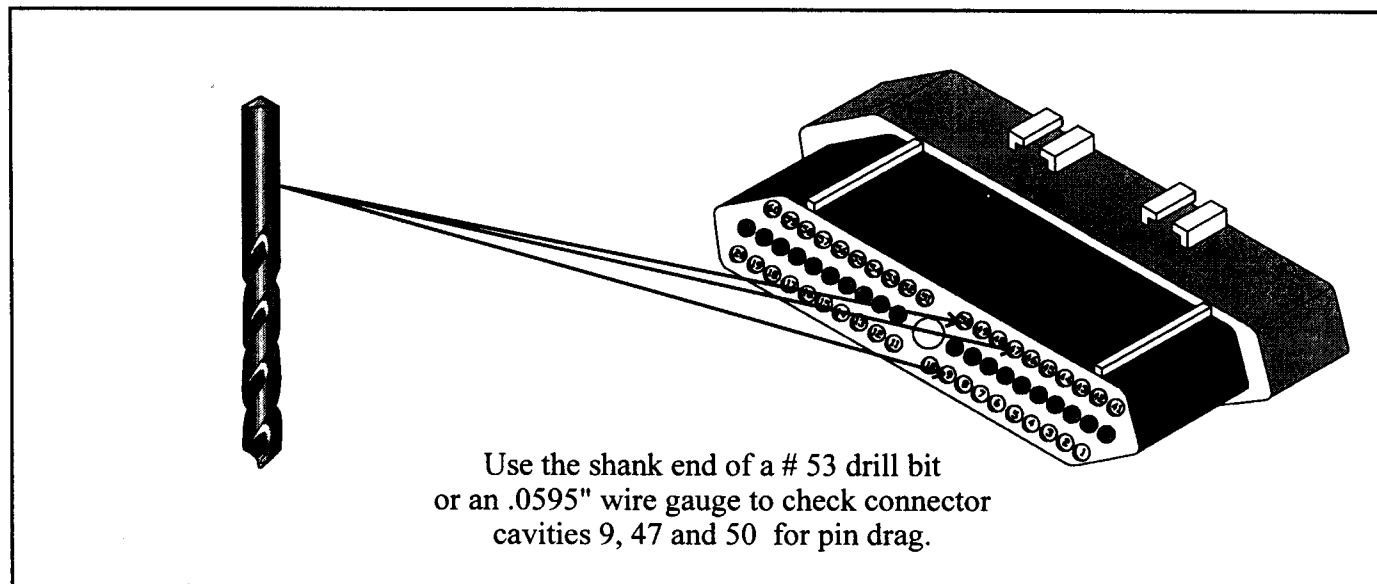
Figure 30

- Inspect cavities 9, 47 and 50 in the TCM 60 way connector for being spread, corroded or pushed back to far. Use the shank end of a # 53 drill bit or a .0595" wire gauge to check the terminal for pin drag (See Figure 30). A connector repair kit available from Chrysler under part number 4419479 if connector replacement is needed.
- If the 60 way connector is good, go to the next step.

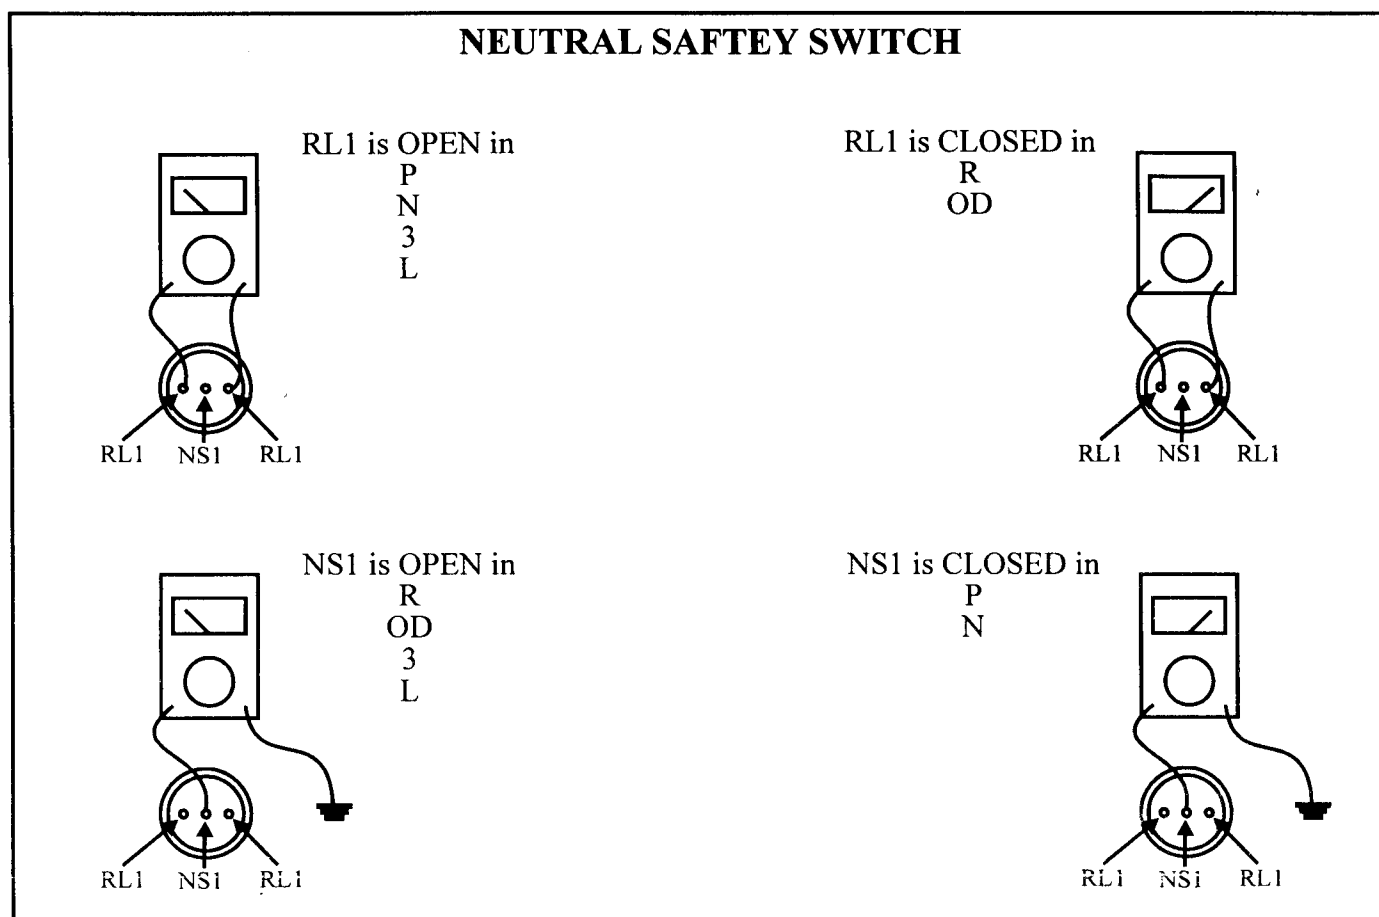
- Once the circuit which malfunctioned has been identified, a check needs to be made on that specific circuit. The first step is to check the PRONDL & Neutral switch operation with the use of a ohm meter. This will check the integrity of the switch as well as the plastic cam located on the manual valve detent assembly. Use Figure 36 to check the specific circuit in question for the Neutral Safety switch or Figure 37 for the PRNODL switch.

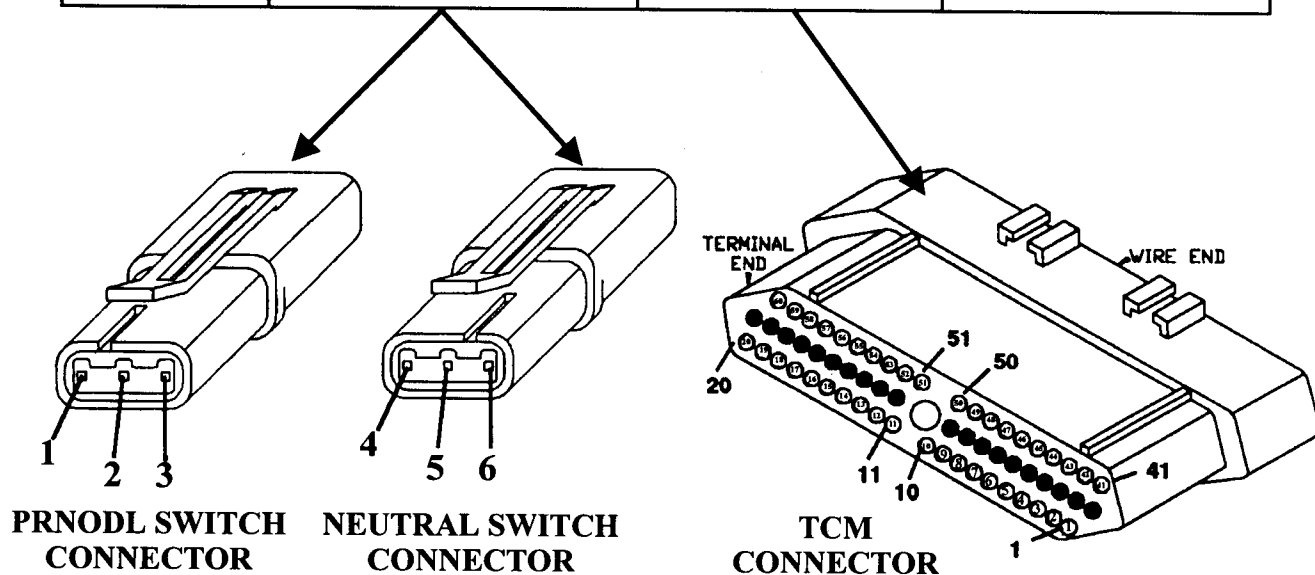
- If the connectors check good, use the chart found in Figure 38 to perform continuity checks across each individual circuit.
- If all circuits have continuity, the TCM may need to be replaced. Before doing so, refer to a bulletin found on page 49.

- If a code 28 comes up due to a bad shift lever position signal and both the PRNODL and Neutral switch are known to be good, then a circuit check will have to be performed. This will require the use of an ohmmeter in order to check for continuity across each individual wire going from the switch to the controller. Use the chart and illustrations below to assist you in making the check. It has been ATSG's experience that the majority of open circuits have been traced down to bad connectors. Chrysler has a connector repair kit available for the PRNODL and Neutral Switches under part number 4638996

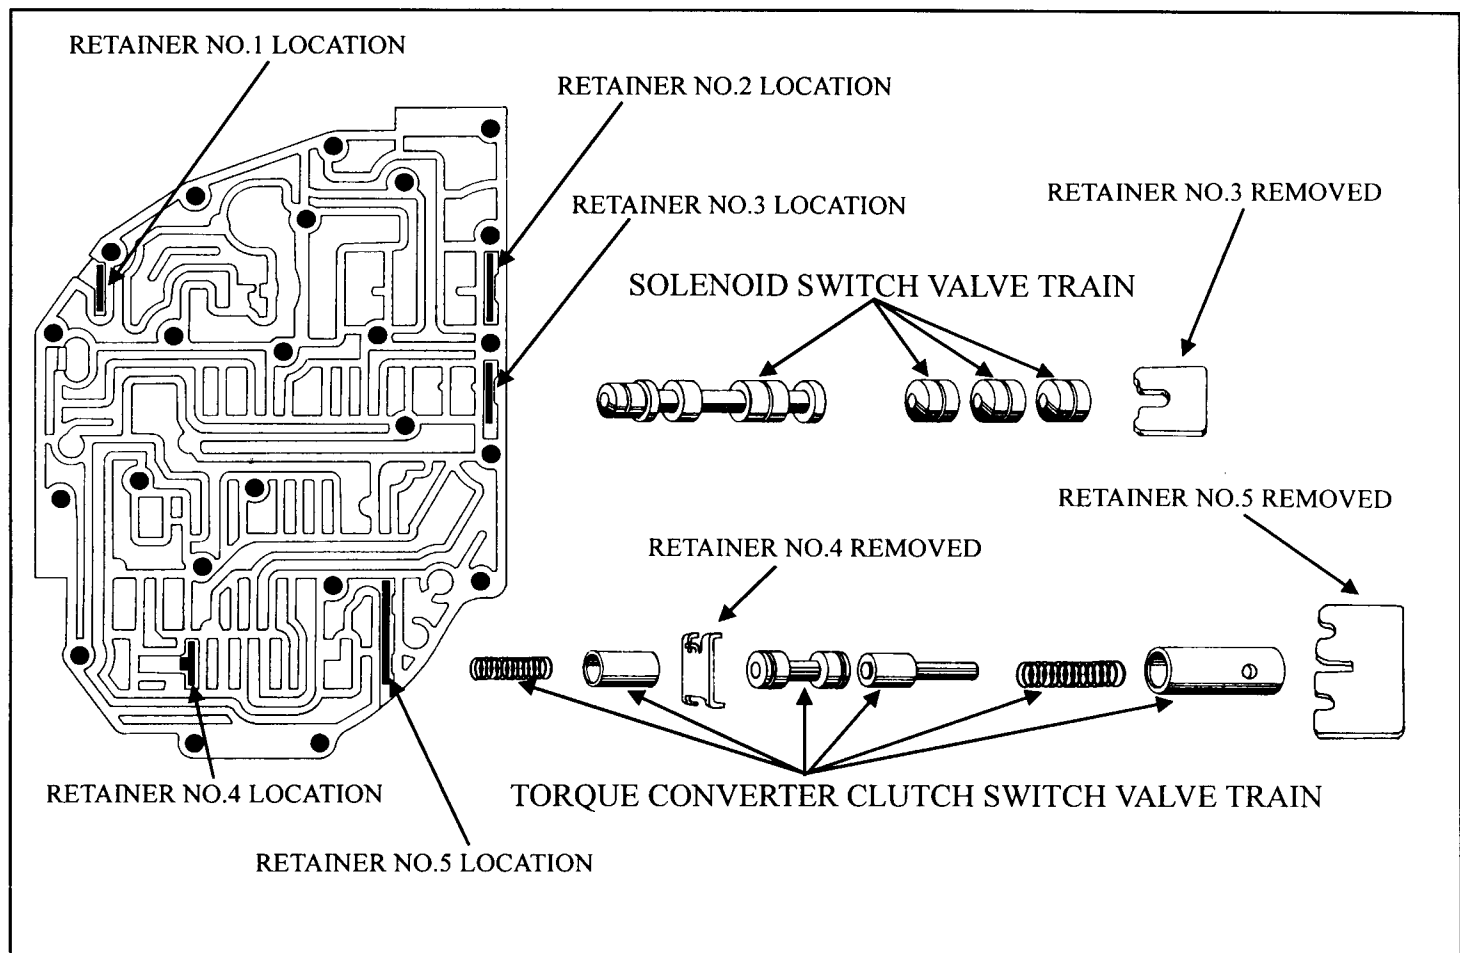
CORRECTION: Install the solenoid switch valve train and retainer No.3 as shown in Figure 39.
NOTE: Retainer location No.4 and Torque Converter Clutch Switch Valve Train shown in Figure 39 are for "92" and later only!

CAUSE: The cause may be, that during the valve body cleaning process, retainer No.3 and/or one of the small "Buttons" in the solenoid switch valve train was not installed during reassembly. These parts can usually be found in the bottom of the solvent tank.

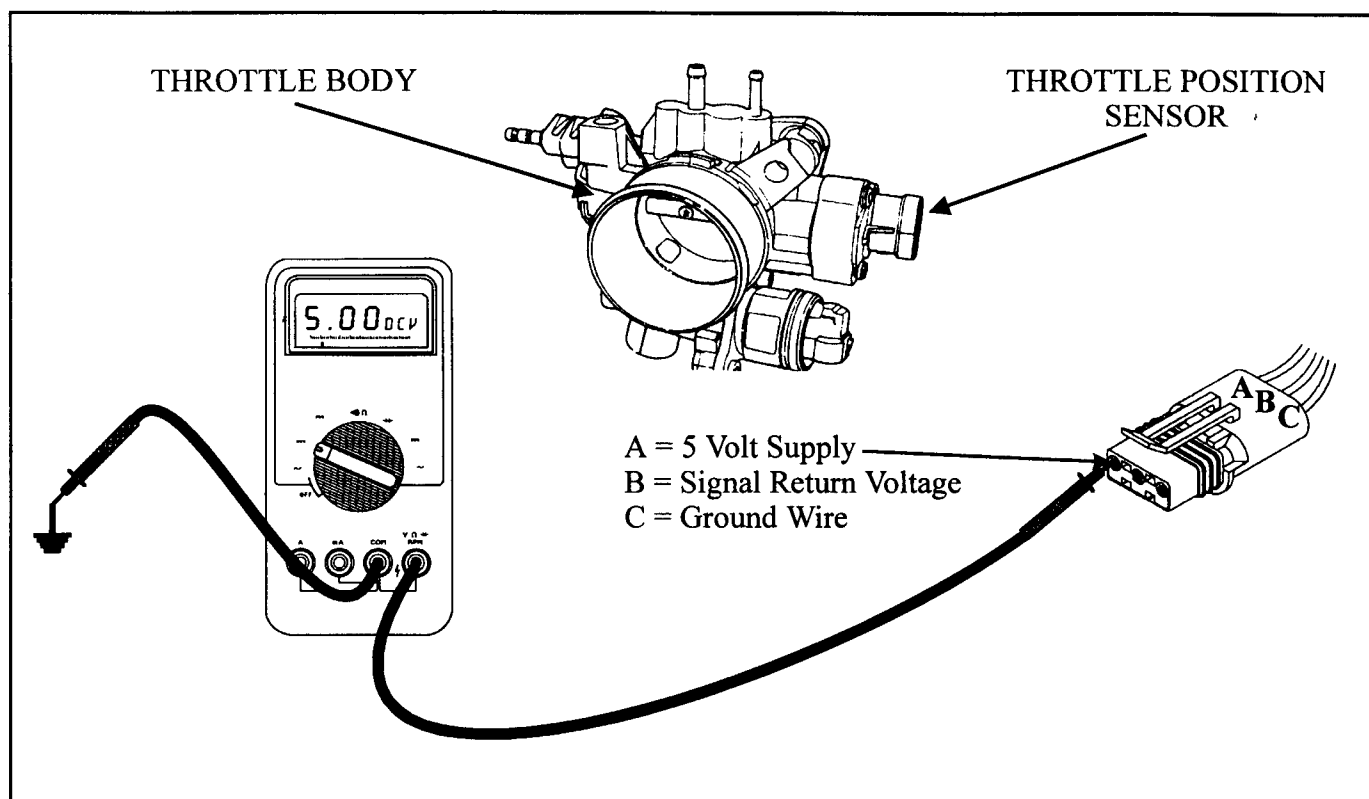
Figure 44

- Locate and unplug the TPS on the throttle body as shown in Figure 44. With the engine off, turn the ignition to the "ON" position. Set the meter to DC volts and place the negative lead to the negative battery post. With the positive lead check terminal A in the harness connector for approximately 5 volts as seen in Figure 44. If voltage is not seen, a bad PCM (Engine Computer) may be the problem as it supplies the 5 volt feed to the TPS. It would be wise to first verify that the wire itself is not severed from the PCM to the TPS by performing a continuity check across the wire. All vehicles up to and including model year 1995 the check should be made from terminal 6 in the PCM connector to terminal A in the TPS connector. For 1996 and later vehicles the check should be made from terminal 61 at the PCM to terminal A in the TPS connector. If continuity is seen across the wire and there is not 5 volts going to the TPS, the PCM will need to be replaced. If 5 volts is seen at the TPS connector, go to the next step.

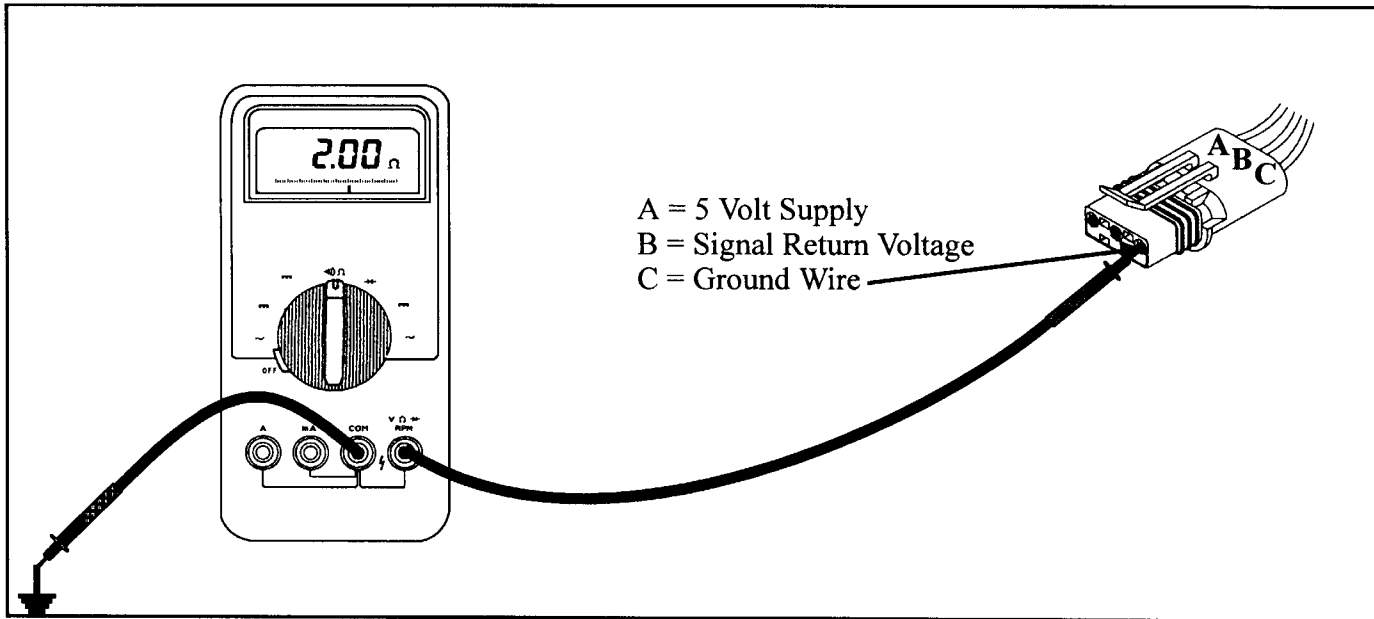
Figure 45

- With a meter set to ohms, place the negative lead to the negative post of the battery and the positive lead to terminal C in the TPS connector (See Figure 45). Approximately 0 to 5 ohms should be seen. If the resistance is greater than 5 ohms or the meter displayed an open circuit, the ground wire will need to be repaired. A quick and simple method would be to splice into the wire with another wire and run it to a good known ground (See Figure 46). If the ground wire is good and the TPS is still malfunctioning, go to the next step.

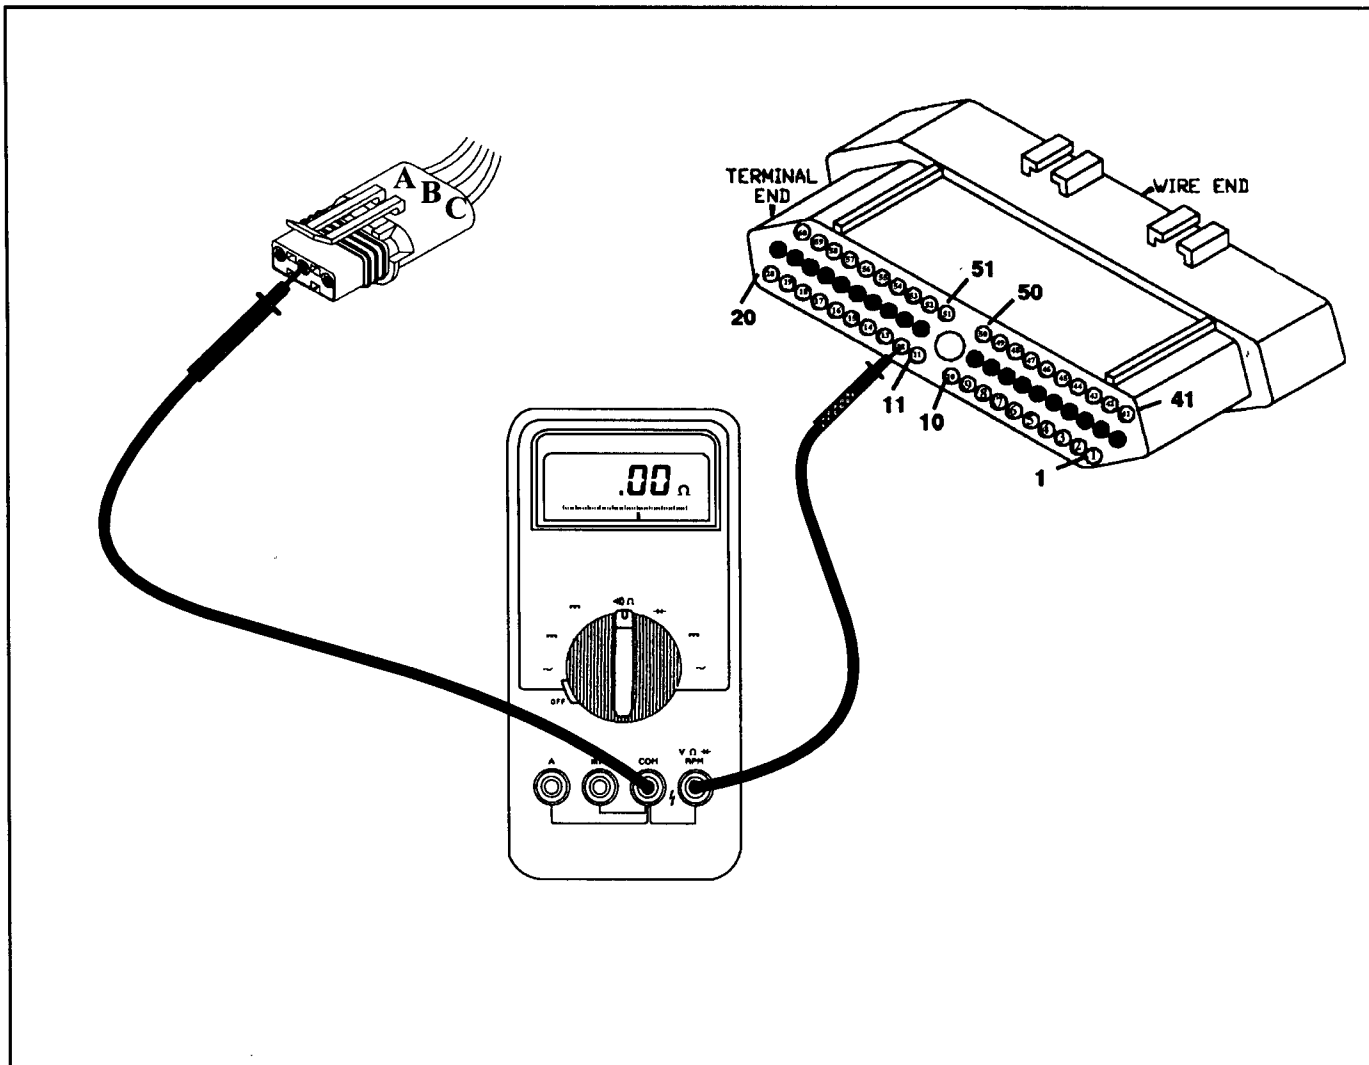
Figure 47

- Unplug both the TCM and TPS. Perform a continuity check from terminal B in the TPS connector to terminal 12 in the TCM connector (See Figure 47). If continuity is not seen, repair the severed wire. If continuity is seen, replace the TPS.

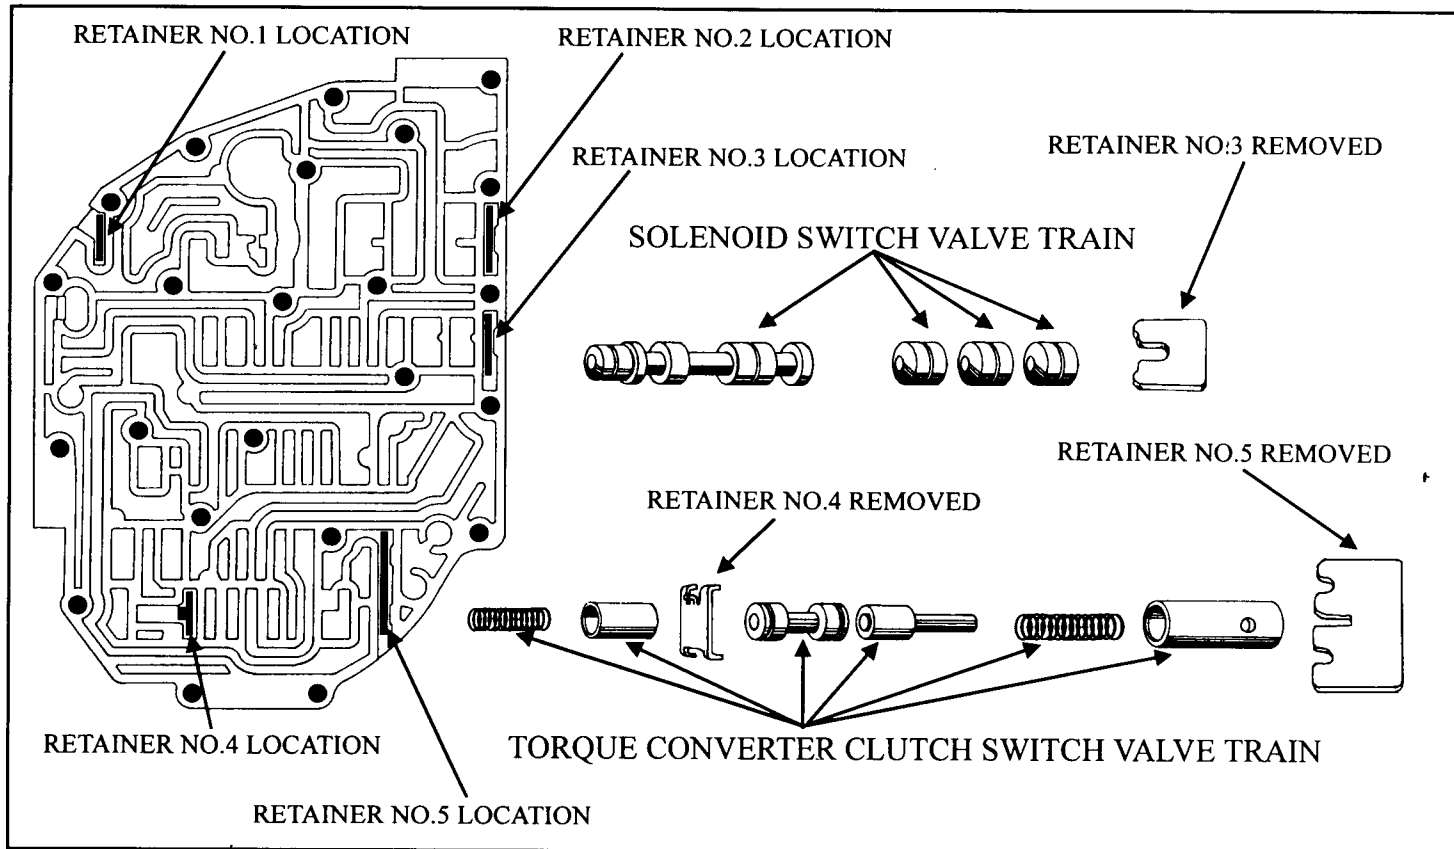
Figure 48

- Use a scanner to observe the Shift Lever Position. If OD is displayed while in the Reverse position the PRNODL switch may be defective. Refer to pages 45 to 52 for step by step diagnosis.
- Inspect the valve body for a stuck Solenoid Switch Valve or a missing # 3 retainer (See Figure 48).
