41TE & 42LE CODE BOOK

41TE & 42LE DIAGNOSTIC CODE BOOK

INTRODUCTION

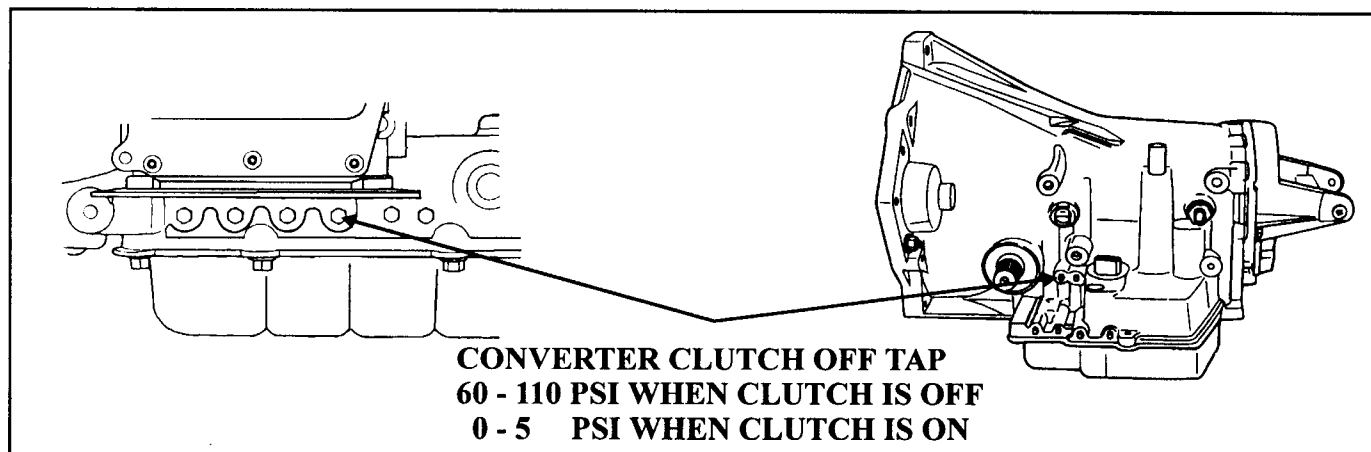
Figure 50

- Record and clear all codes with a scanner via the diagnostic BUS connector. Use the scanner to then observe both engine RPM and Turbine Shaft RPM. Install a pressure gauge onto the converter clutch off tap (See Figure 50). Take the vehicle for a road test. When the scanner indicates full lock up, both the engine RPM and Turbine Shaft RPM should read the same. The pressure gauge should also drop to 5 psi or less. The following results would indicate the different possibilities.

- The Engine and Turbine Shaft RPM's are considerably different but the pressure gauge dropped to 0 psi. The Torque Converter Clutch is slipping or there is low converter clutch apply pressure due to the primary use of an auxiliary cooler or or a defective valve body. Low apply pressure can be determined by observing converter clutch off pressure before lock up. It should be between 60 to 110 psi.

- If full lock up is commanded and pressure drops slightly, inspect the valve body, pump bushing, pump stator and turbine shaft sealing rings for excessive wear or damage.

- If both the Engine RPM and Turbine RPM are the same with a pressure gauge reading 0 psi, the converter clutch is fully locked up. If a code is stored under these conditions, the TCM would be misinterpreting information producing a false code. Replace the TCM.

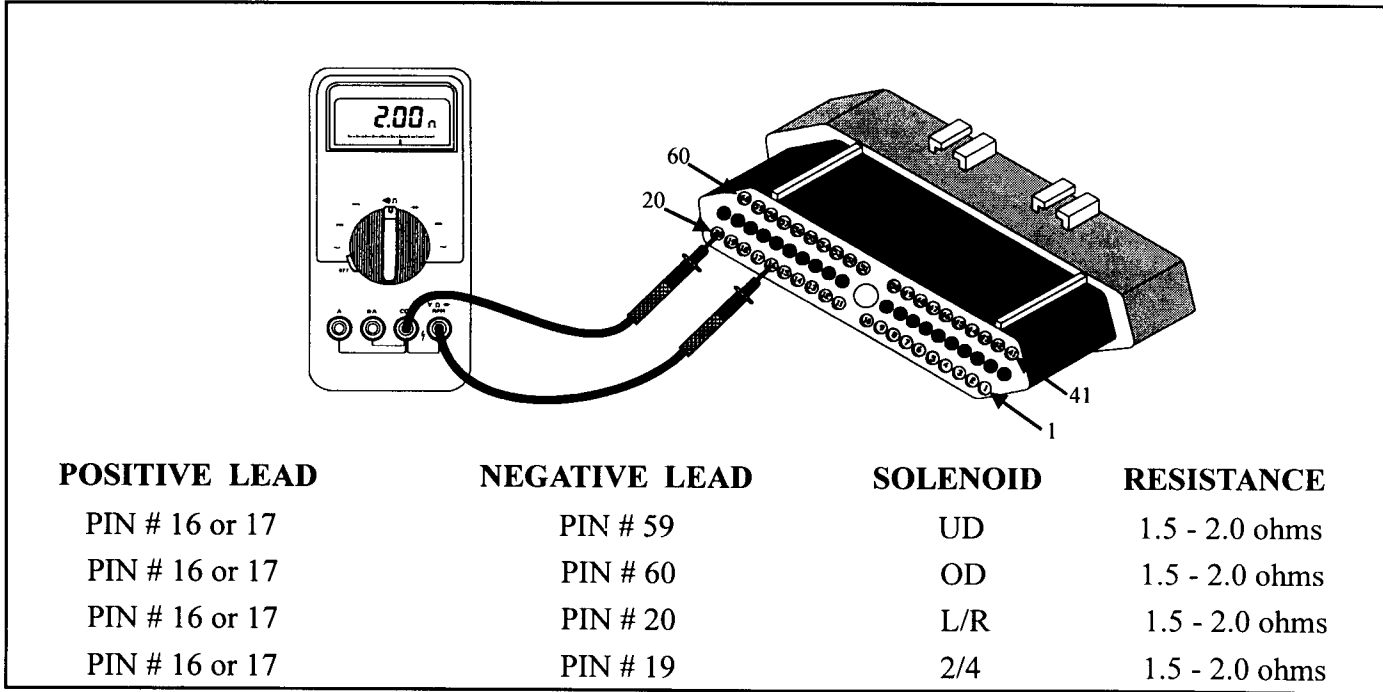
Figure 51

- Unplug the TCM's 60 way connector. Using a DVOM check the resistance of all four solenoid circuits by placing the positive lead onto pin 16 or 17 as seen in Figure 51. With the negative lead, carefully touch pins 19, 20, 59 and 60 one at a time. Each solenoid should measure approximately 1.5 to 2.0 ohms. If the solenoid providing the code reads considerably higher or lower from the other three solenoids, change the solenoid body. If all the readings are the same, wiggle the solenoid wires with the meter still attached and see if the readings behave erratic. If so, the solenoid connector is bad and will need to be replaced with part 4419476.

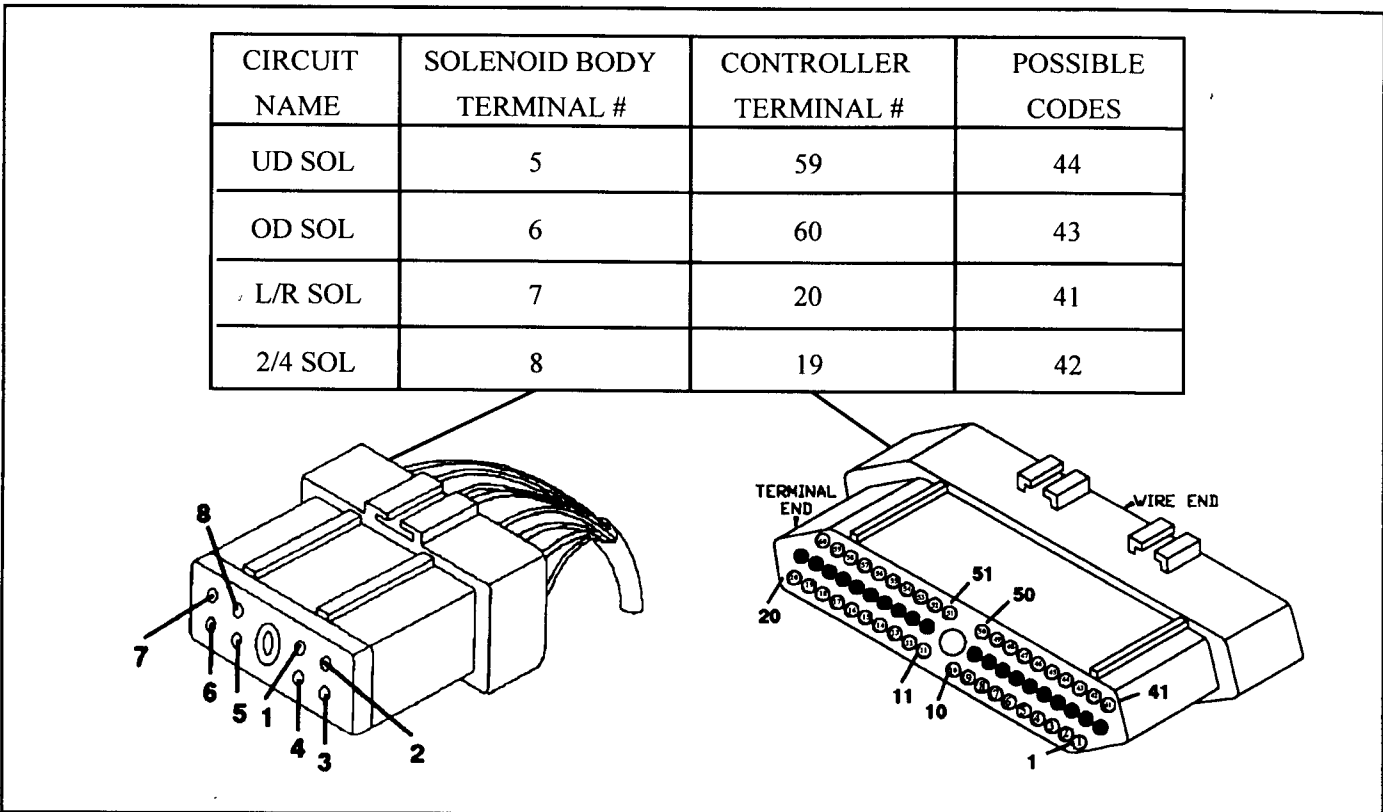
- If when performing the above check an open is seen on one of the solenoid wires, use Figure 52 to perform a continuity check on the wire in question. If it is determined that the wire is severed, a new wire can be run and spliced in outside the harness.

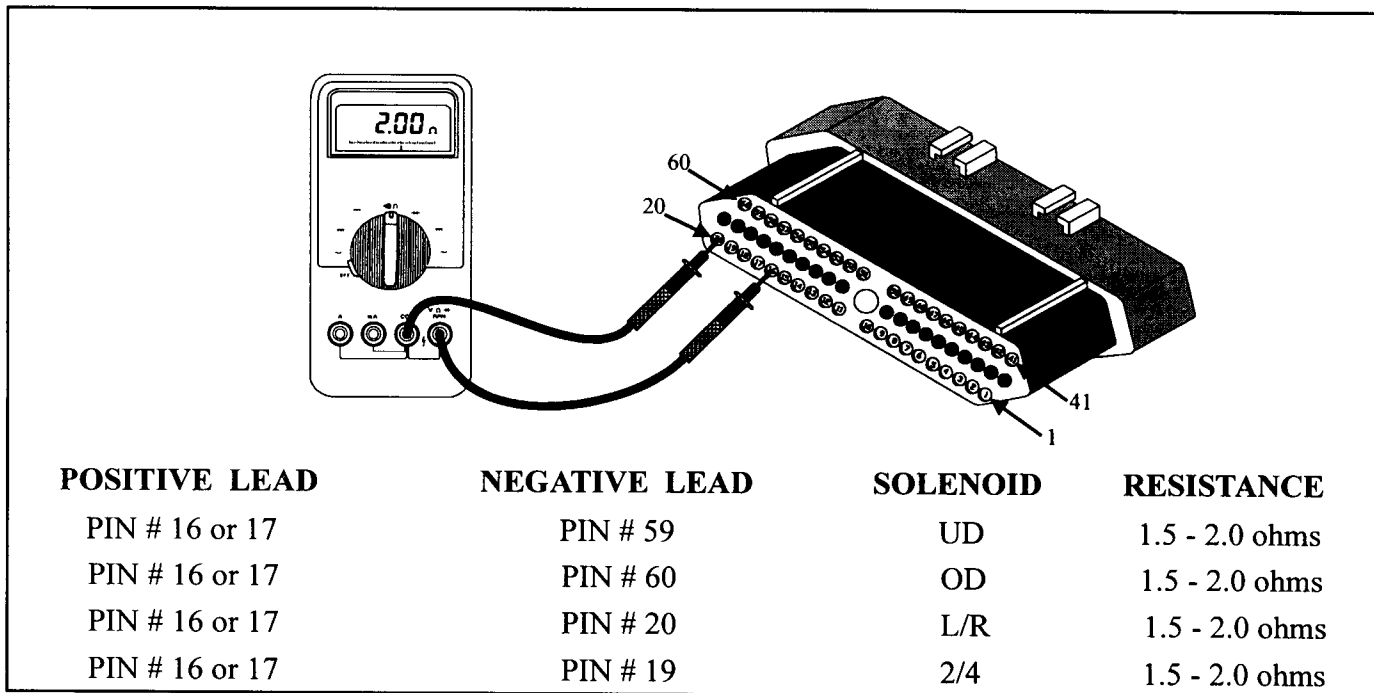
Figure 54

- Unplug the TCM's 60 way connector. Using a DVOM check the resistance of all four solenoid circuits by placing the positive lead onto pin 16 or 17 as seen in Figure 54. With the negative lead, carefully touch pins 19, 20, 59 and 60 one at a time. Each solenoid should measure approximately 1.5 to 2.0 ohms. If the solenoid providing the code reads considerably higher or lower from the other three solenoids, change the solenoid body. If all the readings are the same, wiggle the solenoid wires with the meter still attached and see if the readings behave erratic. If so, the solenoid connector is bad and will need to be repaired.

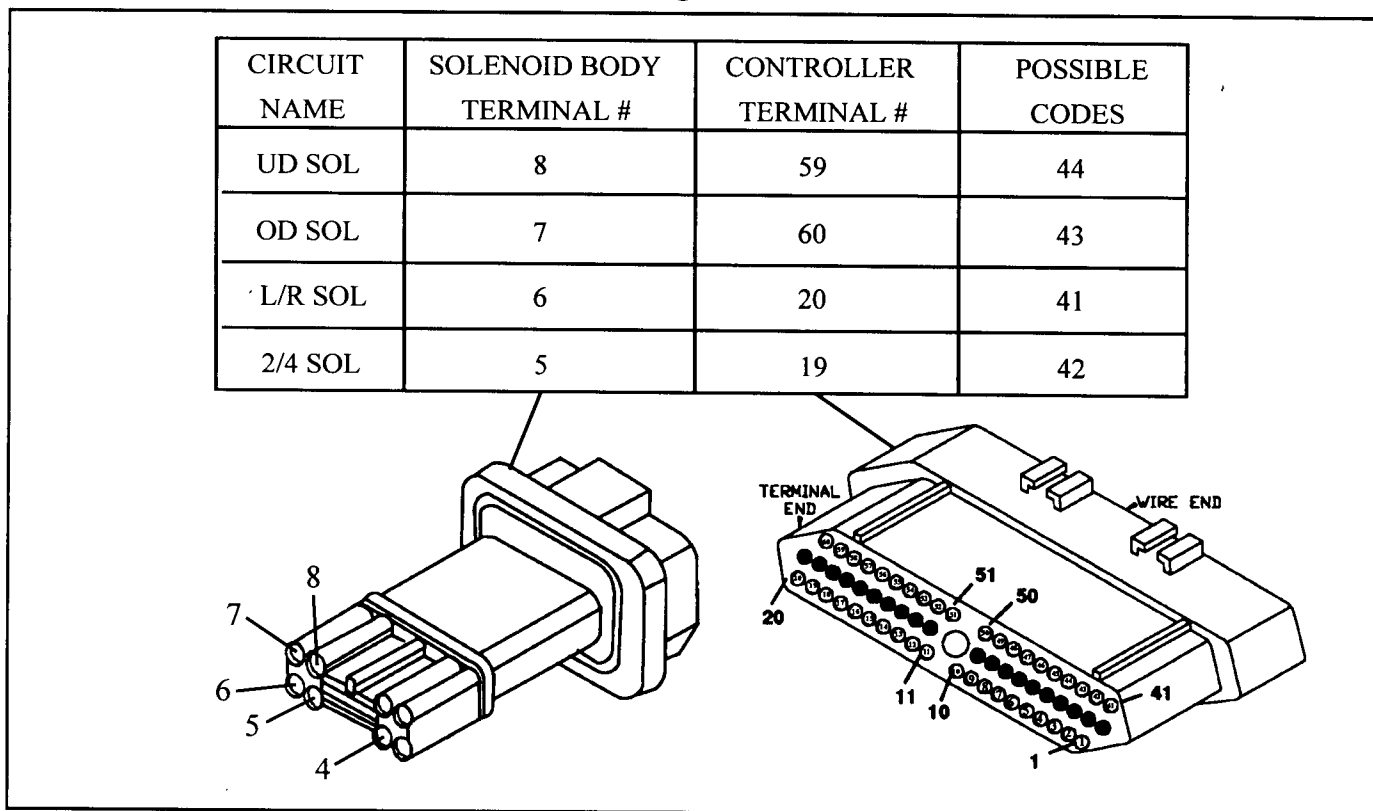
- If when performing the above check an open is seen on one of the solenoid wires, use Figure 55 to perform a continuity check on the wire in question. If it is determined that the wire is severed, a new wire can be run and spliced in outside the harness.

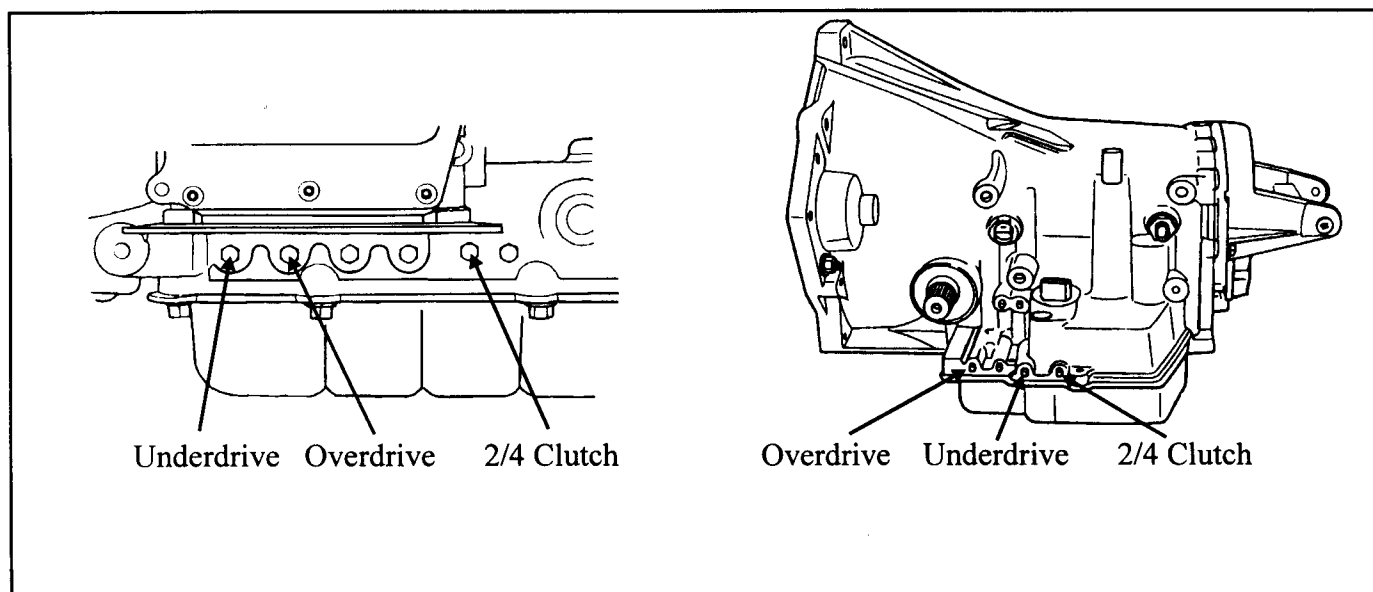
Figure 56

- With the pressure specifications given on page 65, the UD, OD and 2/4 hydraulic circuits should be checked with a pressure gauge (See Figure 56). The 2/4 clutch pressure should be checked in 2nd gear. 120-145 psi should be seen and 0 psi in first and third. Since the transaxle is experiencing a 3-4 shift abort, the full 75-95 psi may not be seen at the 2/4 tap when attempting to go to fourth and should be considered as normal. If the pressure in the 2/4 clutch circuit is substantially low in second gear or pressure is seen in first or third, this hydraulic circuit needs to be investigated.

- The UD clutch circuit is next and can be the most likely hydraulic problem causing the 3-4 shift abort. This clutch circuit should show 120-145 psi in first and second and 75-95 in third. There should be 0 psi in this circuit when in 4th gear. Since the transaxle will not fully go into 4th gear, a 0 psi reading may be hard to detect. To get around this problem, when the transaxle is in third gear, step heavy into the throttle and bring the vehicle up to speed so as to be able to do an OFF throttle upshift into 4th gear. If a 3-4 shift takes place without being on the throttle, the controller will allow a 3-4 shift to take place. While in 4th gear, read the UD pressure gauge. If pressure is seen, this hydraulic circuit needs to be investigated. A bad solenoid body, valve body or pump can cause this type of cross leak.

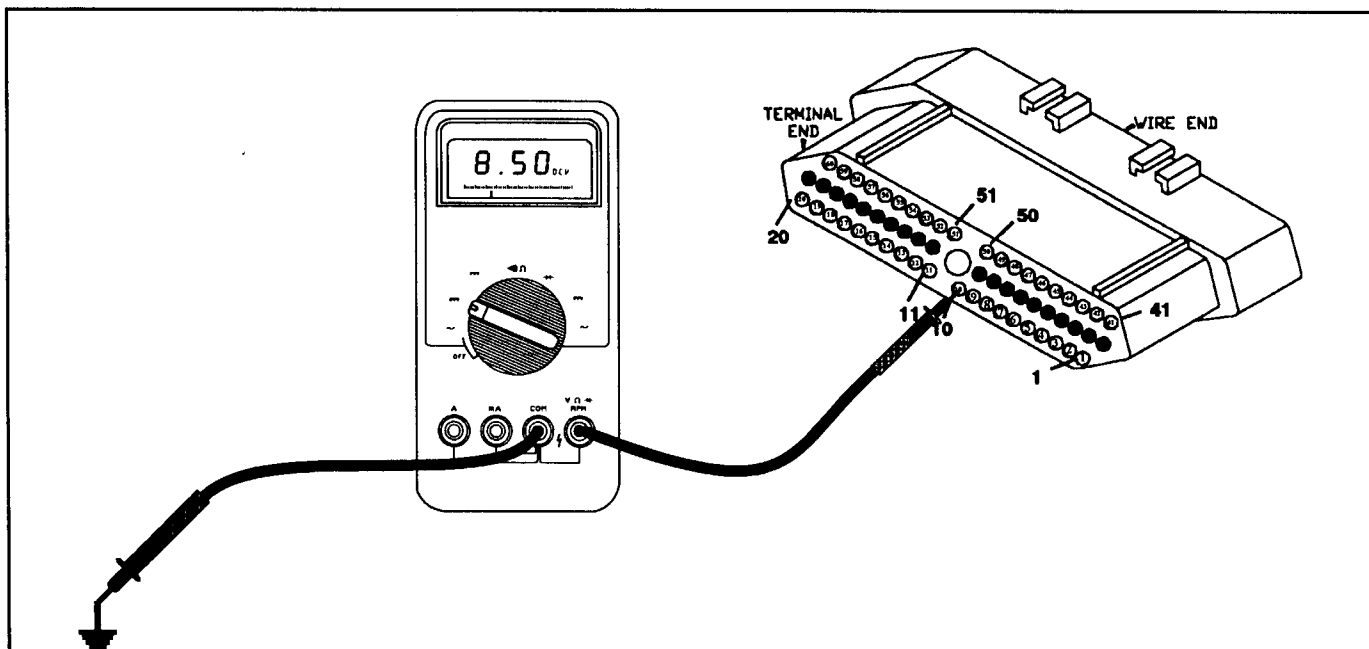
Figure 57

- Unplug the TCM connector with the ignition off. Once disconnected, turn the ignition on and check terminal 10 for 7 to 10 DC volts (See Figure 57). If 7 to 10 volts is observed, replace the TCM. If there is not, go to the next step.

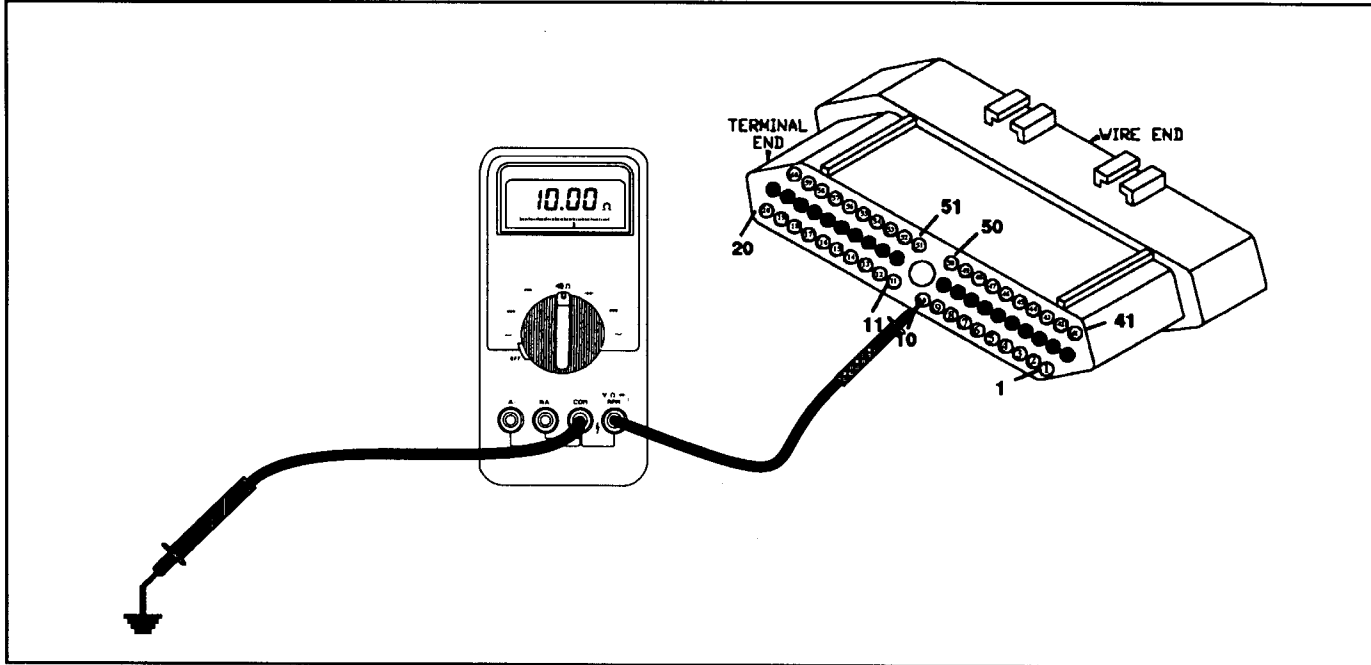
Figure 58

- Turn the ignition off. With the meter still on terminal 10, change to an ohms setting (See Figure 58). If the resistance is below 5 ohms, the wire is shorted to ground and will need to be repaired or replaced. If resistance is above 5 ohms, go to the next step.

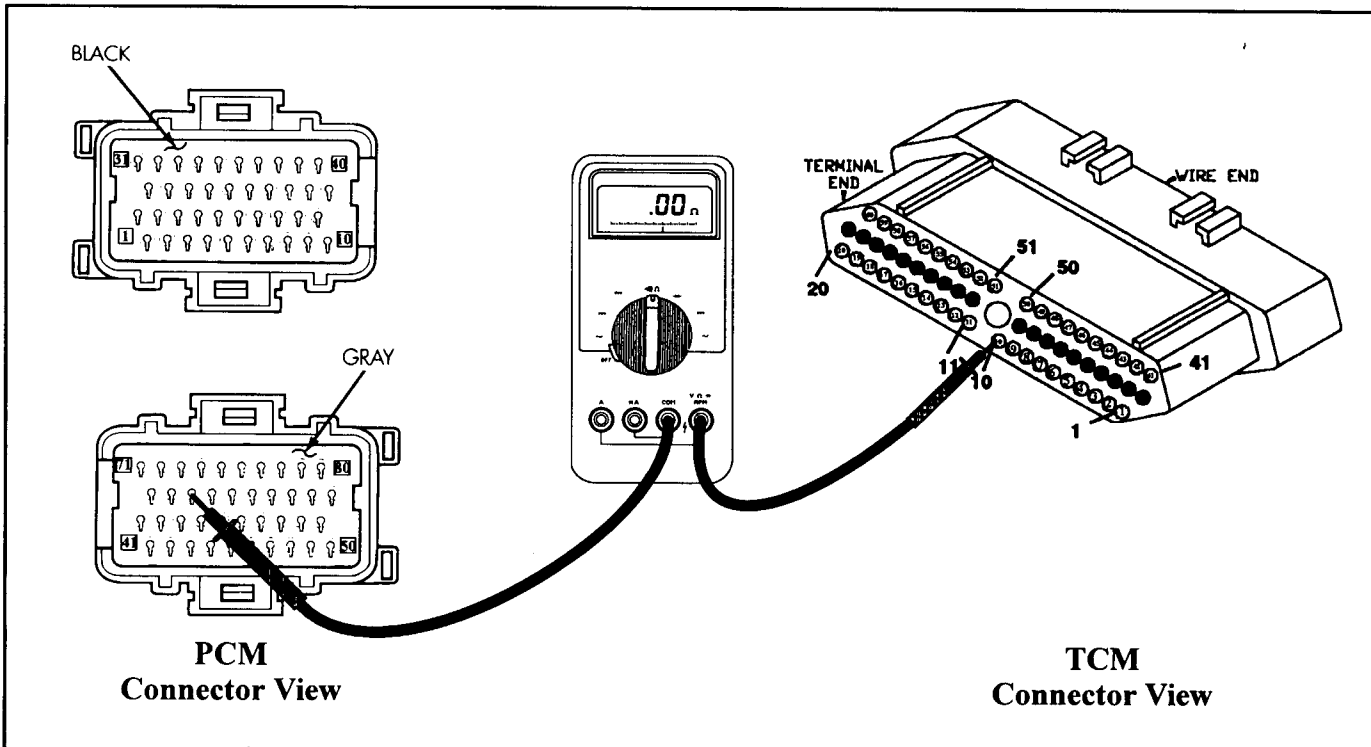
Figure 59

- Keep the ignition off and unplug the PCM and perform a continuity check across the wire. Place one meter lead to cavity 63 in the PCM connector and 10 in the TCM connector (See Figure 59). If resistance is below 5 ohms change the PCM. If an open is seen, repair or replace the severed wire.

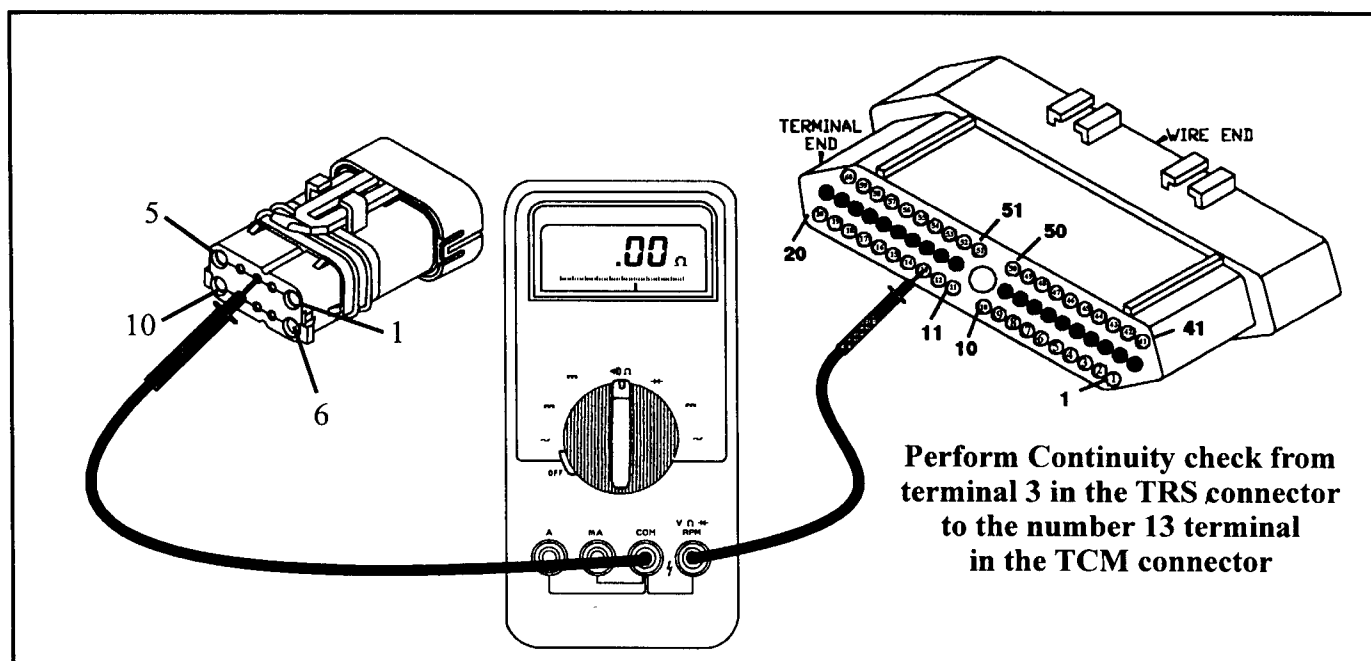
Figure 62

- 1996 and later vehicles have a Transmission Fluid Temperature Sensor built into the Transmission Range Sensor. The ground wire for this sensor is shared with the Turbine and Output RPM sensor at pin 13 in the TCM connector. Should this ground wire become severed, a code 58 and 72 may be set. A continuity check can be performed by placing one meter lead to terminal 3 in the TRS connector and terminal 13 in the TCM (See Figure 62). For further TFT sensor checks, refer to page 84.

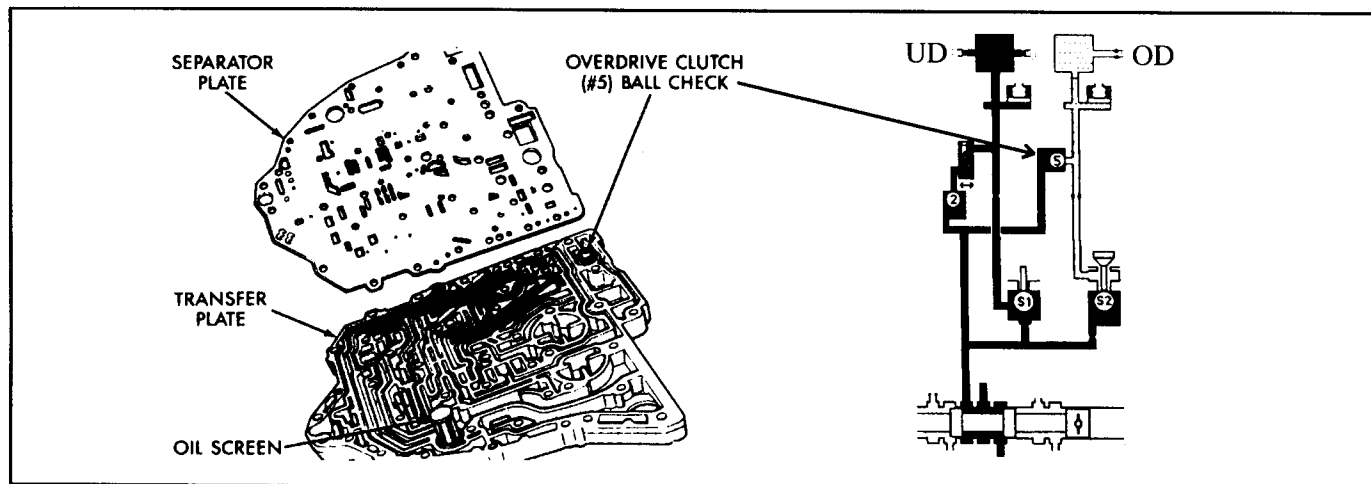
Figure 64

• A low clutch volume reading in just the OD clutch circuit has been commonly caused by a defective O ring on the # 5 check ball capsule in the transfer plate as shown in Figure 64. This blocks controlled line pressure from entering the OD clutch circuit. If the O ring or the capsule itself fails to hold back this pressure, the low OD clutch volume reading will vary depending upon the severity of the leak. If the leak is slight, most of the oil will exhaust past the OD solenoid and the OD clutch volume may appear to be normal. As the leak gets worse, the OD solenoid is flooded and the OD circuit becomes charged with oil causing below minimum CVI. *Note: The # 5 check ball capsule has been eliminated in late model 41TE's and all 42LE's.*

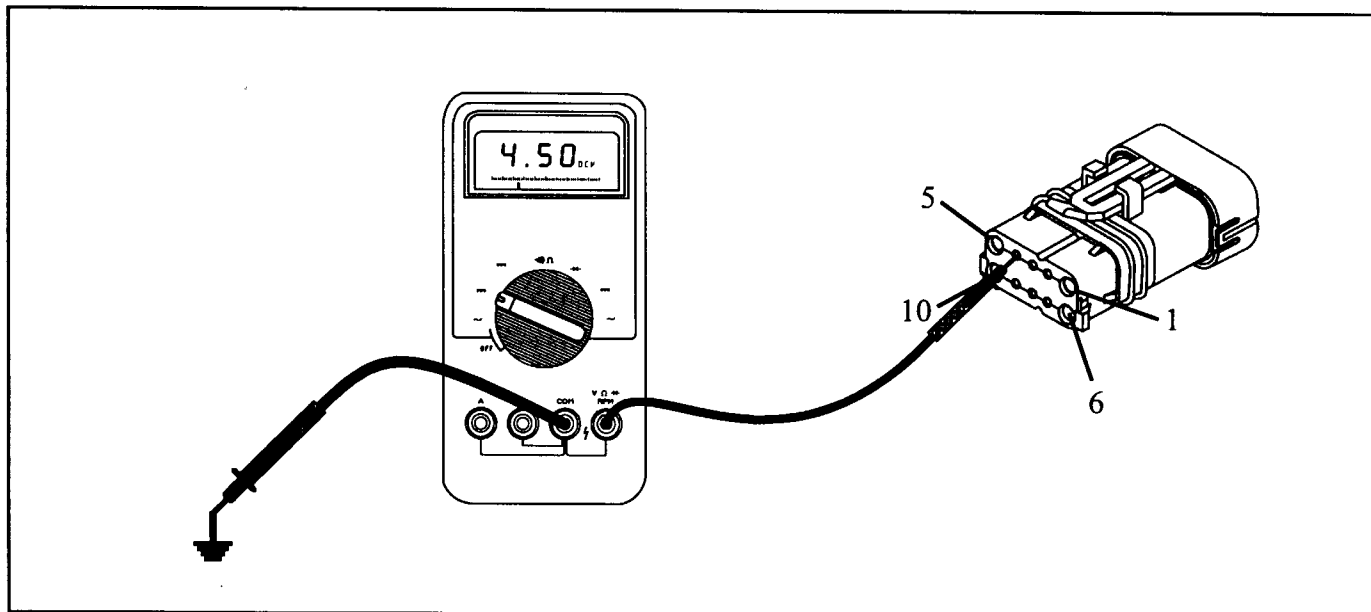
Figure 73

- Unplug the TRS connector. Place the ignition to the "ON" position. With a volt meter placed to DC volts, put the negative lead to a good known ground. With the positive lead, check terminal 4 for voltage (See Figure 73). If voltage is above 4.5 volts move to the next step. If less than 4.5 volts is observed, turn the ignition off and unplug the TCM. Change the meter to an ohms setting and check for continuity between terminal 54 in the TCM connector to terminal 4 in the TRS connector (See Figure 74). If continuity (5 ohms or less) is seen, replace the TCM. If continuity is not seen, repair or replace the wire.

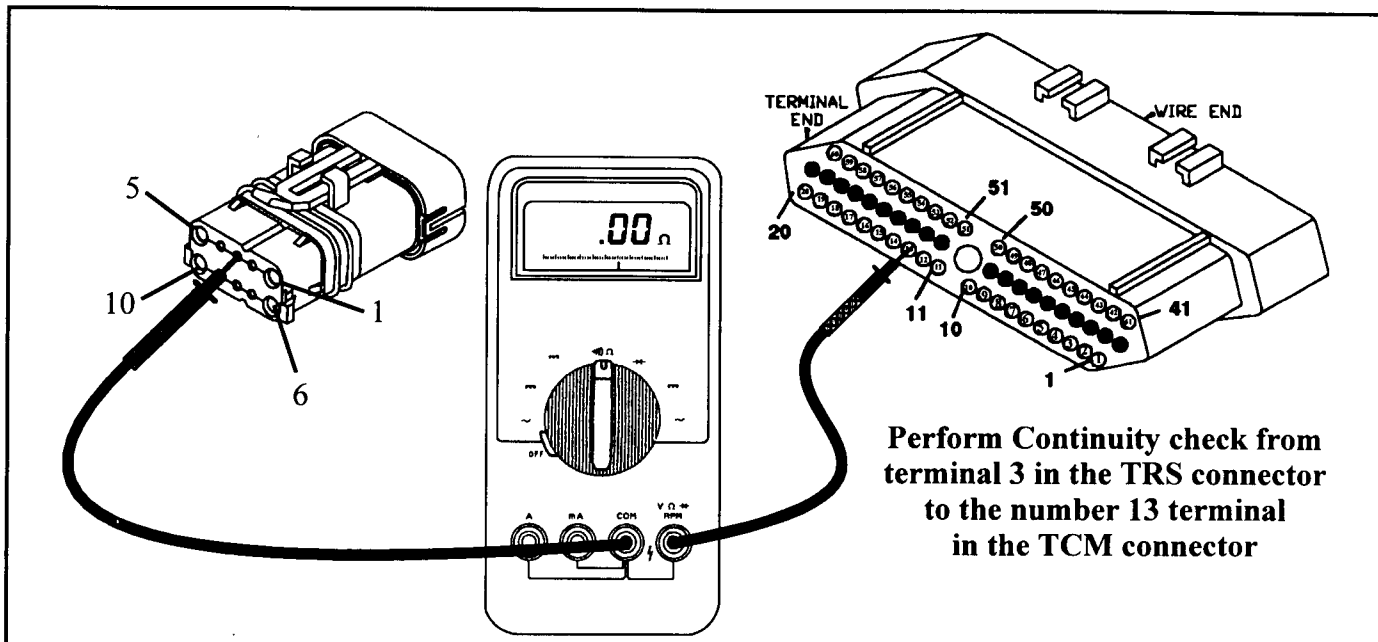
Figure 75

- Perform a continuity check on the TFT's ground wire by placing one meter lead to terminal 3 in the TRS connector and terminal 13 in the TCM as shown in Figure 75. If continuity is seen, go to the next step. If continuity is not seen, repair or replace wire. If the wire is to be replaced, the turbine and output RPM sensor also uses this wire for ground. Be sure to include them in the new wire (See Page 74).

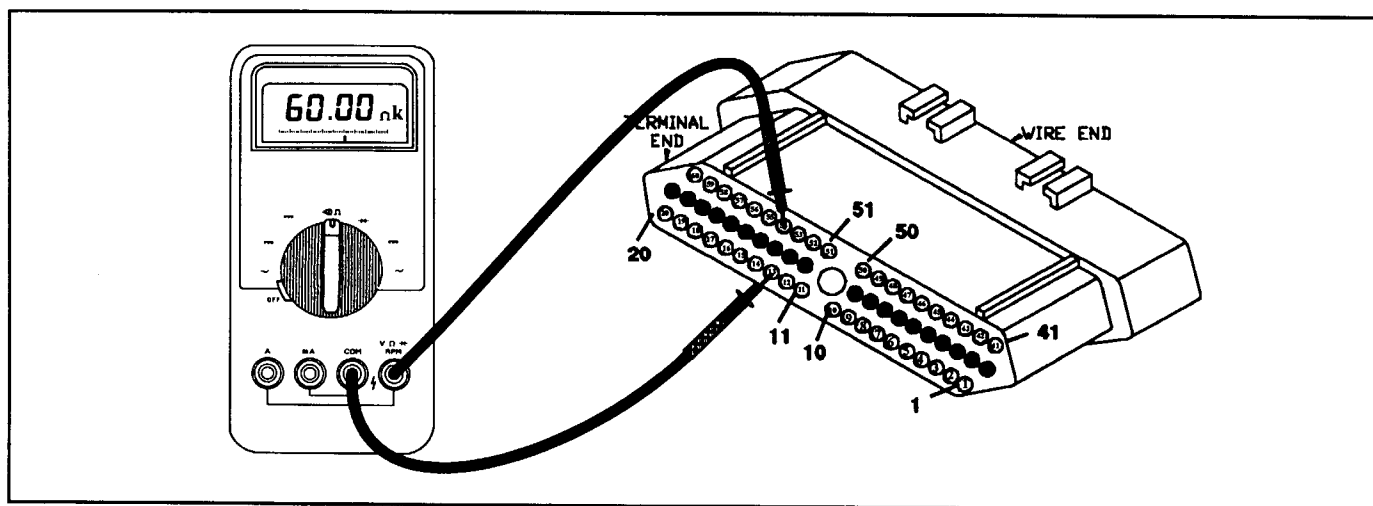
Figure 76

- Re-connect the TRS sensor and perform a resistance check on the TFT sensor from the TCM connector. Place one meter lead into terminal 13 and the other meter lead into terminal 54 (See Figure 76). The range for the sensor from cold to hot is 100,000 ohms to 150 ohms (See Table Below). If the change in resistance is proportional to the change in the transmission fluid temperature and the resistance remains within specification, change the TCM. If the resistance is out of specification or does not change in resistance proportional to temperature, change the TRS.

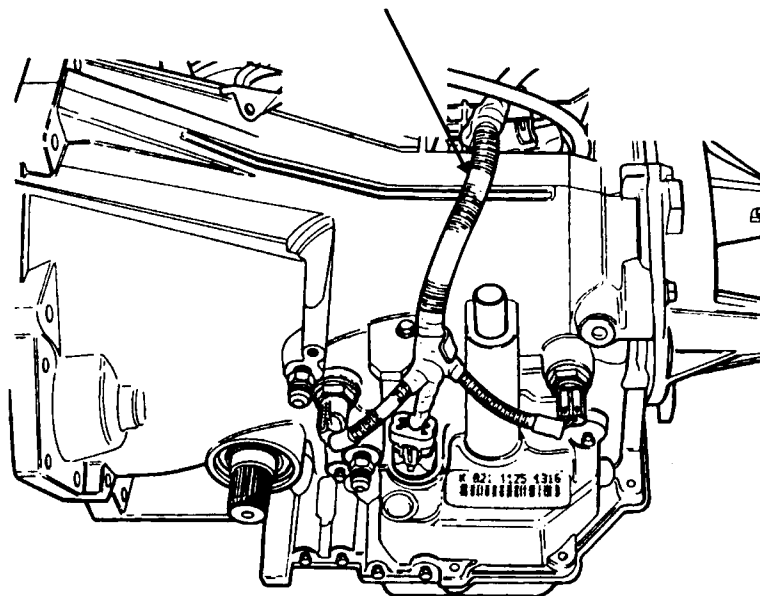
Figure 77

The 42LE transaxle has both the solenoid body and transmission range sensor mounted on the valve body. Each have their own connector coming through the case both of which are not easily accessible with the unit installed in the vehicle. To perform resistance checks of the solenoids, voltage checks on the pressure switches, resistance or volt checks on the Transmission Range Sensor (TRS) is near impossible at the case connector. The harness plugging into the solenoid body and the Transmission Range Sensor runs up to the top of the case above the bell housing where it plugs into the main vehicle harness (See Figure 77). This short wiring harness from the bell housing down to the solenoid body and TRS will allow for checks to be performed with ease. Figure 78 shows the top two connectors in this short pig tail harness. Each pin in these two connectors are numbered and identified. Should a resistance check need to be made on the solenoid body, rather than unplugging the solenoid body at the case (which could fill up with fluid if the unit is full), locate the 8 pin connector above the bell housing and unplug it. Place the positive meter lead of an ohm meter to pin 7. With the negative lead, touch pins 1, 2, 3 and 8 to obtain all 4 solenoid resistance values (See Figure 79). The chart in Figure 79 also provides checks that can be made through the 12 pin connector on the Turbine Shaft RPM sensor, the Output RPM sensor and the Transmission Fluid Temperature sensor.

SHORT HARNESS

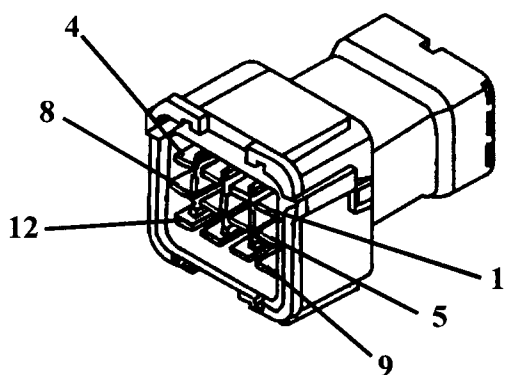
**12 PIN CONNECTOR
(TRANSMISSION SIDE)**

CAVITY	COLOR	FUNCTION
1	RD/BK	INPUT SPEED SENSOR SIGNAL
2	DB/BK	SPEED SENSOR GROUND
3	LG/WT	OUTPUT SPEED SENSOR SIGNAL
4	BR/YL	TRS-T1 SENSE
5	VT/WT	TRS-T2 SENSE
6	VT	TRS-T3 SENSE
7	LG/BK	TRS-T4 SENSE
8	VT *	TRANS TEMP. SENSOR SIGNAL
9	DG/OR *	AUTOMATIC SHUT DOWN RELAY
10	VT/BK	REVERSE LAMP SENSE
11	WT	FUSED IGNITION SWITCH OUTPUT
12	BK/LG	FUSED IGNITION SWITCH OUTPUT

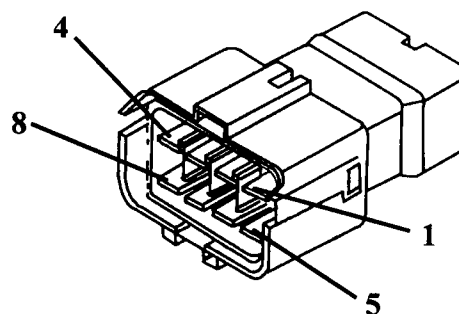
**8 PIN CONNECTOR
(TRANSMISSION SIDE)**

CAVITY	COLOR	FUNCTION
1	BR	O.D. SOLENOID
2	WT	2-4 SOLENOID
3	PK	U.D. SOLENOID
4	DG	L-R PRESSURE SWITCH
5	YL/BK	2-4 PRESSURE SWITCH
6	OR/BK	O.D. PRESSURE SWITCH
7	RD	TRANS CONTROL RELAY OUTPUT
8	LB	L-R SOLENOID

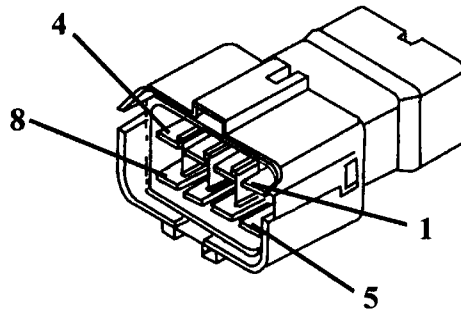
<u>TEST</u>	<u>POSITIVE LEAD</u>	<u>NEGATIVE LEAD</u>	<u>RESISTANCE</u>
L/R SOLENOID		8	1.5-2.0 OHMS
2-4 SOLENOID	7	2	1.5-2.0 OHMS
UD SOLENOID		3	1.5-2.0 OHMS
OD SOLENOID		1	1.5-2.0 OHMS

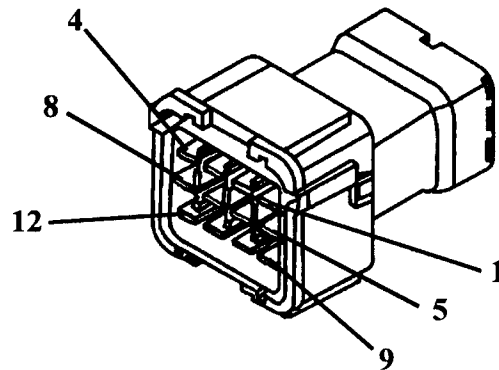
Figure 79

<u>TEST</u>	<u>POSITIVE LEAD</u>	<u>NEGATIVE LEAD</u>	<u>RESISTANCE</u>
TURBINE RPM	1		300-1200 OHMS
OUTPUT RPM	3	2	300-1200 OHMS
TEMP. SENSOR	8		VARIES (See Page 86)

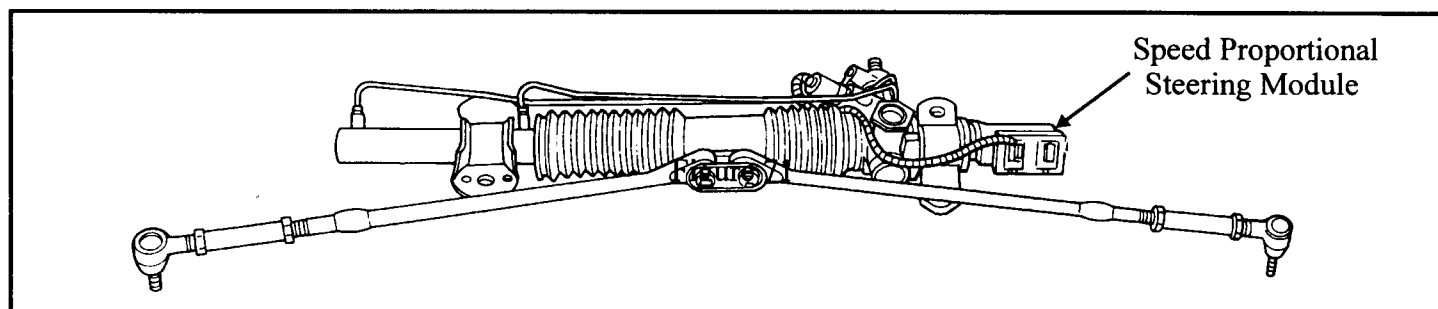
- Locate the Speed Proportional Steering Module on the steering rack as shown in Figure 80 and unplug it. Terminal 1 is battery feed from the ignition switch through either fuse 6 or 20. If battery voltage is not seen with the ignition ON, repair or replace fuse, ignition switch or severed wire. If voltage is seen go to the next step.

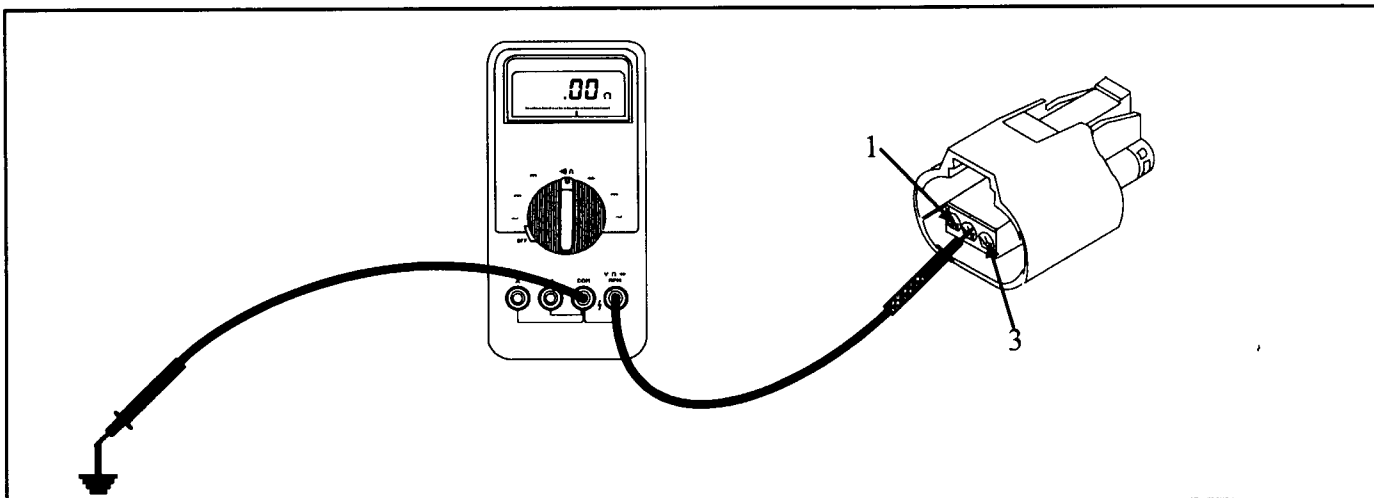
Figure 82

- Set meter to ohms and check the middle terminal for continuity as the middle wire goes to ground (See Figure 82). If continuity is seen (5 ohms or less), go to the next step. If continuity is not seen, repair or replace the wire.
- Perform a continuity check from terminal 3 in the Speed Proportional Steering Module connector to terminal 58 in the TCM connector (See Figure 83). If continuity is seen, go to the next step. If an open is seen repair or replace the wire.
- Plug the module and TCM back in and carefully back probe the # 3 wire with the meter set to DC volts. Start the vehicle and allow to the wheel to spin slowly. A 5 volts pulse should be seen. If there is, replace the Speed Proportional Steering Module. If there is not, either the TCM has not been flash with pinion factor information or the TCM is defective. Flash or replace the TCM.
