ENGINE Engine - Repair Instructions - V8 (N62, N62TU)

# Engine - Repair Instructions - V8 (N62, N62TU)

# 00 ENGINE, GENERAL

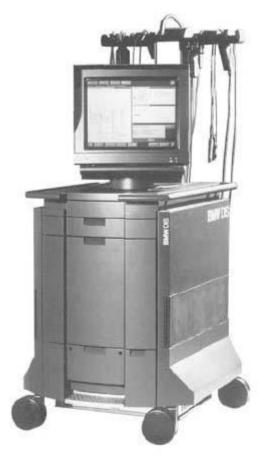
W05 95 001

Fig. 4: Diagnosis And Information System (DIS) Tester Courtesy of BMW OF NORTH AMERICA, INC.
