ENGINE Engine - Repair Instructions - X5 (N62TU V8)

00 ENGINE, GENERAL

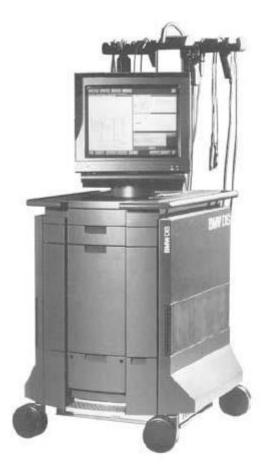
W05 95 001

11 00 045 CHECKING ABSOLUTE COMPRESSION OF ALL CYLINDERS

Fig. 4: Identifying Diagnosis And Information System (DIS) Courtesy of BMW OF NORTH AMERICA, INC.

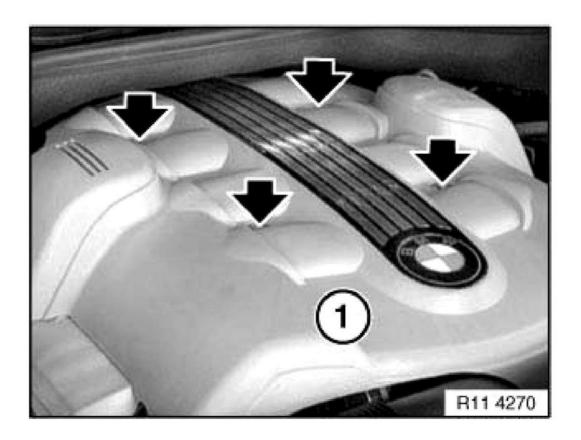
Raise acoustic cover (1) and remove towards front.

<u>Fig. 108: Identifying Acoustic Cover</u> Courtesy of BMW OF NORTH AMERICA, INC.

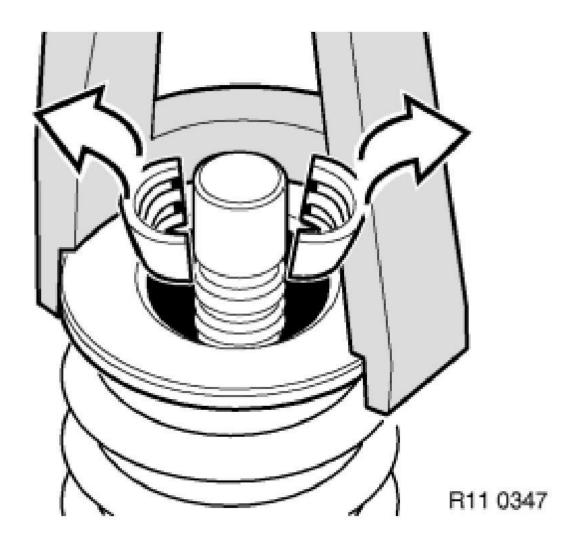
Press down valve spring on spring cap, top, and remove valve keys.

Fig. 499: Removing Valve Keys
Courtesy of BMW OF NORTH AMERICA, INC.
